**Port of Anchorage Intermodal Expansion Project
North Extension/Wet Barge Berth Sheet Pile Inspections**

Wet Barge Berth and North Extension
Preliminary Inspection Summary Report
Volume 2 of 2

10 December 2010

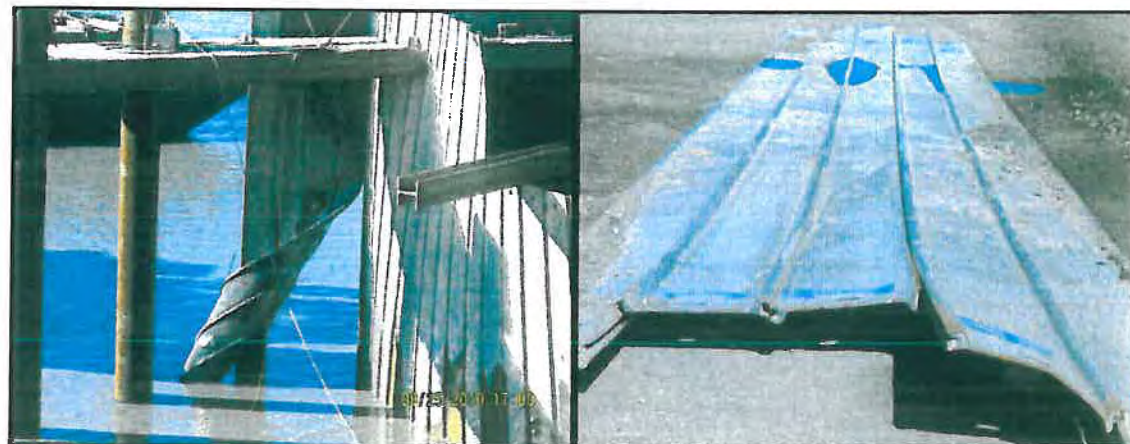
Examples of separated interlocks – WBB Cell 36 (left), face sheets pulled from NE Cell 39 (right).

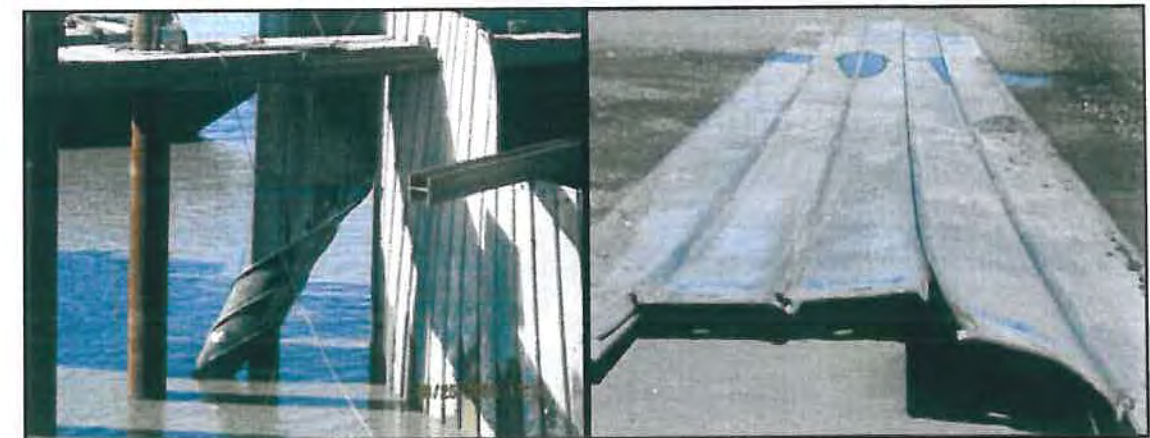
Examples of separated interlocks – WBB Cell 36 (left), face sheets pulled from NE Cell 39 (right).

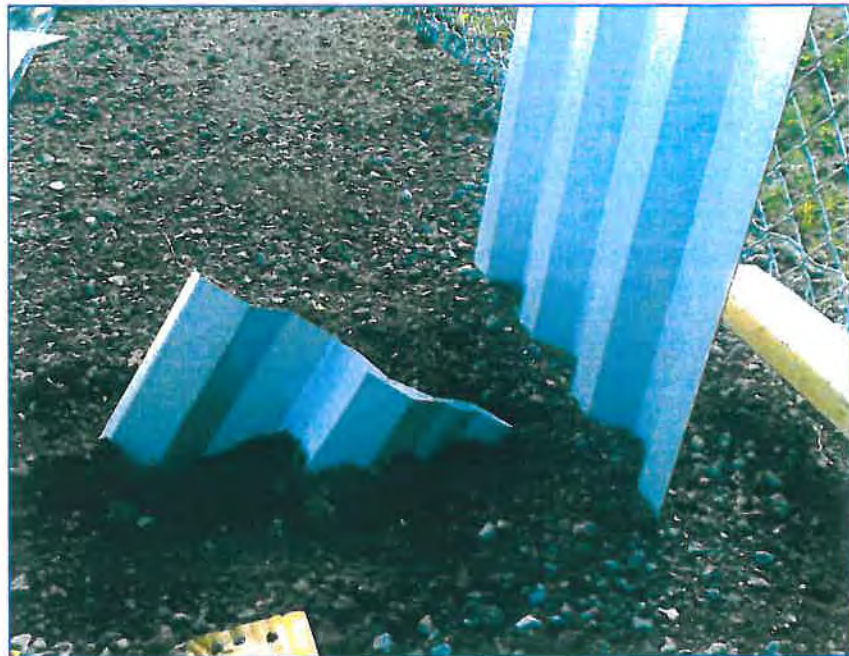
Diver results: All interlocks on the sheets were found to be without damage as well as the connecting joints to each adjacent cell. A 24" ledge was observed at mudline against the sheet wall that dropped off into deeper water where the dredging had occurred. At sheet 11, an end of a sheet pile was found sticking out of the bottom toward the vertical sheet 11 at a 45 degree angle in the manner indicated by the representative picture below. The end of the sheet was perpendicular to the vertical sheets on the wall and 18" inches away from the sheet pile wall. The diver was not able to move the sheet end, and was unable to determine the sheet's length or connectivity to the wall.

Representative model of sheet pile end found at sheet 11 in cell 50.

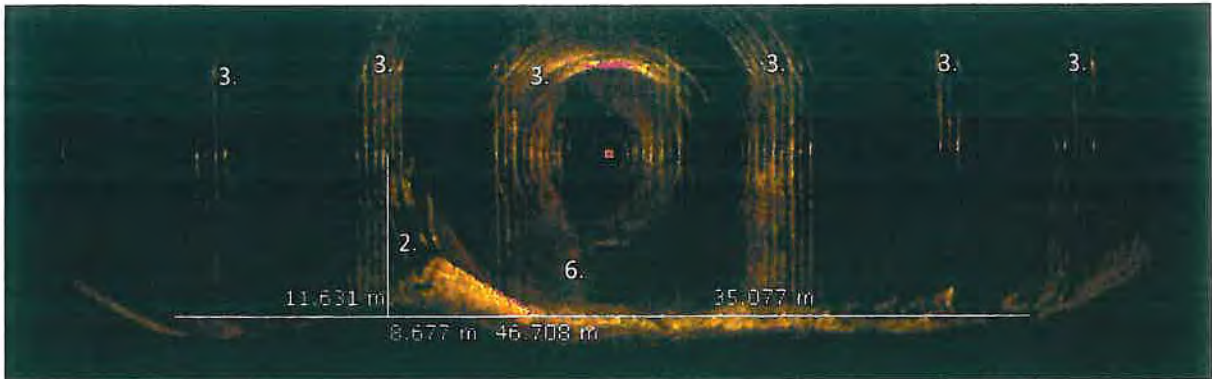
1, 2 Dim 58-64 Point of interest

- 1. 30m Range
 - a. View 58 through 64 point of interest is at south side of cell 59 with spill pile damage centered a north side of cell 60.
 - b. Horizontal dimensions indicate approximate distance in low point in trenched area. Vertical dimensions indicate approximate distance from bottom of trench to top of point of interest.

- 2. 30m Range
 - a. Approximate height of mud line before dredging. Note height of point of interest, marked sheet pile, compared to height of mud line.

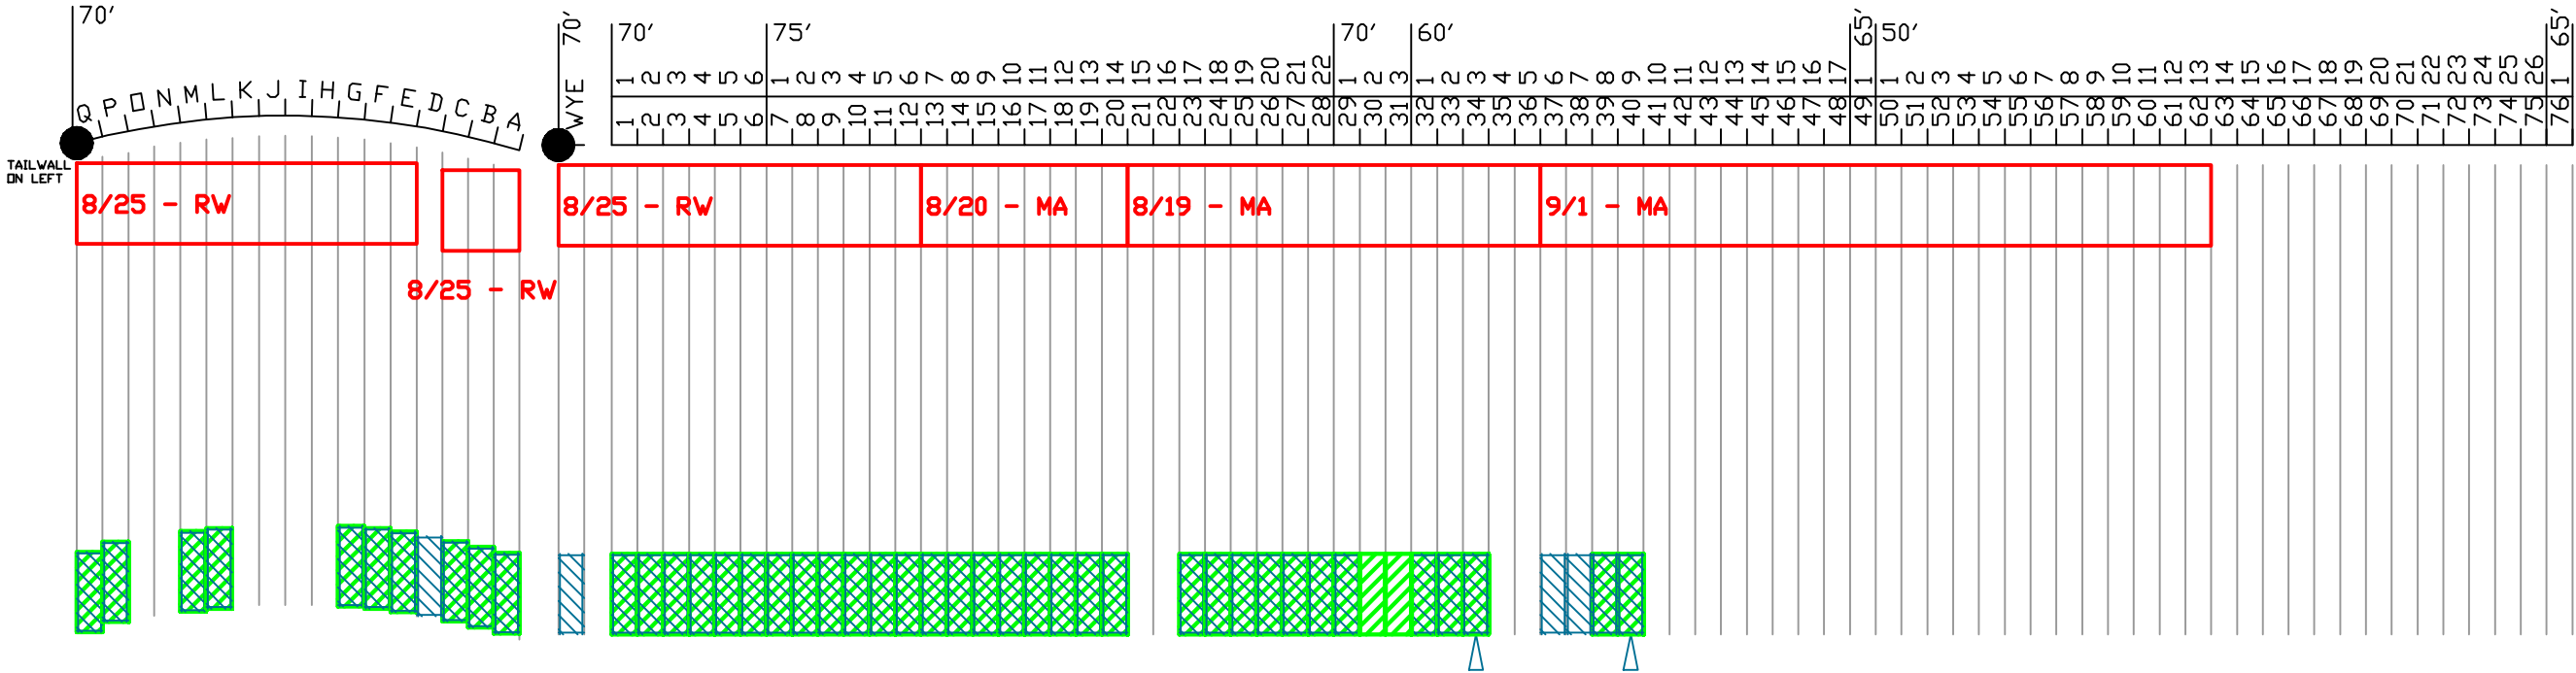
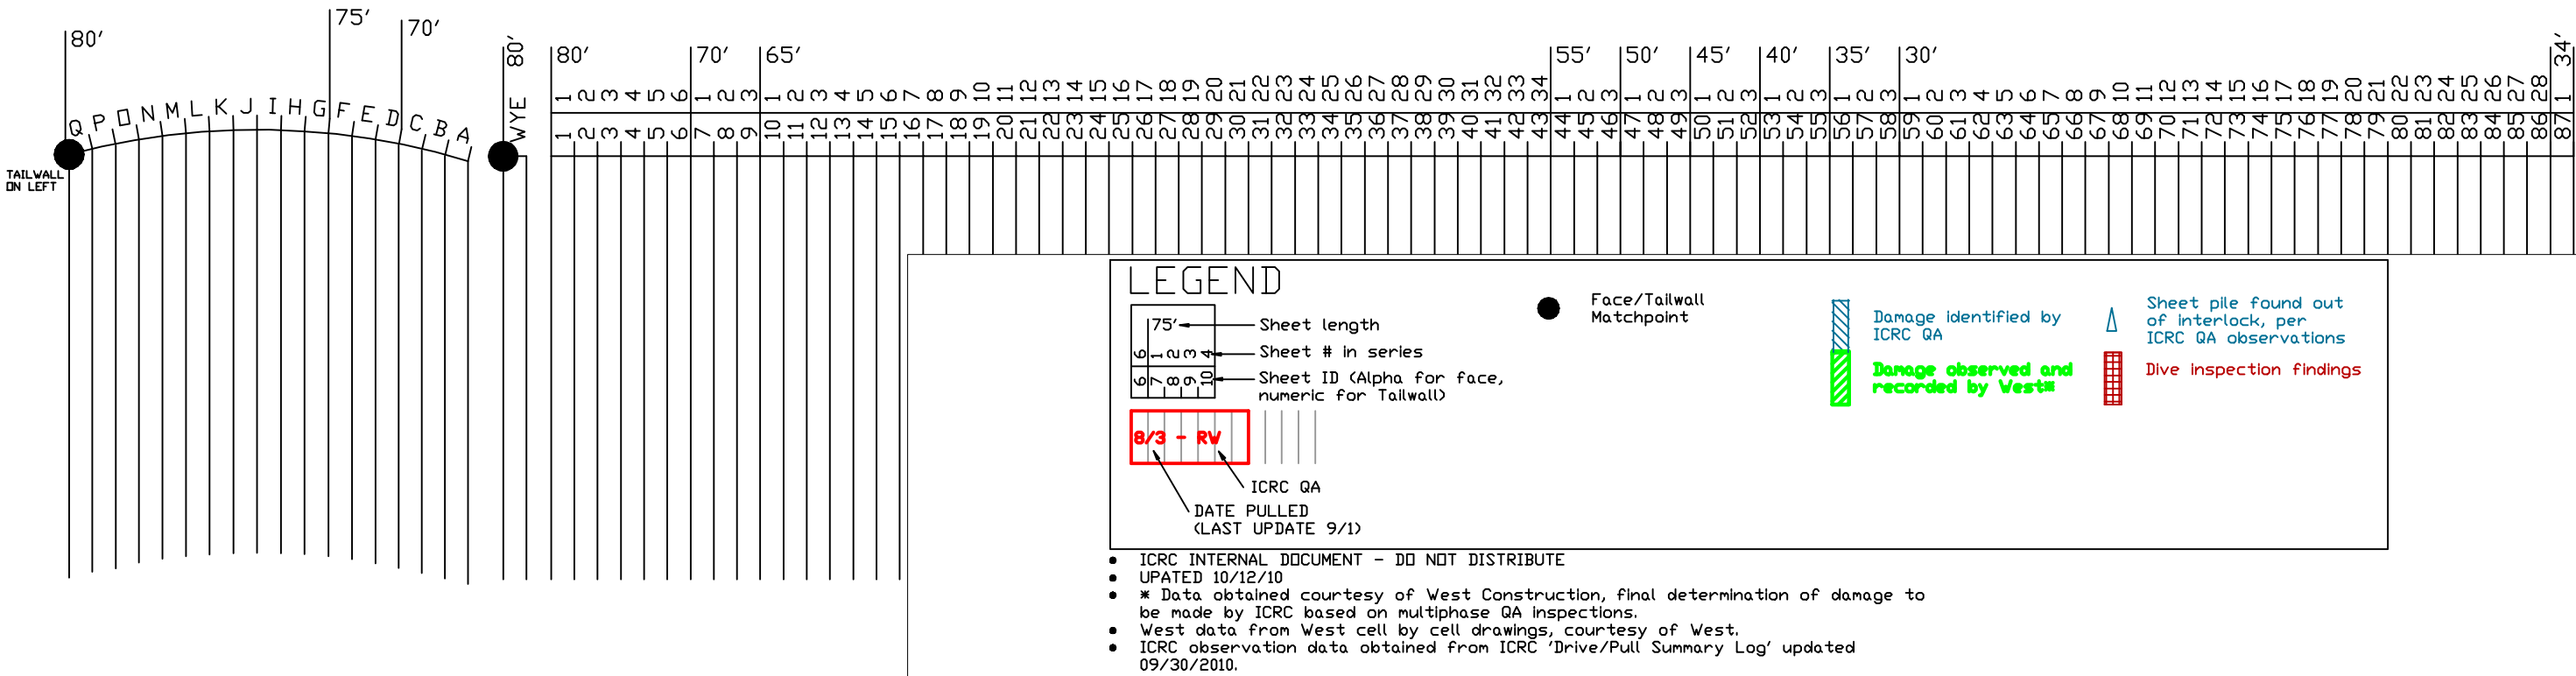
WBB 36
EXISTING

- c. Diver inspection of cells WBB 36, 37 and 38 found damage at WBB cells 36 and 38. These three cells were removed during August 2010 by West Construction Company to implement repairs. Inspection of pulled sheets at that time found significant damage to face sheets in all three cells, and is documented in records from that work.

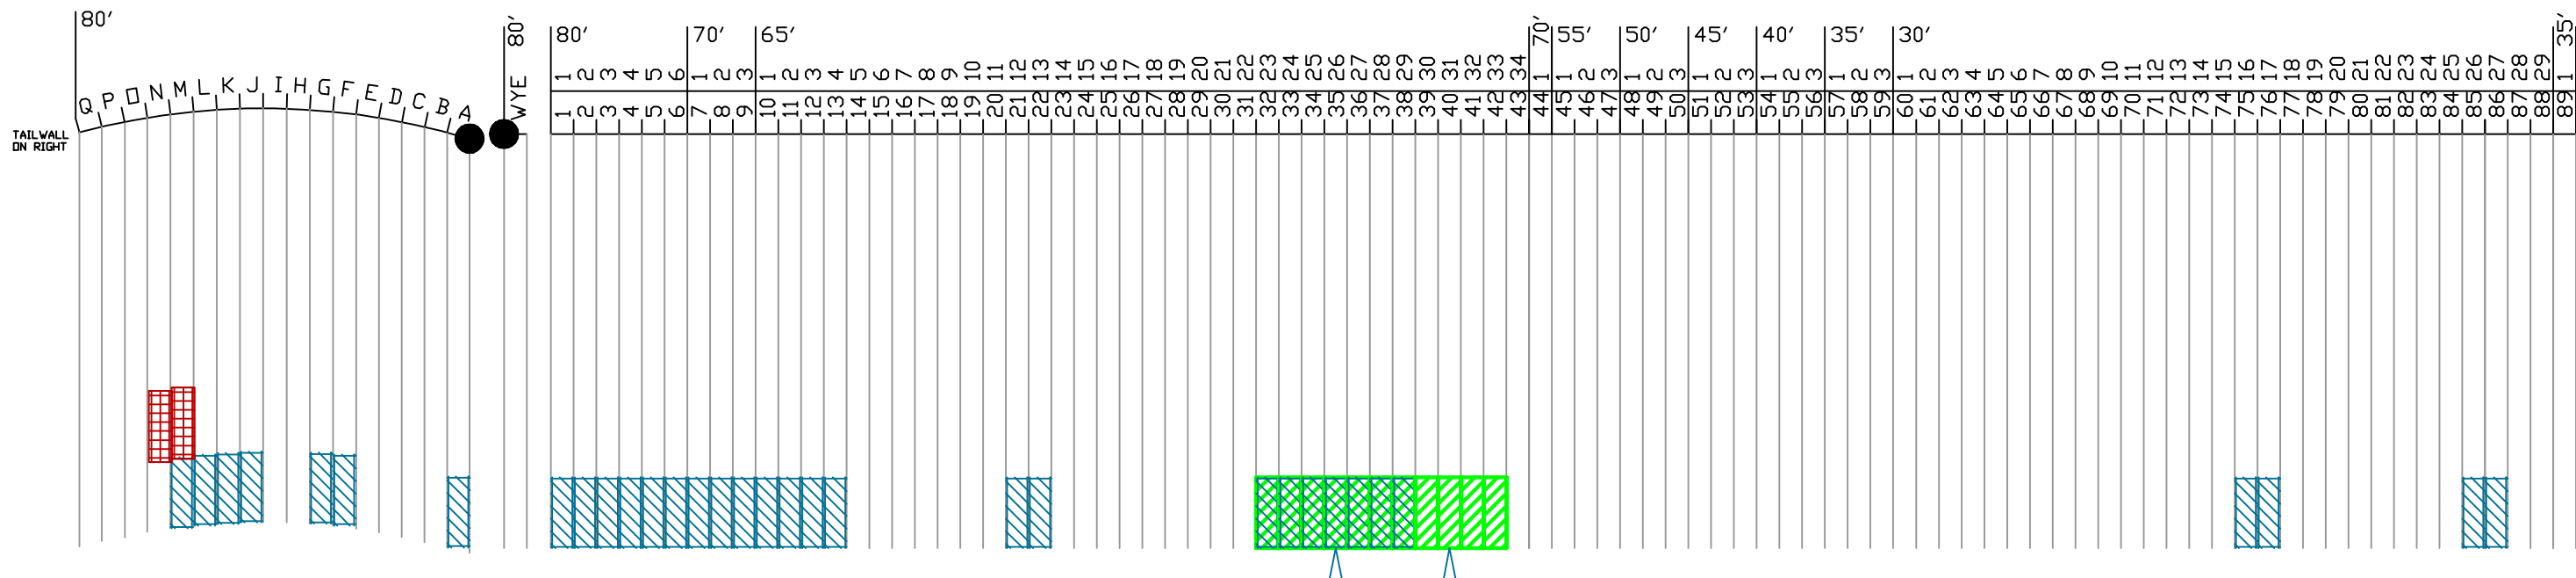
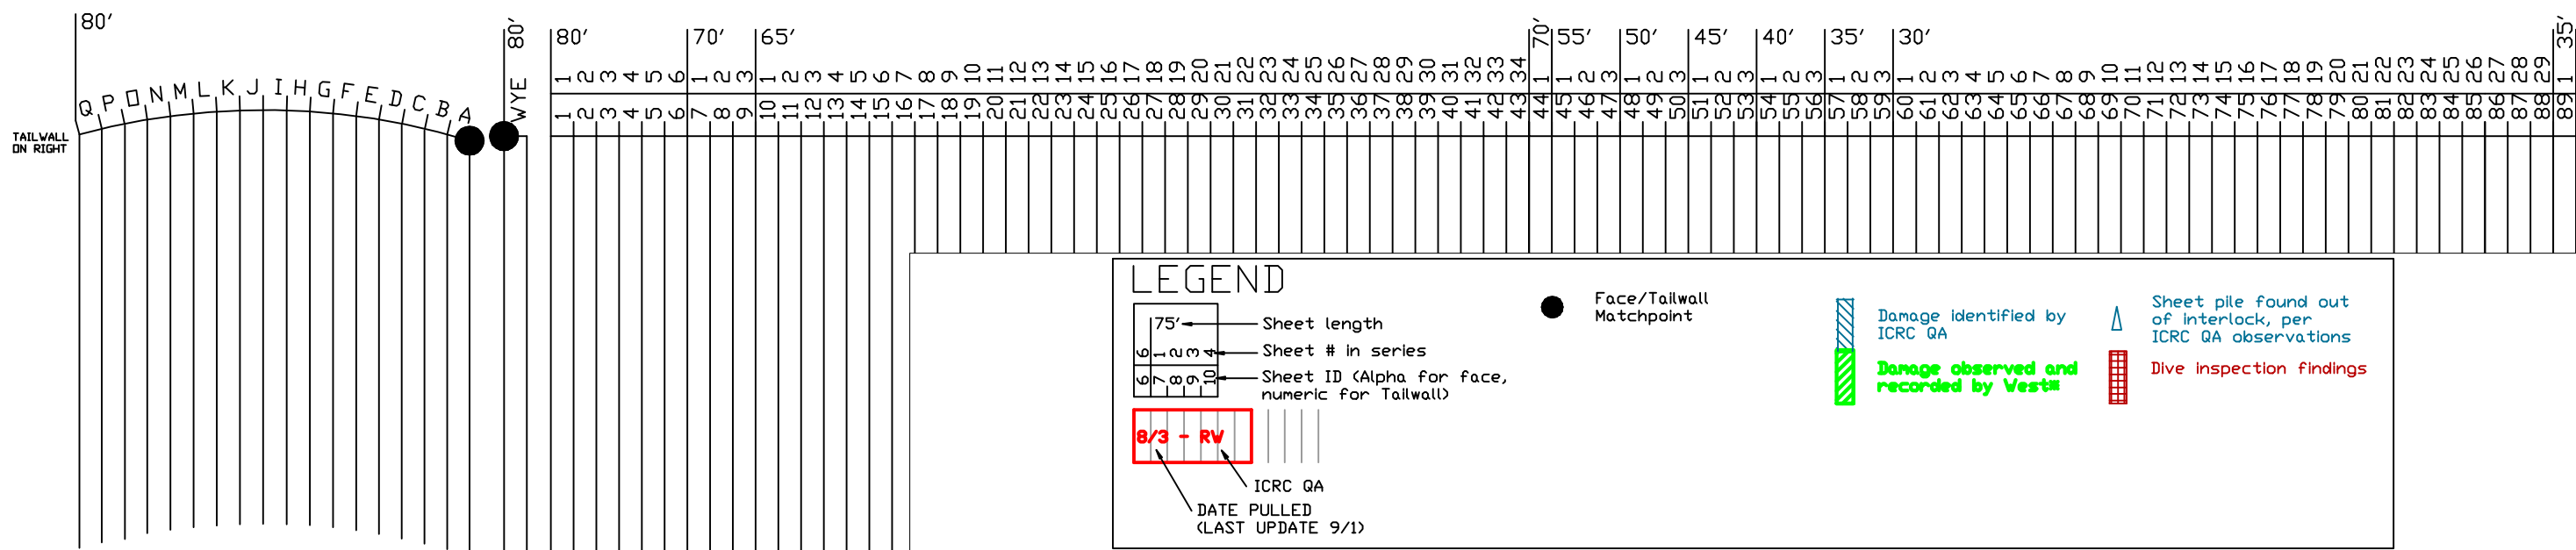
**NE 10
EXISTING**

Inspection Date	Cell	Damage Type	Damage Location and Description	Estimated Elevation of Damage * (ft MLLW)	Estimated Mudline Elevation During Inspection * (feet MLLW)
8/16/2010	NE 10	Split interlock	Sheet 13-14 split interlock starts 4 feet off mud line. 1.5" gap at mud line.	-26	-30 to -36 ***
8/16/2010	NE 11	Bent sheets at wye	Sheet 1 is bent out 1.5 feet to the west side. Sheet appears wrinkled to 4 feet above mud line.	-26	-29 to -31 ***
8/16/2010	NE 11	Sheet out of both interlocks	The interlock between sheets 2 and 3 is ripped. Sheet 2 is bent out to the west side 6" and twisted.	-27	-
8/16/2010	NE 11	Horizontal rip in sheets	Sheets 11-14 ripped horizontally across the sheets and interlocks. Rip is approximately 3 feet above mud line. Center sheets are bent out to west side.	-27	-
8/16/2010	NE 11	Split interlock	Sheet 16-17 split interlock starts 3" below mud line.	-29	-
8/16/2010	NE 12	Sheet out of both interlocks	Sheet 1 appears bowed out to west side. Sheet 2 is out of both interlocks, bent 180 degrees and sticking up out of mud line 2 feet.	-26	-25 to -26 ***

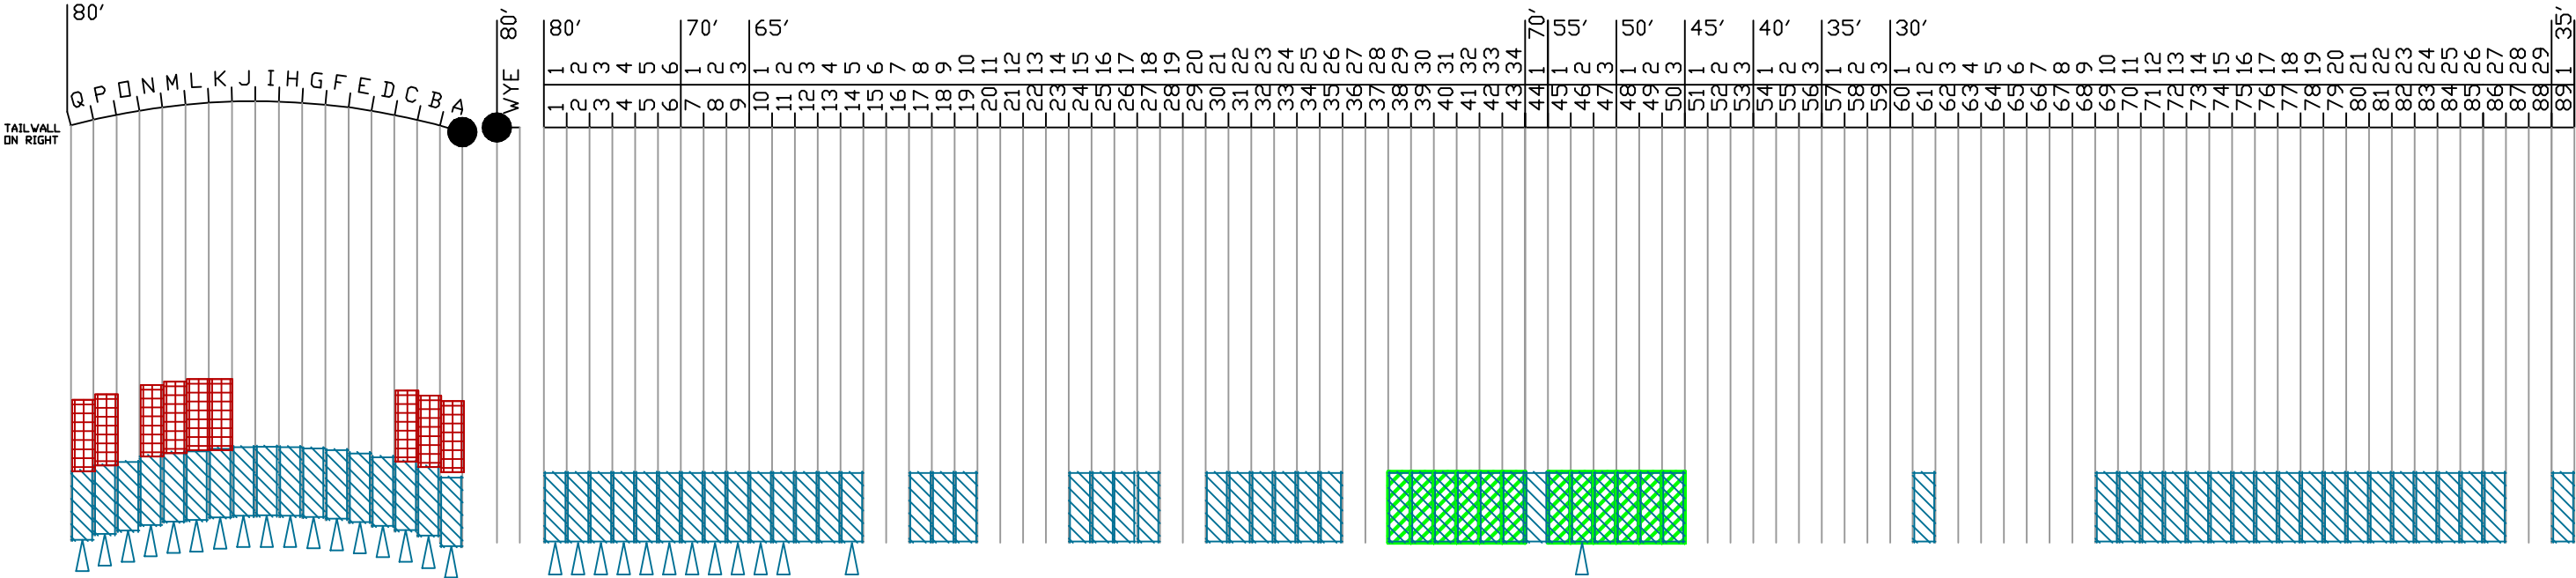
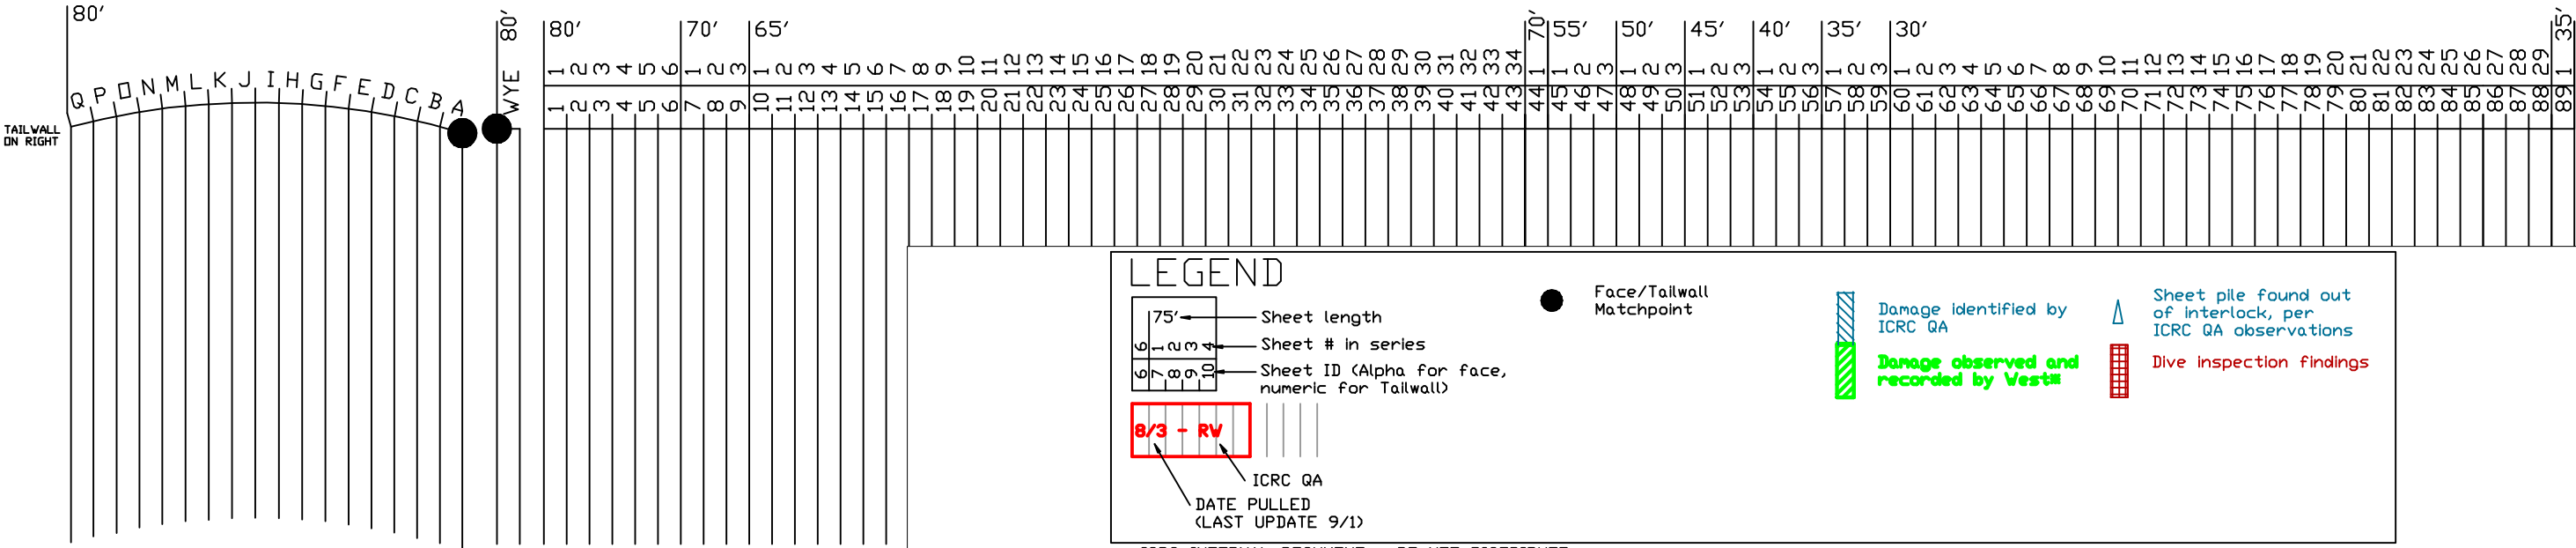
NE 11
EXISTING

- Cell 11 sheets were driven to 1 to 12 feet above grade. The assumed sheet pile tip elevations varied from -47 to -36’ MLLW based on survey provided by QAP in 2009. Multiple damaged sheets were located in this cell. The second sheet from the 11/12 wye had a separated interlock just below mud line that the diver could fit his gloved hand through. Sheets 5, 6, 7 were ripped and twisted away from the wall 3 feet up from mud line. Sheets 16 and 17 from (south to north) were also ripped and curled out like a corkscrew about 3 feet above mud line and small spoils pile formed outside the wall.

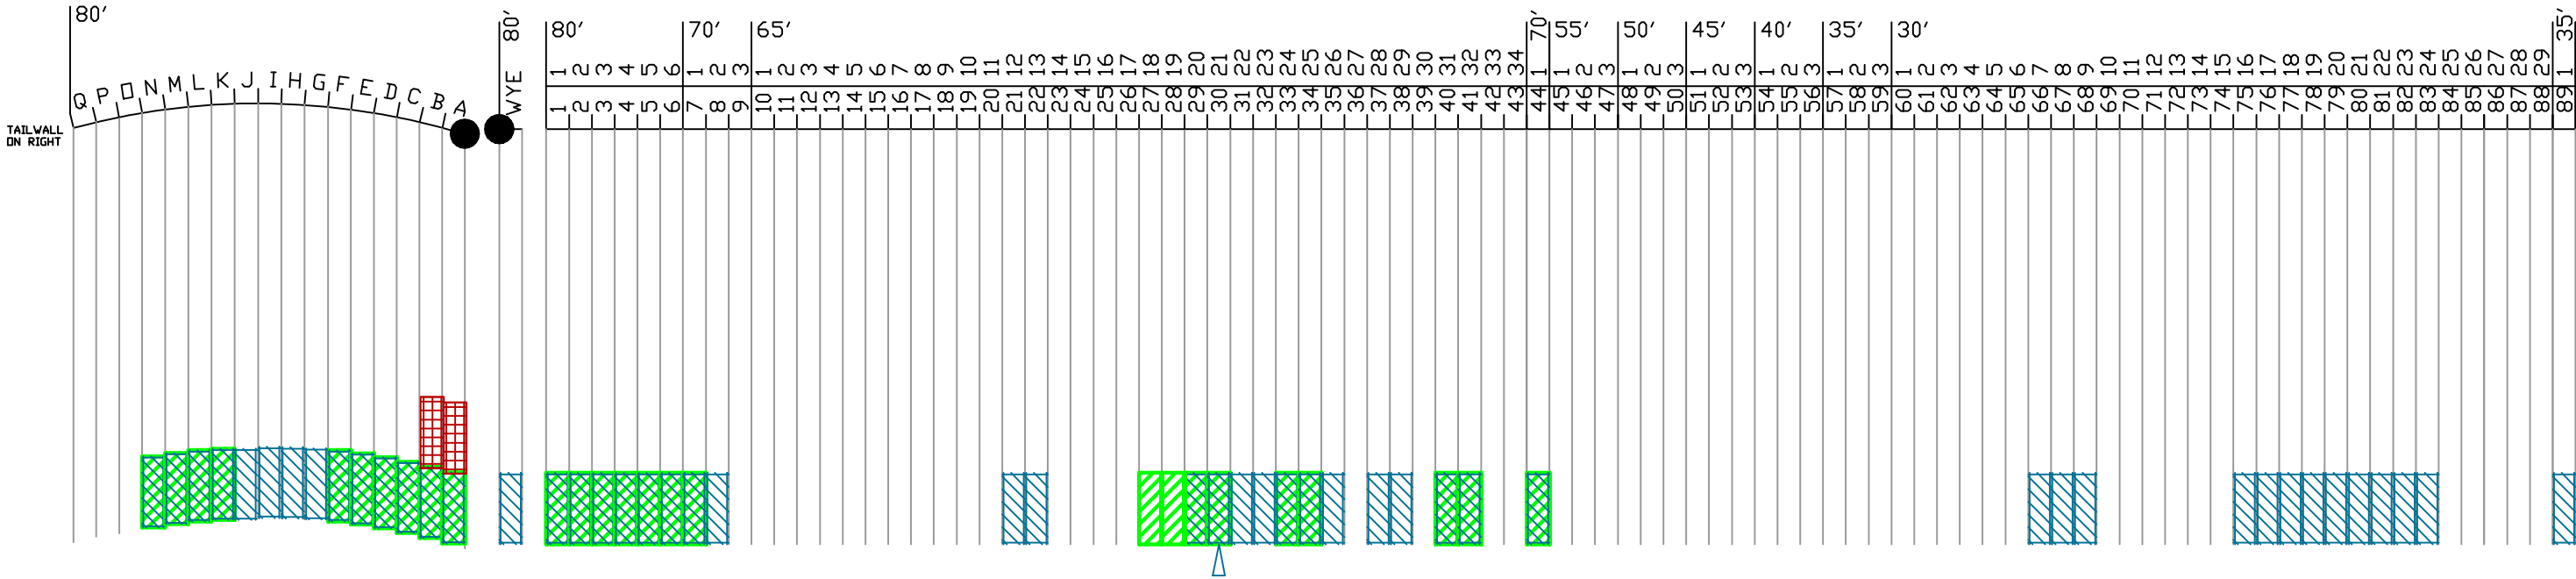
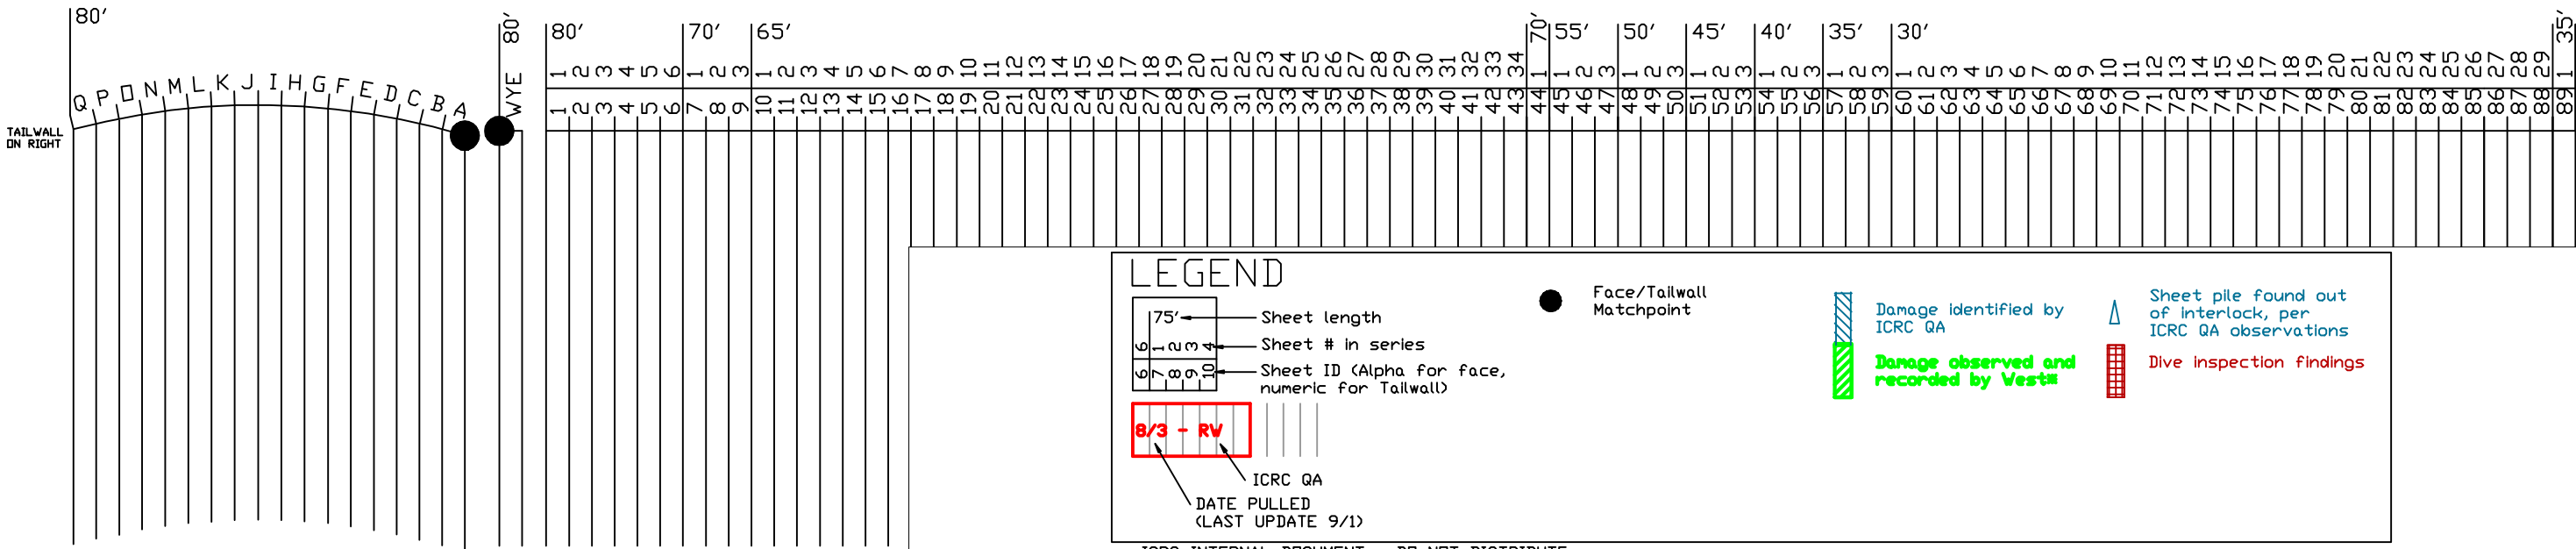
NE 12
PLAN

- Cell 12 sheets were assumed to be driven to grade with an estimated sheet tip elevation of -48 MLLW, no survey data was available for cell 12. Cell 12 had one sheet (#16) bent up and seaward for approximately 8 feet at the bottom. The diver initially noted the corner of a sheet sticking out of the mud but was unable to move it or uncover it. Another diver with a pressure washer was able to clear off some of the material covering the sheet and identify the 8’ length of sheet was bent out from the wall. Global Offshore Divers report to follow.

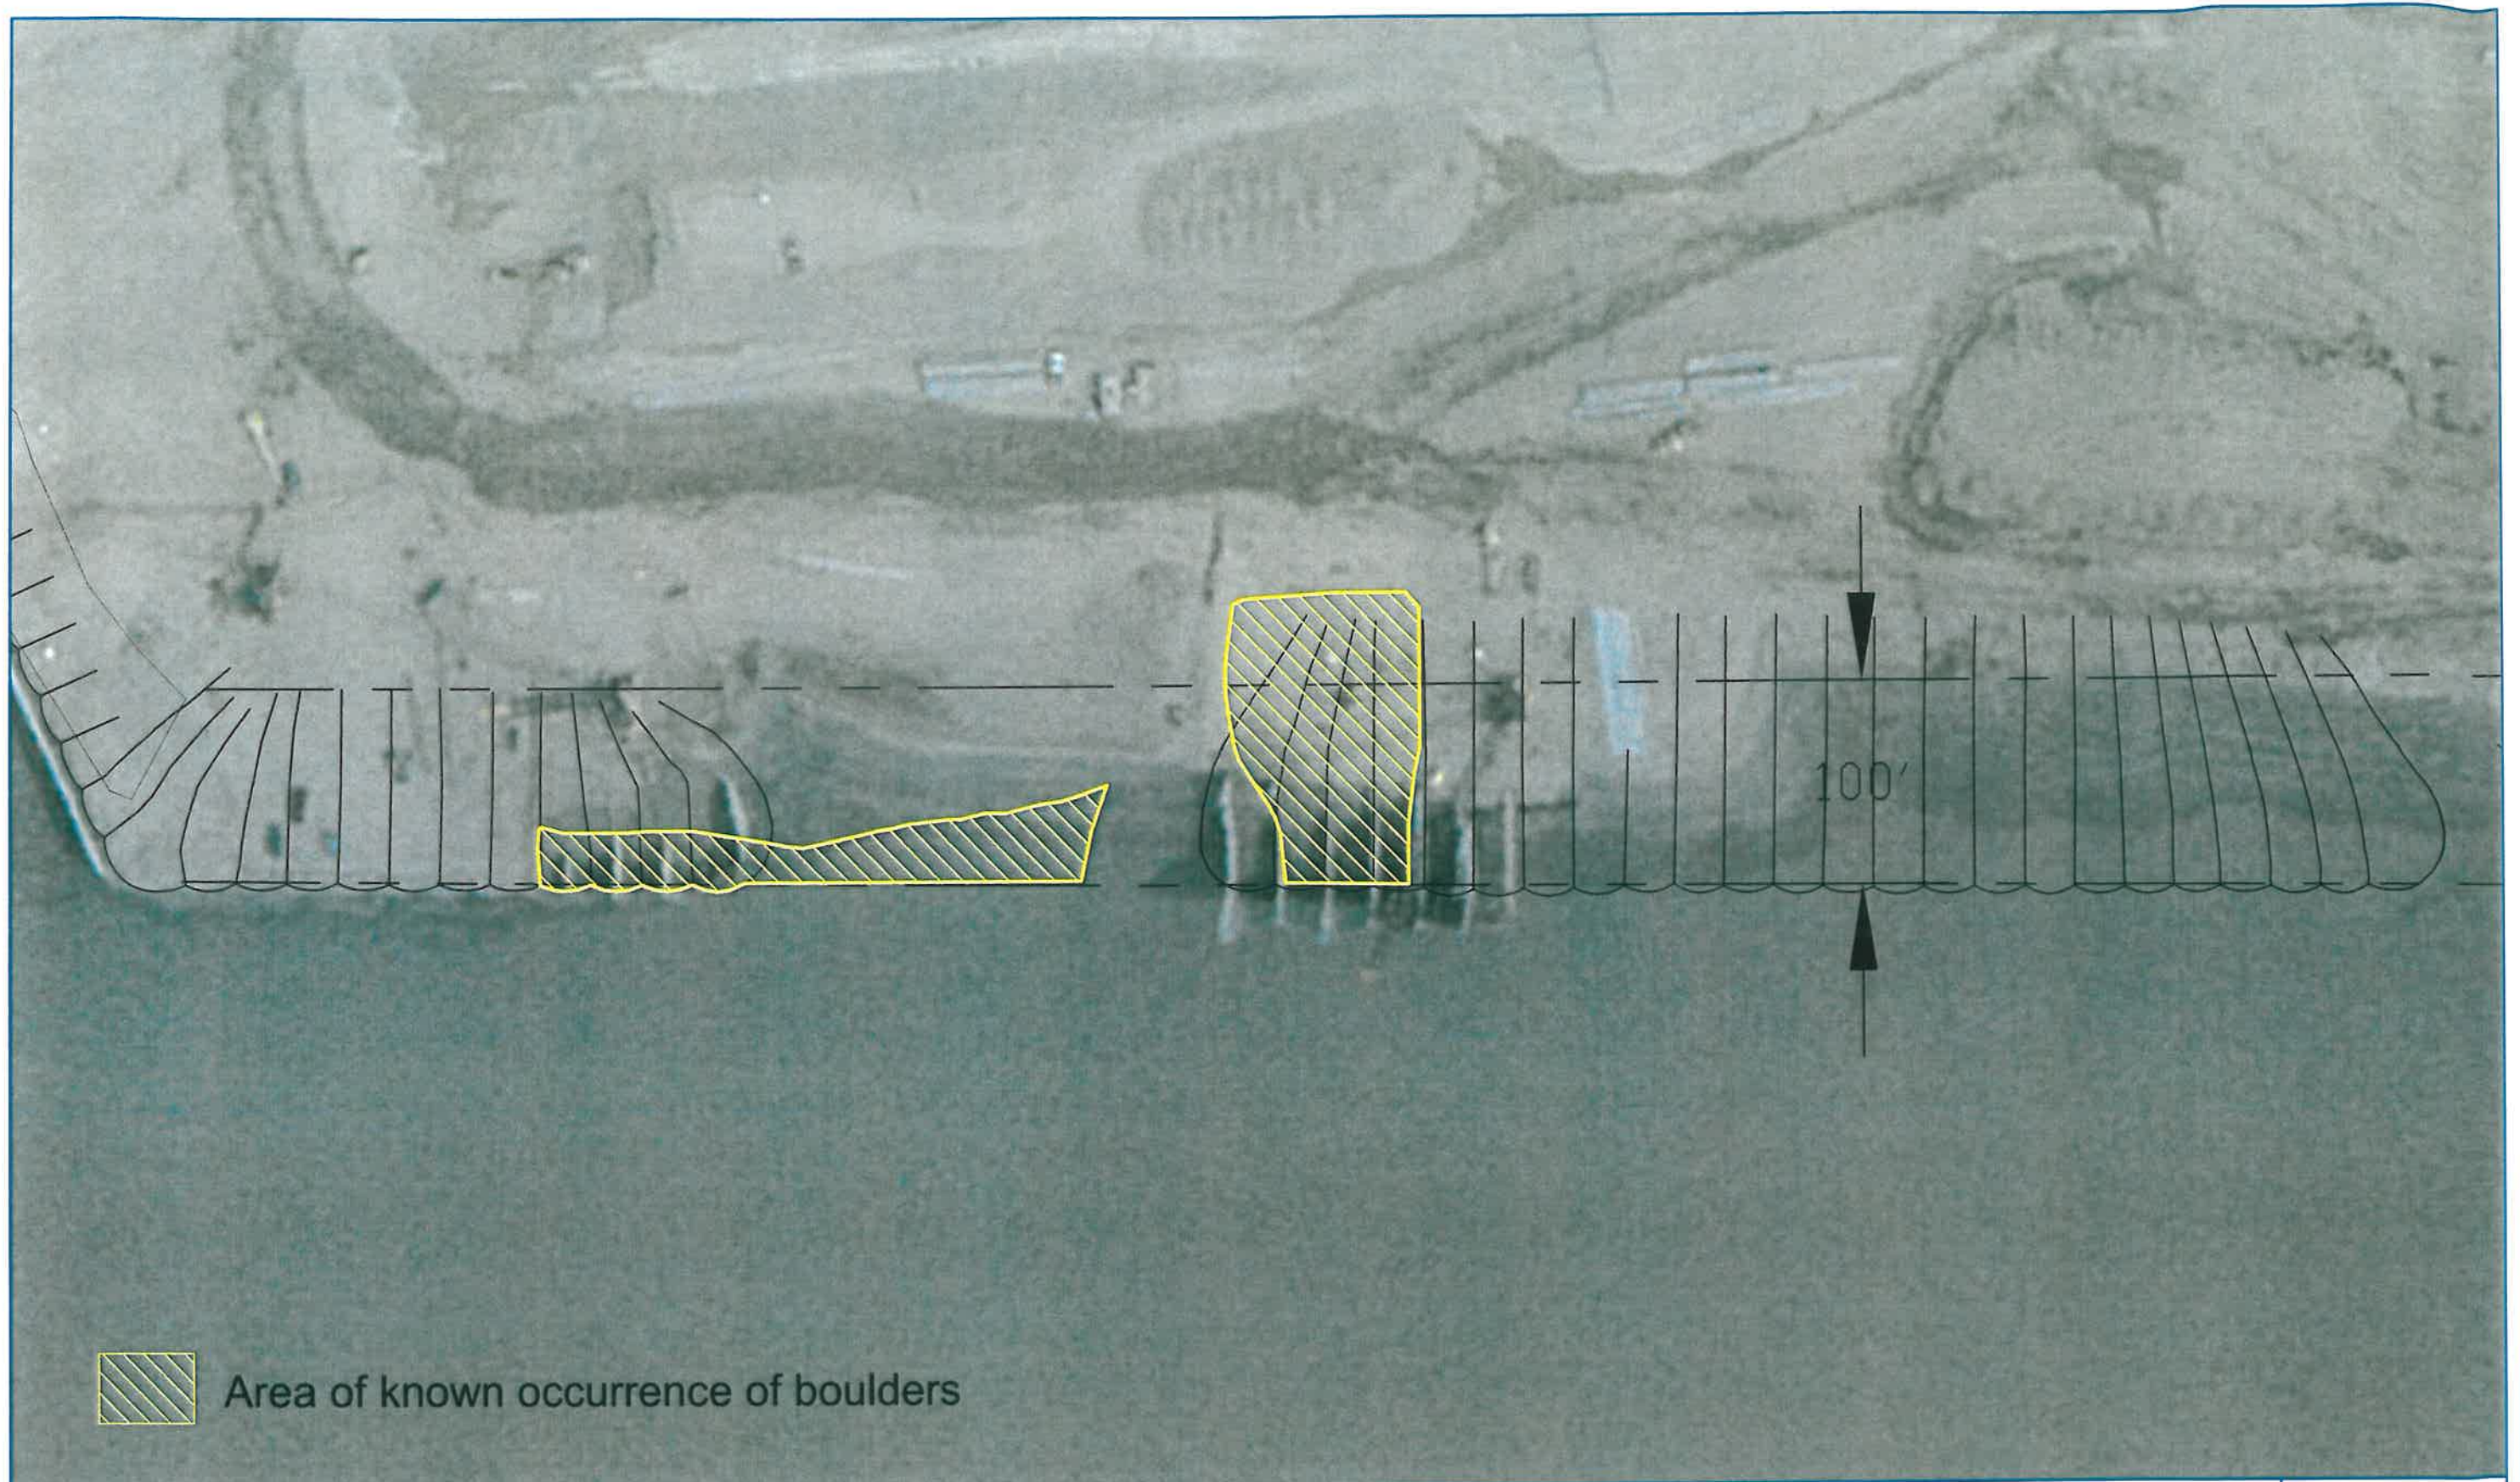
Subsurface Rocks

Area of known occurrence of boulders
