Port Board Says Tides Not At Fault

Damage Heavy As Oil Tanker Rams City Dock

Tanker Slams Into Petroleum Dock

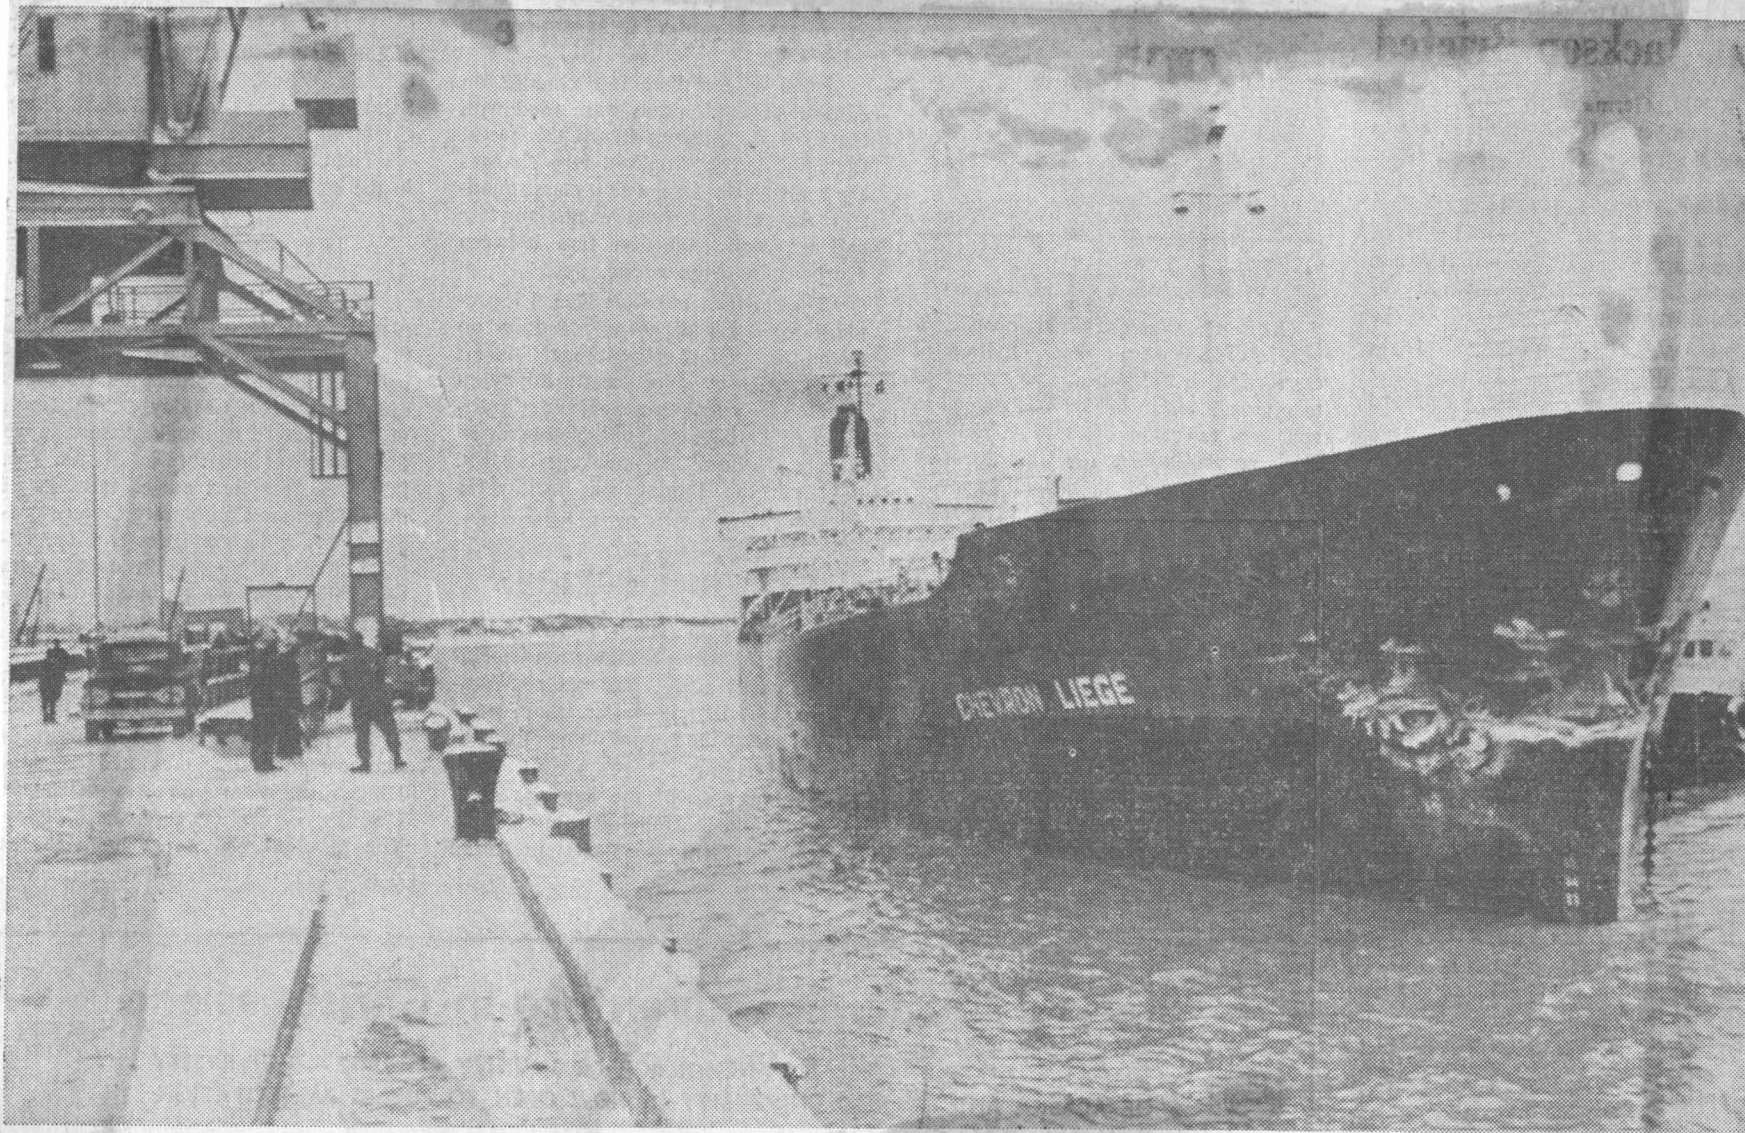
THE CHEVRON LIEGE sits quietly alongside the city dock Friday with its damaged bow shortly after it rammed the petroleum docking facility. Damage to the dock and vessel was reported as extensive. The Standard Oil tanker was carrying about 180,000 barrels of jet fuel. Below, the damaged portion of the petroleum dock is shown as workers move to unload the jet fuel. (Daily Newsphotos by Robin Smith)

"IT FRACTURED the dock structure in two," he said.

The collision left the Chevron Liege, owned by Standard Oil of California, with a bow disfigured by a high about 12 feet above the water line.

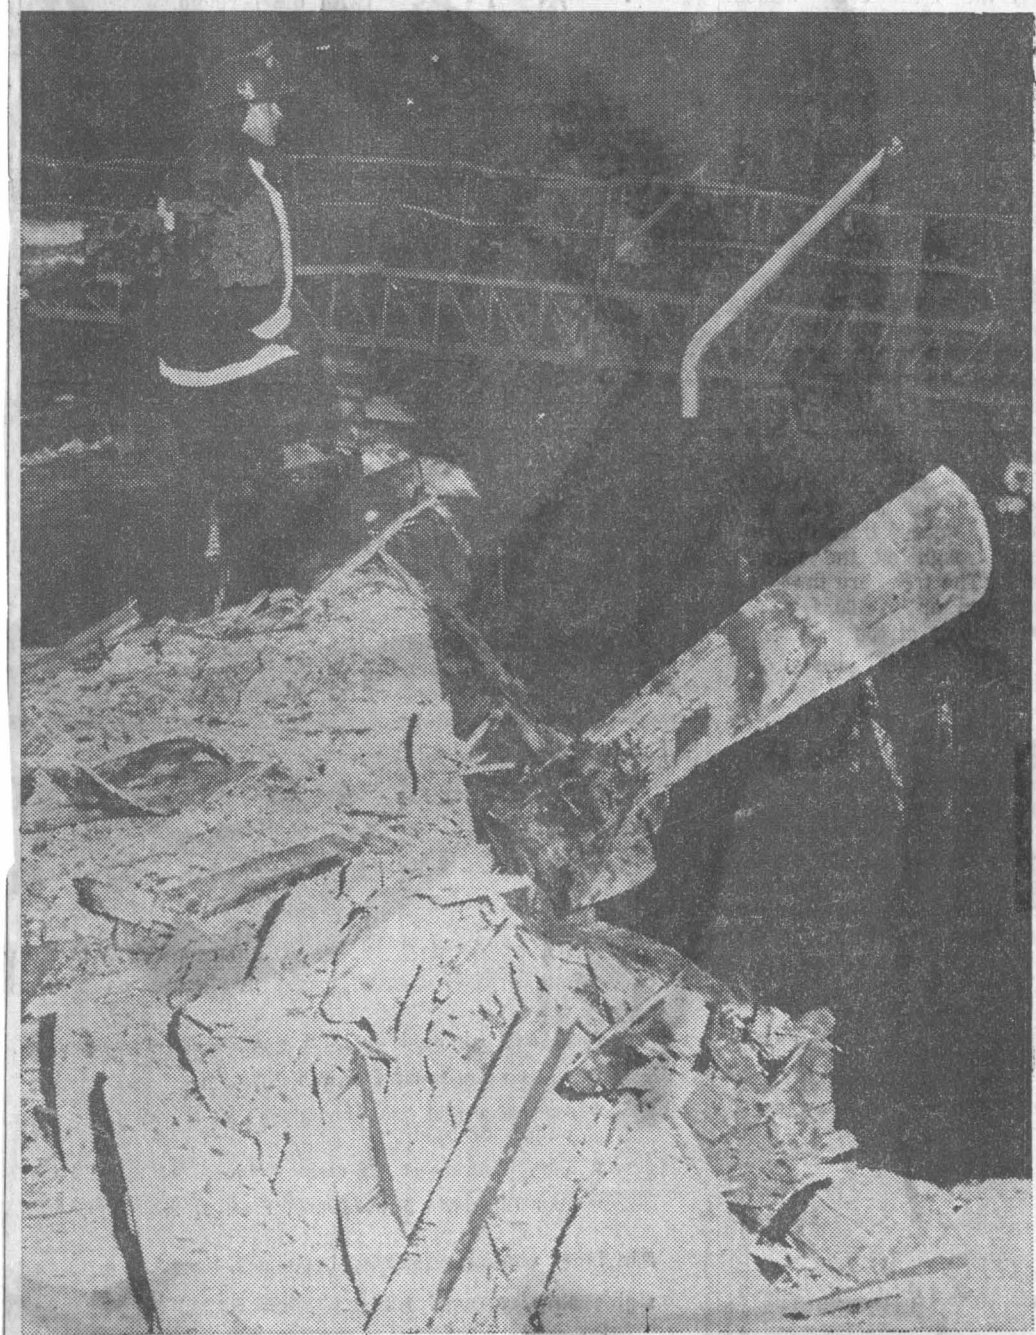
Damage estimates are not yet available, but Port Director Russell Painter said the collision fractured the dock structure and will require extensive repairs. The vessel struck about midway in the 179-foot main section of the dock. The impact left the tanker's two bow anchors in the mud below the dock. One on the starboard side apparently dropped into water when the collision cut its chain. The port anchor had been dropped for use in the berthing operation, but the accident jammed the chain which would be used to lift it.

City Fireman Surveys Damage At Port
