RFI #97 – Vibracompaction Refusal

Port of Anchorage Expansion Project, Draft Report on Sheet Pile Driving Problems for MKB Constructors

# Report on Sheet Pile Driving Problems for MKB Constructors Anchorage, Alaska

Lachel Reference # 10366008.00 January 11, 2011

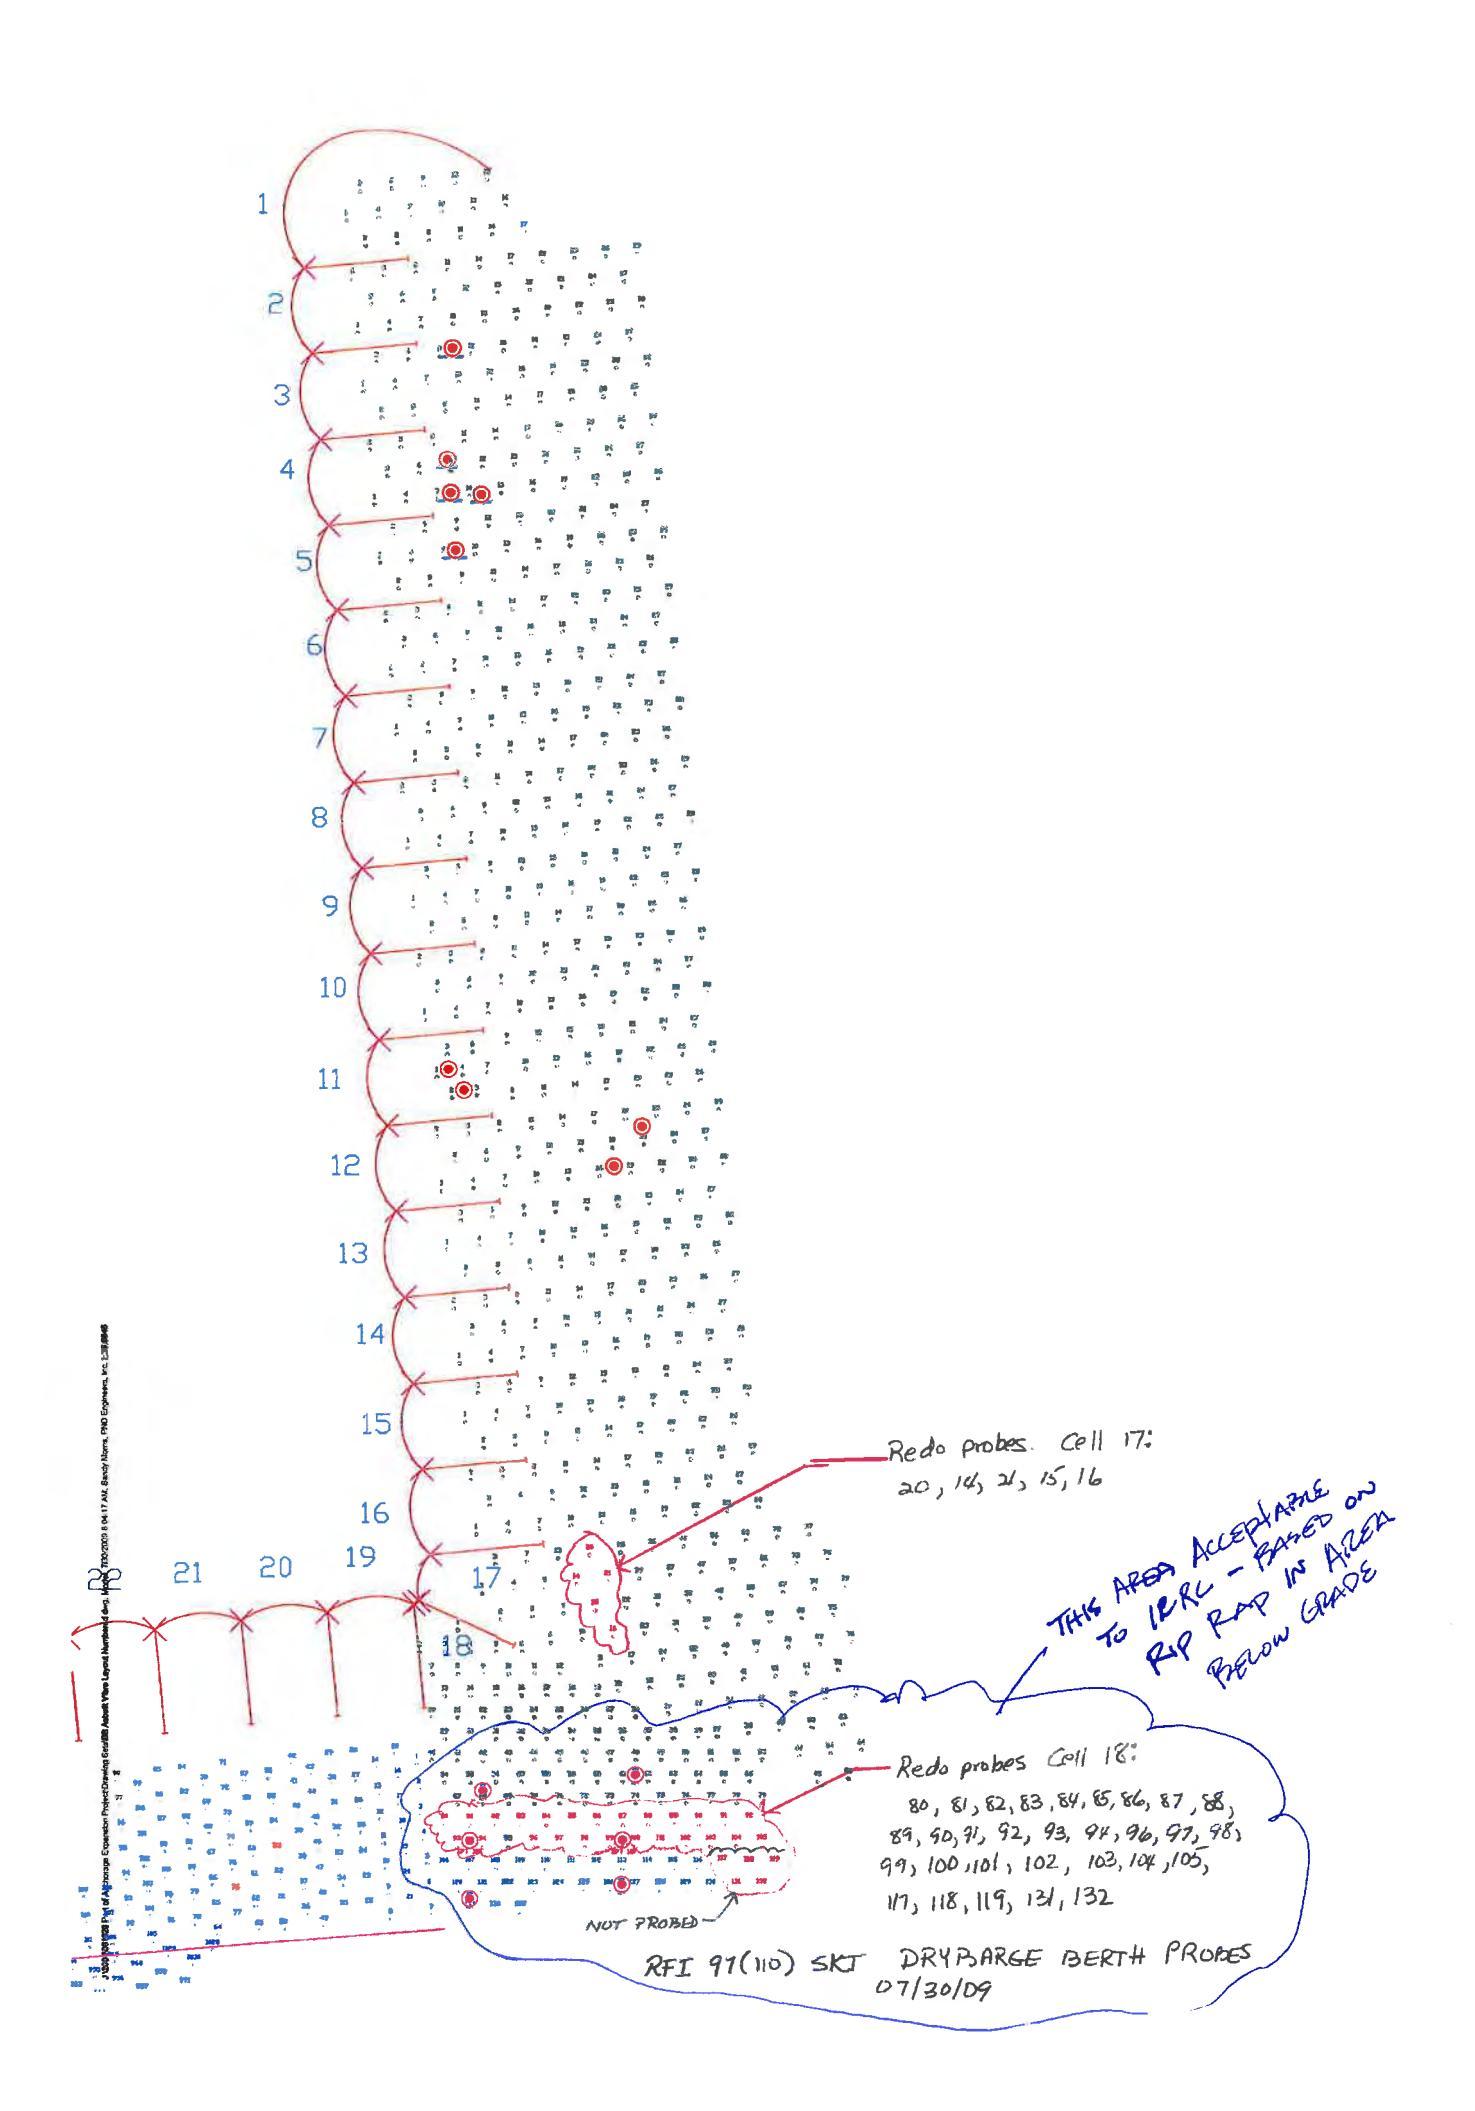
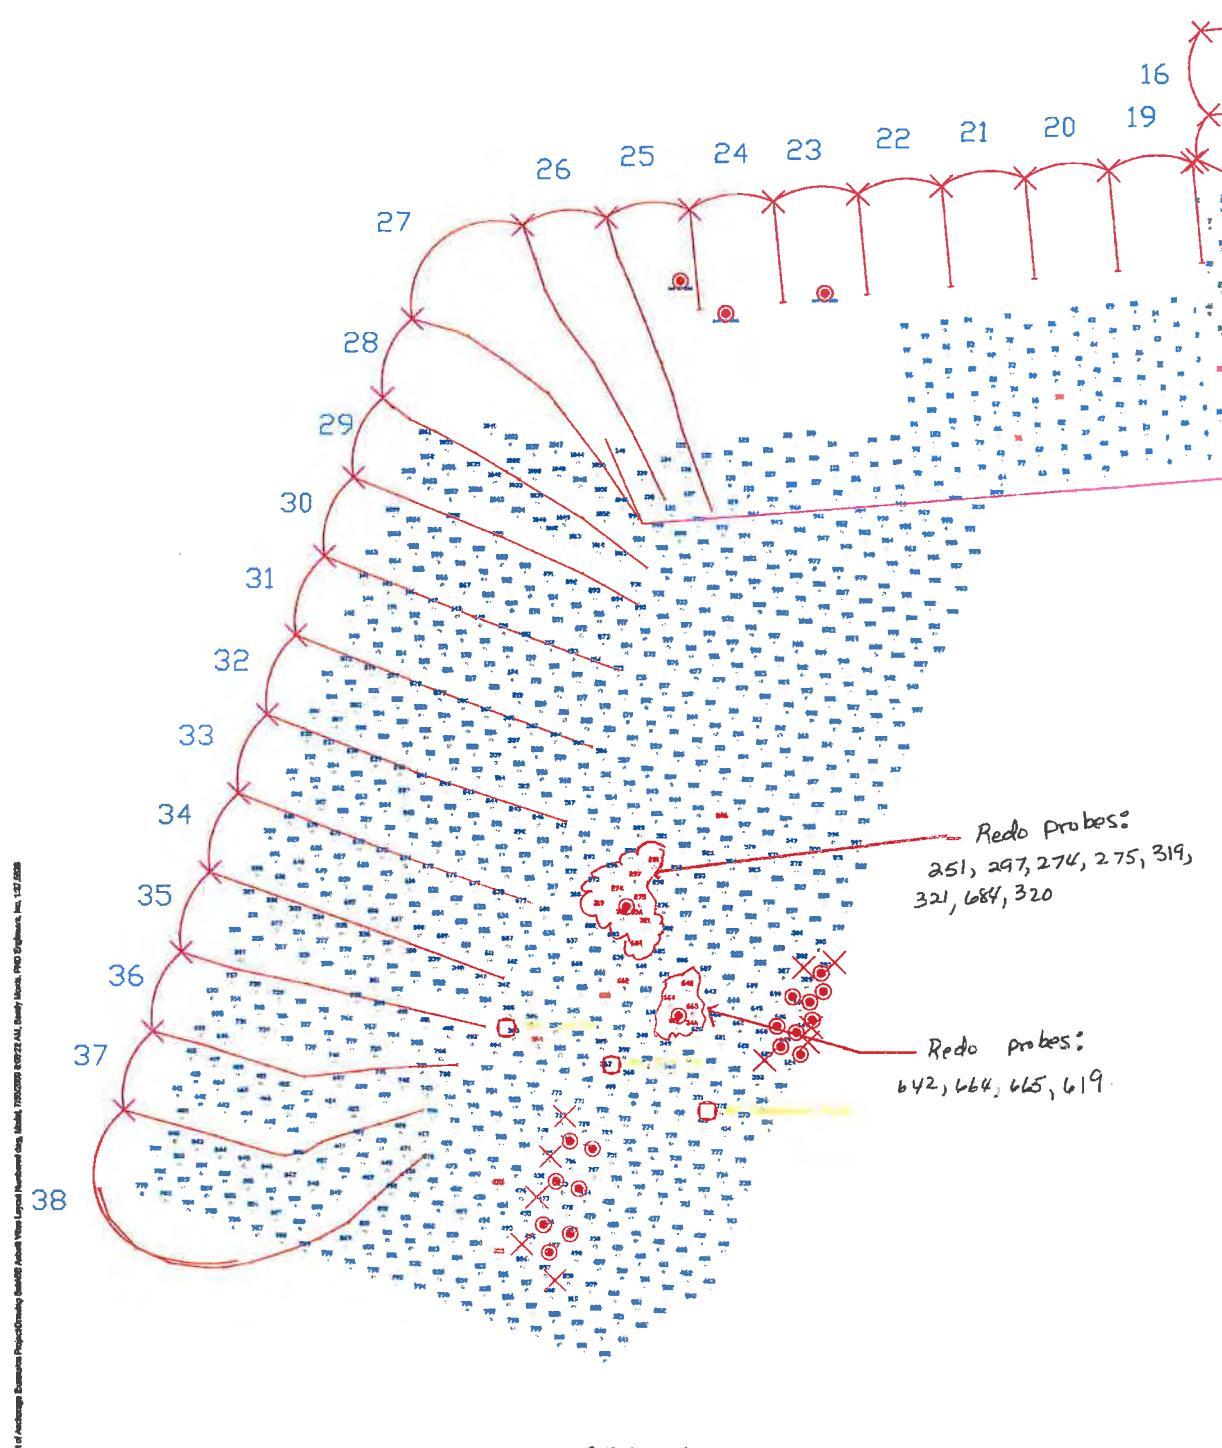
RFE 97(110) SKT WET BARGE BERTH PROBES. 07/30/09

8. SITE LOC	CATION: Wet barge B	erth		9. REQUESTED BY: Andy Romine/MKB Project Manager						
refusal at ele	evations above mud lined.	ine. Attached is a curr	rent probe lo	by grade. We are requesting th og that illustrates the issue.	at ICKC provide ch	tena for anving				
The probe abandoning Vibracomp that are achieving saturating are all powere prev	logs provided g probing effor action probes m difficult to pe penetration. R g the probe loc ossible methods iously abandone	ACKNOWLEDGMENT: to date do not s ts. There will b ust reach the sp netrate are enco emoval of the to ations with wate for achieving p d and are bubble	how any of e no crit ecified d untered, p layer of r, and re enetration d on the	consistent criteria has teria set for refusal a depth for the process t use one of the previou of fill, pre-drilling t emoving the exterior an on. Please install proh attached drawing. Sing	been followe bove mud line o be effective sly discussed hrough the to gles from the bes at the loo de probes that	d when re. When areas methods for p layer, vibraprobe ations that t were

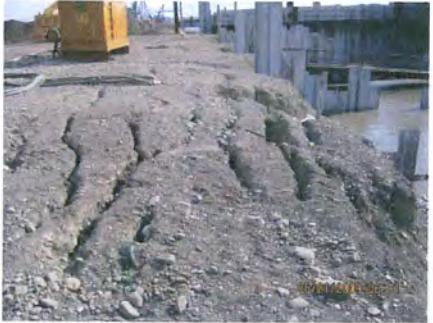
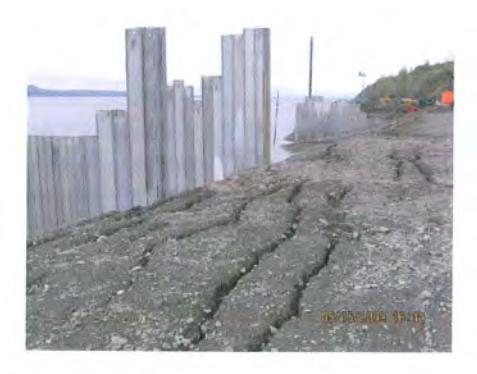
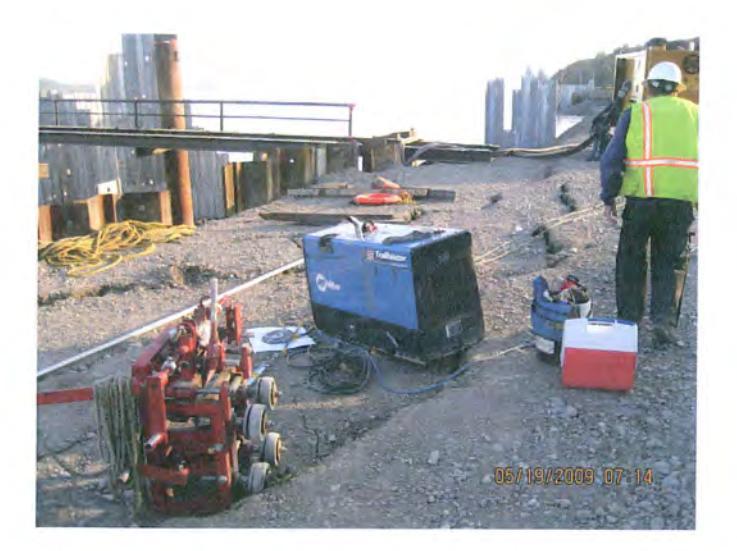
ICRC does not agree with QAP's assertion that there has not been surface failure; actually there has been significant evidence of surface slope failure near the top of the slope (See photos). Based on field observations at the time these photos were taken, it appears that shallow slope failure is at least a contributing factor in the observed movement. Significant discussions at the post bid pre award meeting revolved around QAP's ability to provide the pile drivers an adequate crane platform and what slope stabilization methods would be employed. QAP offer numerous options were being considered, including geotextiles s, Geo-bags, concrete mats and rip rap. It appears the failure to utilize an engineered system to provide a stable slope/crane pad is impacting the OCSP installation.

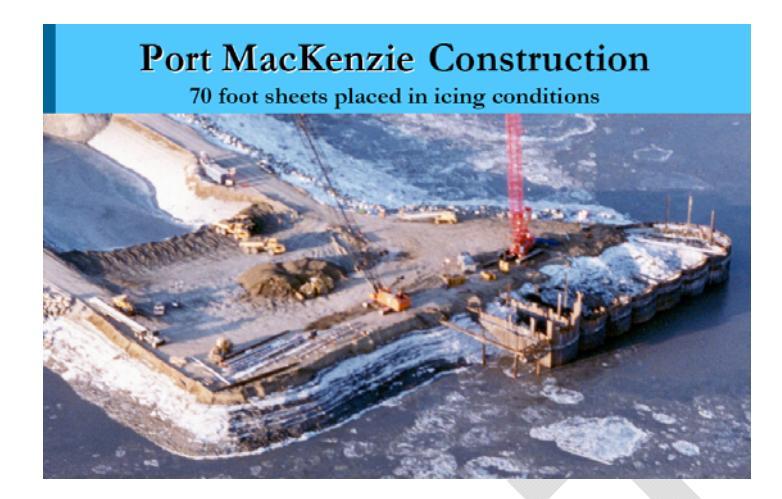
- Port Mackenzie was constructed under icing conditions, as shown below from a slide in PND's May 27, 2008 presentation to the Geotechnical Advisory Committee, as obtained from the Port's web site. It is a matter of record that significant ice formed in the fill and gave rise to settlement the following year when the ice melted. Such icing could certainly help to temporarily hold the slope at an angle steeper than its natural stable angle.
