# Anchorage Port Modernization Program Test Pile Program Report of Findings

Municipality of Anchorage/Port of Anchorage

October 17, 2016

CH2M Engineers, Inc.  
Anchorage, Alaska

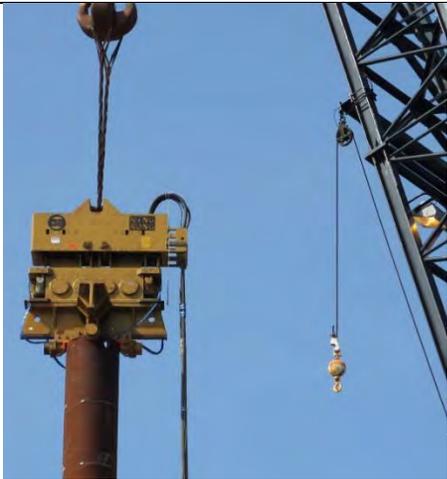
Table 1. Vibratory hammer with performance characteristics.

SPECIFICATIONS	DATA
	Eccentric Moment	11,500 in-lbs (132.49 kNm)
	Drive Force	298 tons (2648 kN)
	Frequency Maximum (VPM)	0 – 1,350 vpm
	Max Line Pull	234 tons (2,082 kN)
	Bare Hammer Weight w/o Clamp	31,570 lbs (14,320 kg)
	Throat Width	33.00 in (84 cm)
	Length	141.00 in (358 cm)
<i>APE 400 Vibratory Hammer</i>	Height w/o Clamp	88.50 in (225 cm)

The APE 400 vibratory hammer was attached to each indicator pile after the pile penetrated a certain distance below the mudline from self-weight. Piles were vibrated from 39 to 50 feet beyond the depth of self-weight penetration. A maximum of 50 feet of vibratory driving was allowed by the approved construction permits for the project. This depth limit was established to minimize the duration of hydroacoustic noise during vibratory installation.

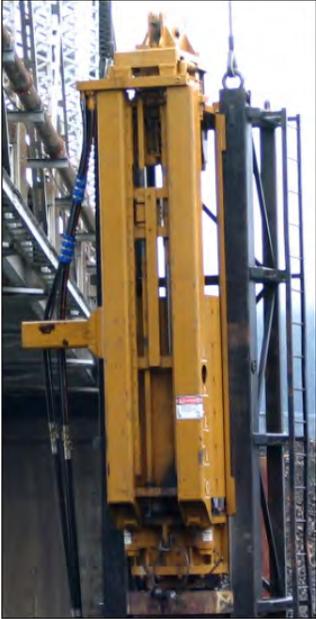
Specifications	Hydraulic Hammer		Diesel Hammer	
	Imperial	Metric	Imperial	Metric
Stroke at maximum rated energy	48 in	121.92 cm	135 in	343 cm
Maximum rated energy	120,000 ft-lbs	162.7 kNm	446,513 ft-lbs	602.79 kNm
Minimum rated energy			272,373 ft-lbs	367.70 kNm
Maximum obtainable stroke			150 in	381 cm
Maximum obtainable energy			666,395 ft-lbs	196 kNm
Ram	30,000 lbs	13,607.77 kg	39,690 lbs	18,000 kg
Anvil			10,223 lbs	4,642 kg
Hammer weight	42,000 lbs	19,050.88 kg	92,000 lbs	11,286 kg
Speed (b/min)	30–65	30–65	34–53	34–53

<p>APE 15-4 Hydraulic Impact Hammer</p>

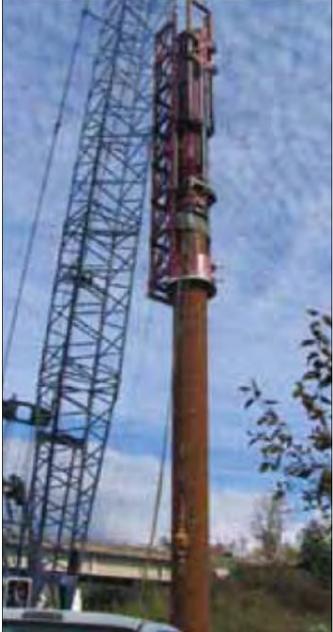
<p>APE 180-42 Diesel Impact Hammer</p>
--	---

The remaining five indicator piles were driven from the maximum depth reached by the vibratory hammer to the planned pile termination depth using a diesel impact hammer. The diesel hammer was included in the APMP TPP contract requirements for the same two reasons as described above for the hydraulic impact hammer: (1) to evaluate the underwater noise caused by this type of impact hammer and (2) to evaluate driving efficiency in the SC/BCF geologic unit. The features of the diesel impact hammer are such that the velocity is much higher than a hydraulic impact hammer, and this difference was expected to result in different underwater noise levels and frequencies and potential differences in driving the indicator pile through a deep clay soil profile.

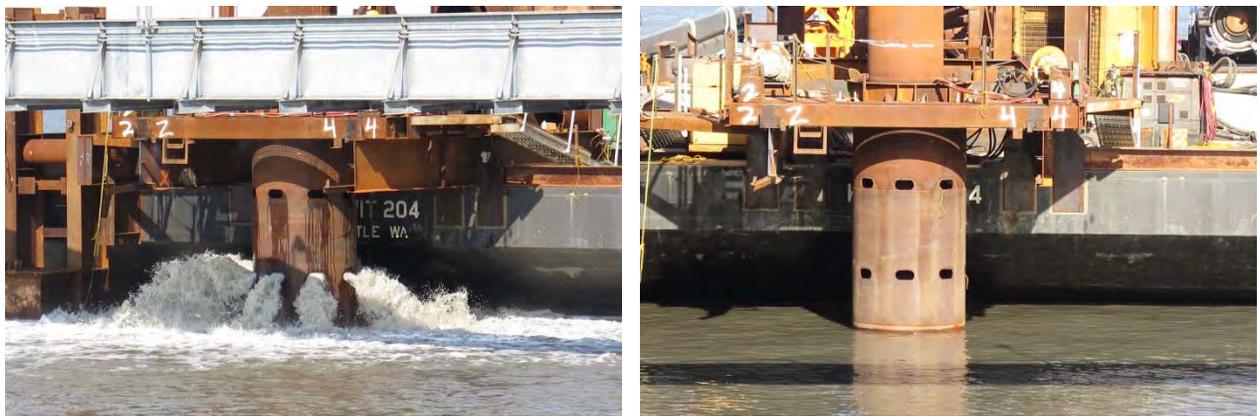
a  
b  
Figure 4. Confined air bubble curtain on (a) and off (b).

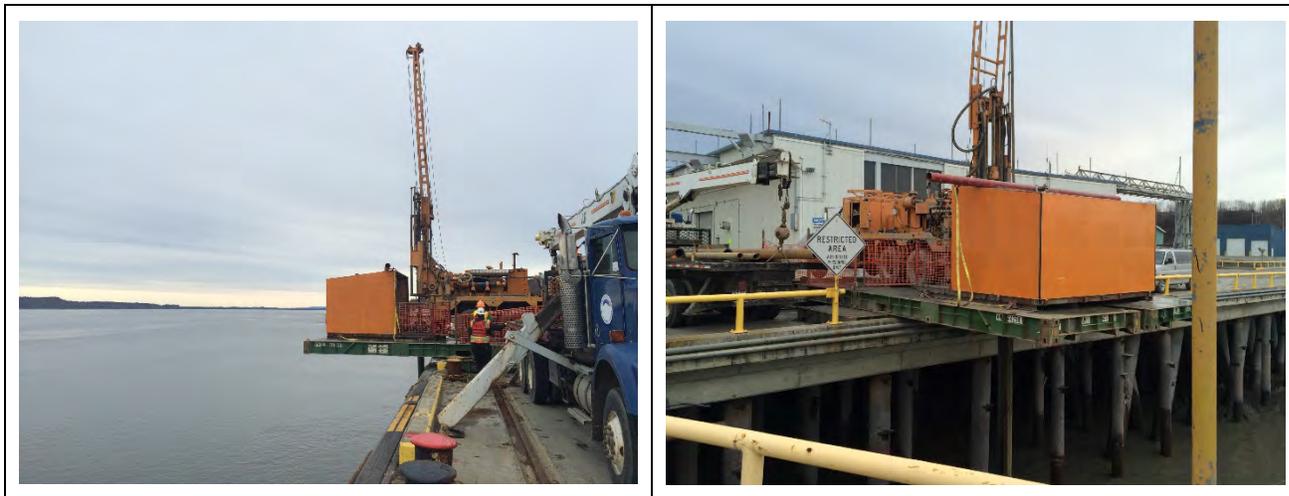
The five explorations were drilled from the existing POA wharves using either CME 75 or 85 truck-mounted drill rigs. Drilling was accomplished from a cantilever platform attached to the existing wharves (Figure 8). An 8-inch diameter conductor pipe extended from the drill rig platform to a depth of approximately 30 feet below the mudline at each drill site. All drilling was conducted through the conductor pipe. The conductor casing was also used for drill fluid circulation. Additional details about the drill-rig set-up, including the handling of drilling mud, are discussed in the Golder (2016) final report.

Figure 8. Photographs of drill rig setup.
