FINAL REPORT

Anchorage Port Modernization Program In-air Noise and Ground-borne Vibration Analysis Monitoring Report

Municipality of Anchorage/Port of Anchorage

August 26, 2016

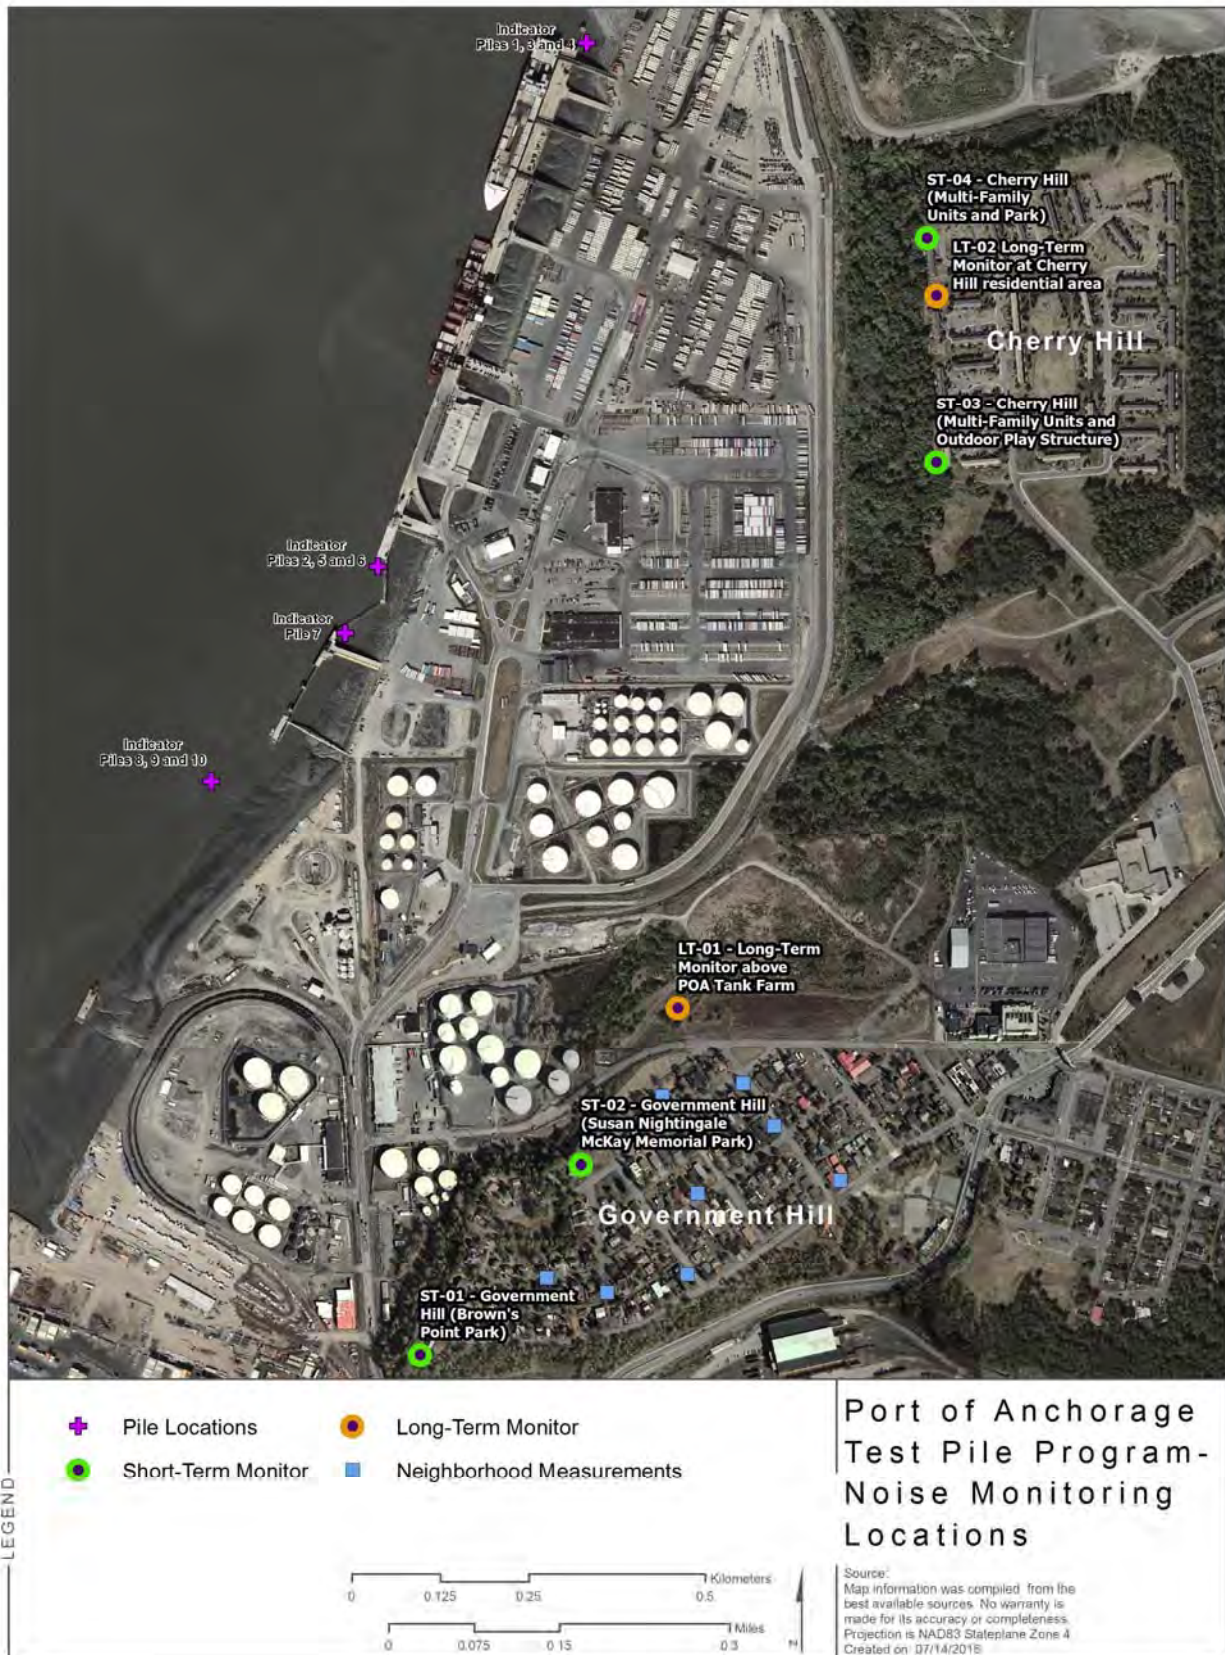
Figure 1. Residential-related Noise Monitoring Locations

LT-01 – Long-term monitoring site at the POA near Government Hill: A long-term noise monitoring station was located on the bluff near the southern boundary of the POA (see Figure 1 and Figure 2). This site was selected due to its secure location, open exposure to construction activities, and proximity to the Government Hill neighborhood. Observed non-pile-driving sound sources included POA-related sources such as heavy truck and construction noise, railroad traffic, roadway traffic, and military and non-military aircraft overhead. Natural sound sources included wind interacting with vegetation and birds.

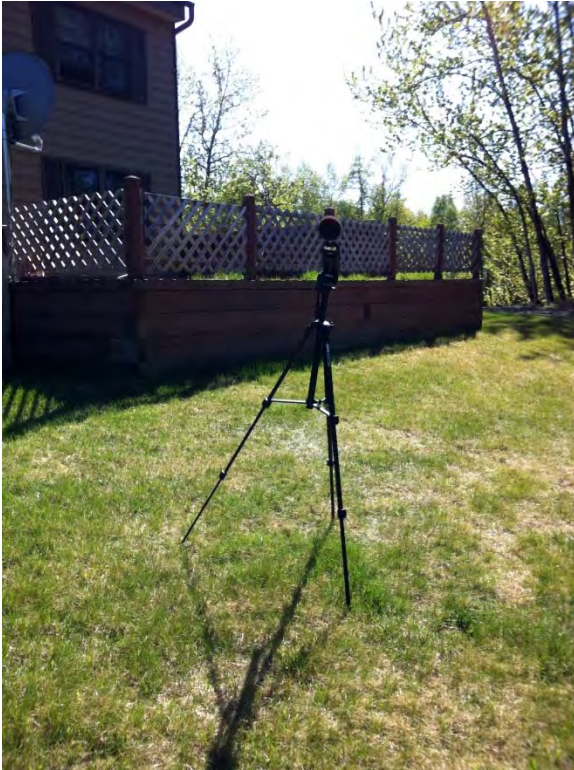
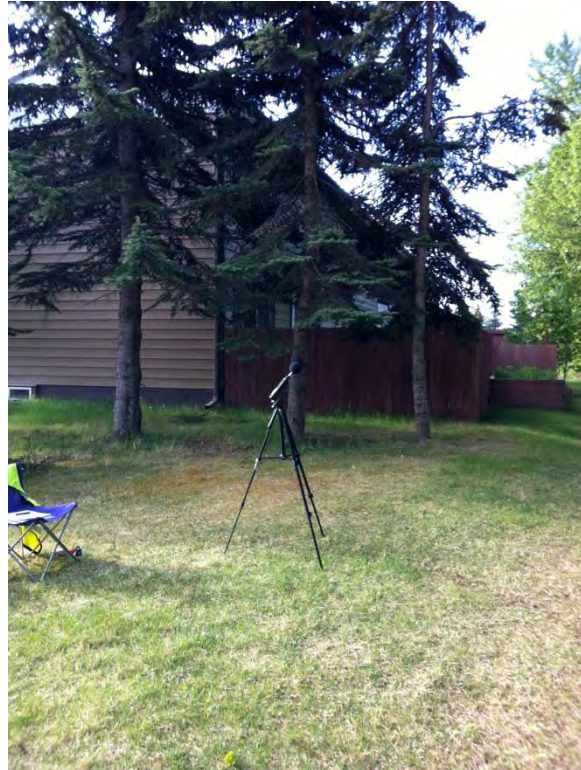
Cherry Hill: Within the Cherry Hill neighborhood, two locations were selected for short-term noise monitoring based on proximity to residences. These measurement locations were adjacent to the multi-family housing units situated atop the bluff closest to the POA. One was located on the southern end of the Cherry Hill residential housing area (ST-03 site) and the other on the northern end of the housing complexes (ST-04 site) closest to the POA property (see Figure 6 and Figure 7).

Figure 6. ST-03 Site: Cherry Hill Short-term Noise Monitoring Site (southern site)

Figure 7. ST-04 Site: Cherry Hill Short-term Noise Monitoring Site (northern site)

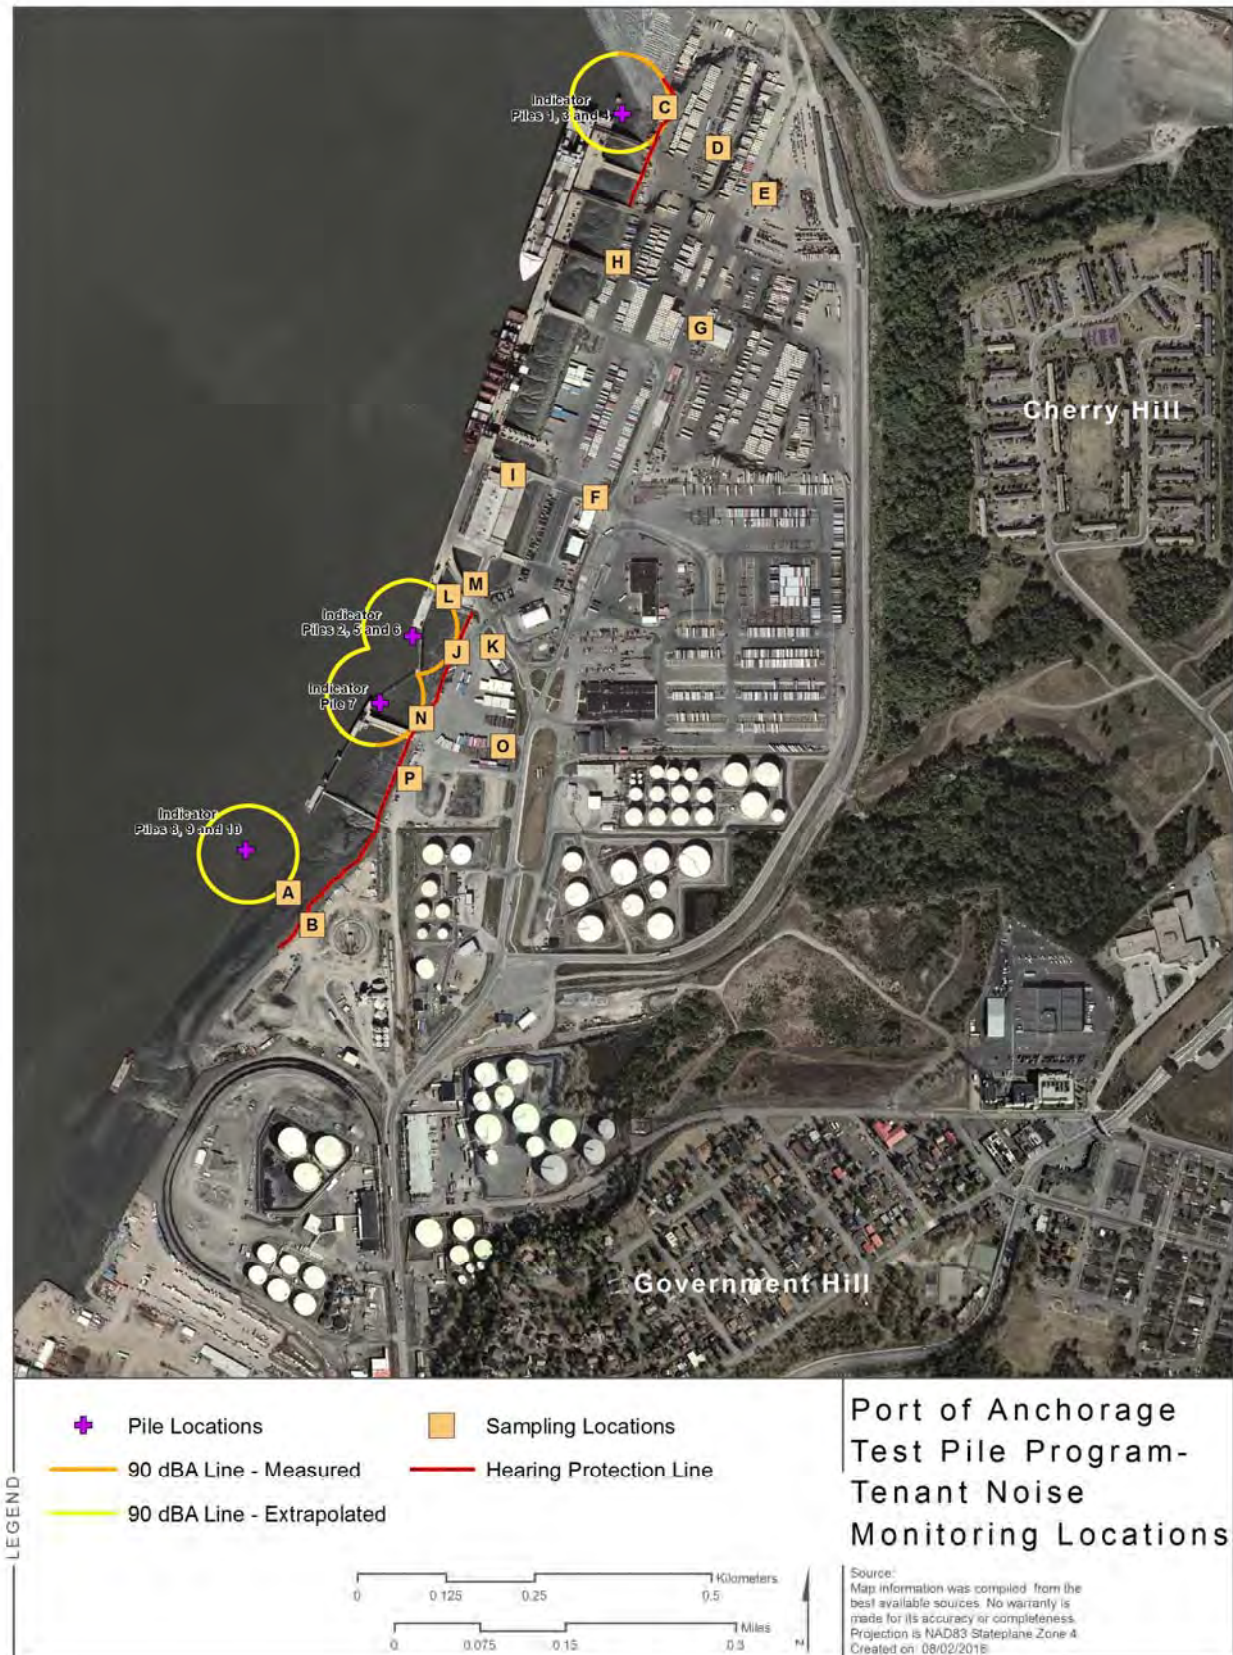
Figure 8. POA Tenant Noise Monitoring Locations
2016 Test Pile Program

Monitoring consisted of noise measurements near the pile-driving location and occupied locations near the work site (Figure 8). Measurements collected during the pile-driving operations are used to develop noise gradients that identify the distance from the source (pile driving) to the threshold of hazardous noise levels (90 dBA OSHA classified hazardous noise) and 80 dBA (MOA Noise Ordinance construction noise limit). Occupied or potentially occupied facilities identified within the hazardous noise zones were assessed for interior noise levels during the pile-driving process and during normal operations. For comparison purposes, baseline sound levels were also collected to identify the change in noise resulting from pile driving at tenant and worker locations. Due to the duration of TTP activities, and to minimize any daily noise variations, both ambient and TPP impacted noise measurements were collected on the same day.

Four pile-driving test sites were evaluated (Indicator Piles 4, 5, 7, and 8), as shown on Figure 8. Because pile driving took place on a barge and this assessment was for shore-based activities, no measurements were collected at the source. The intent was to characterize potentially hazardous noise exposures to shore-based workers and work activities on the POA property. Due to scheduling conflicts, sound levels during pile-driving operations at Pile 8 were not measured.

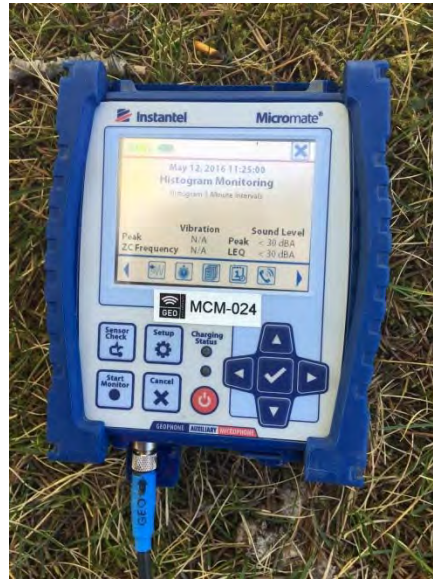
Figure 9. Vibration Equipment: Accelerometer and Geophone Cord

During several of the short-term in-air noise monitoring events, vibration equipment (InstanTel® Micromate units) was deployed (see Figure 9, Figure 10, and Figure 11). This occurred at the following specific sites: ST-01, ST-02, ST-03, ST-04, NM01, and NM02 (see Figure 12). When deployed, one vibration monitor was located immediately adjacent to one of the short-term noise monitoring stations; the other vibration monitor was located in the landward vicinity of the pile being driven at the POA. PPV inches per second were collected at 1-minute intervals to document the potential for human perception and structural damage.

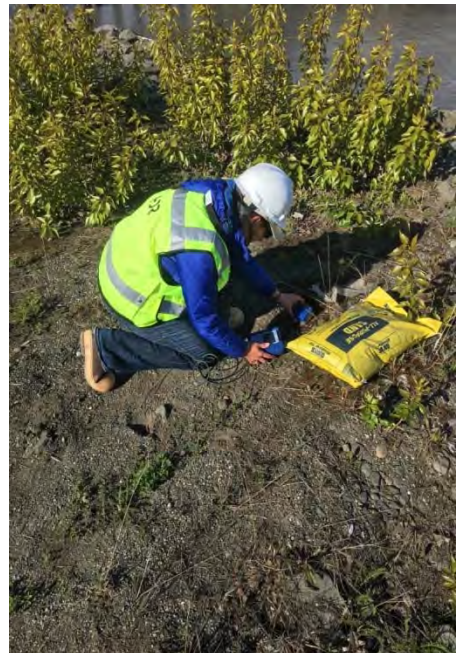
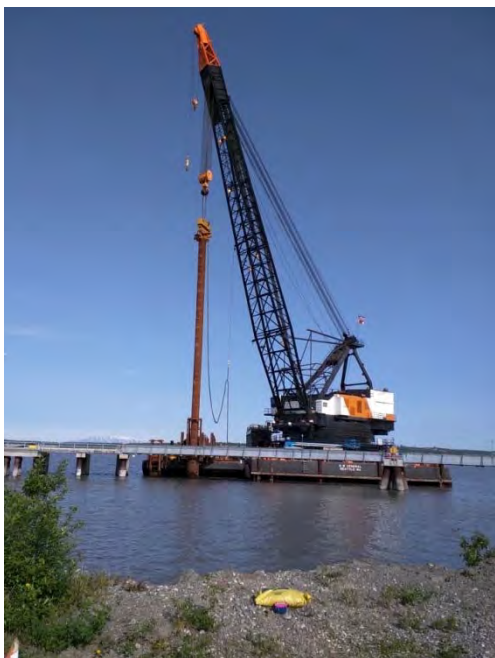
Figure 10. Vibration Monitoring Equipment Set Up Onshore near Pile-Driving Location

Figure 11. Setting Up Vibration Monitoring Equipment near Pile-Driving Location

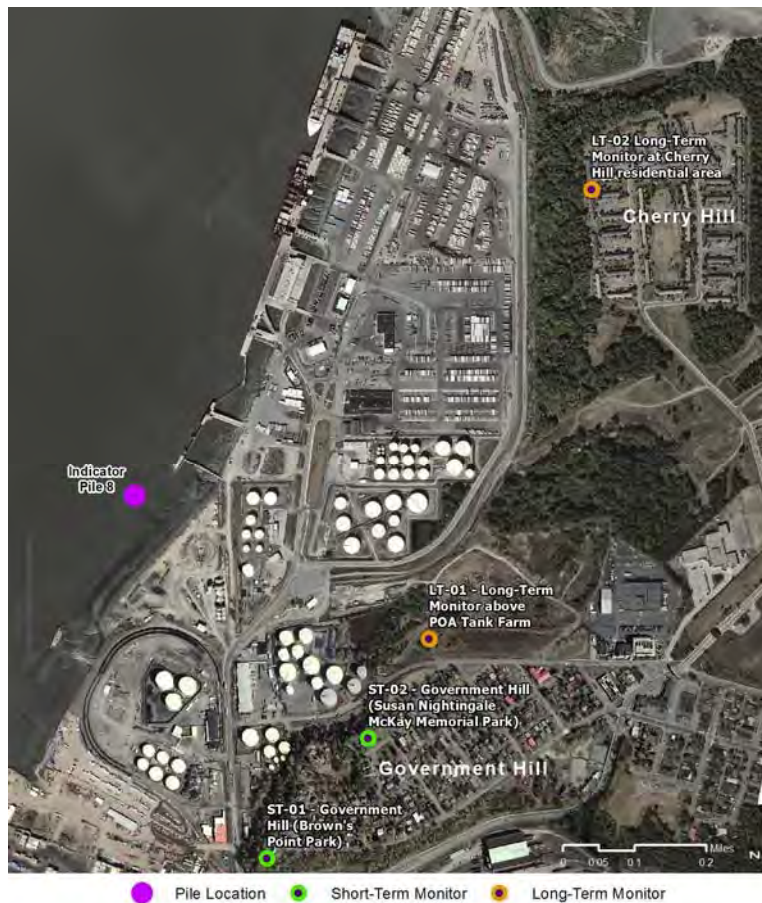
Figure 13. Pile 8 Measurement Locations

Test pile location 8 was set in the pile template on May 2, 2016, and driven to depth via vibratory and hydraulic impact pile drivers on May 3, 2016. Figure 13 depicts the noise measurement locations for Pile 8. Meteorological conditions during the survey were obtained via a nearby meteorological station or

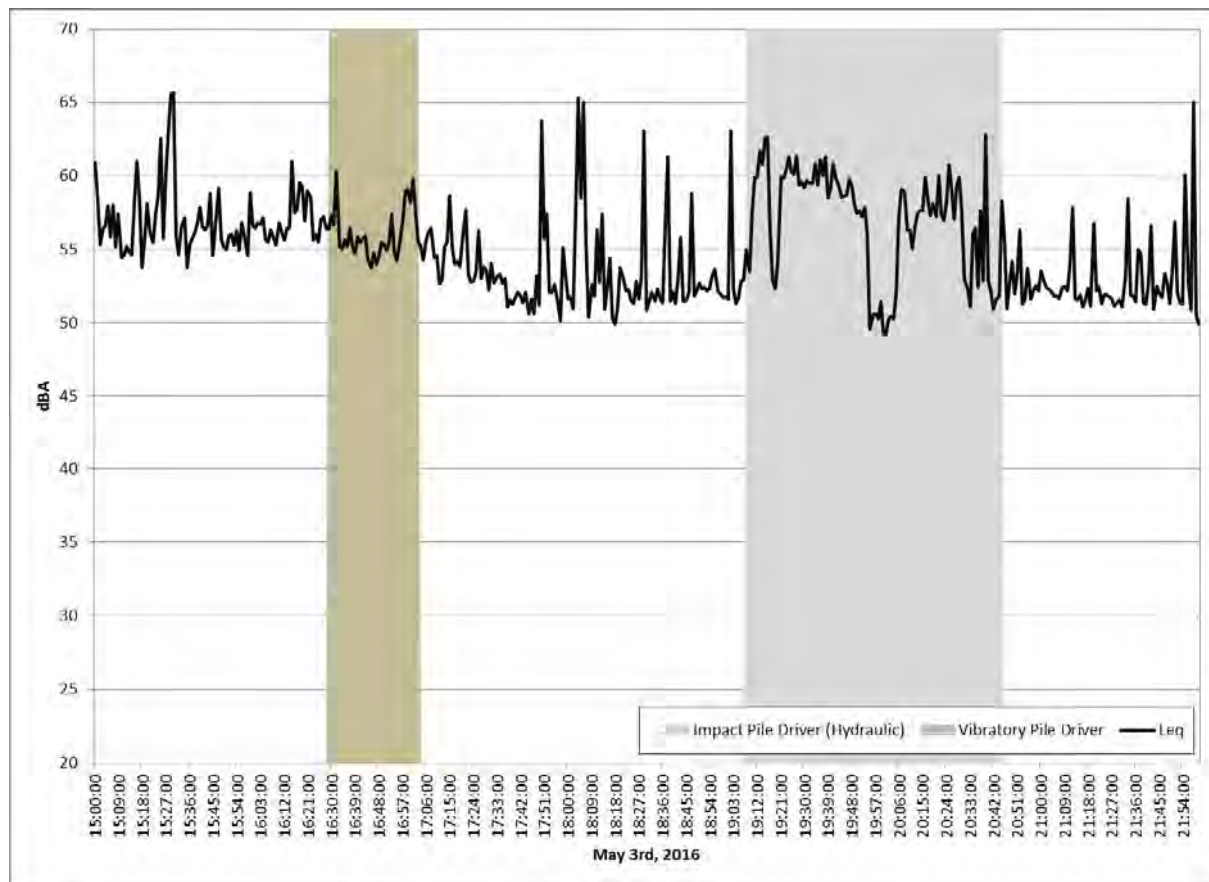
Figure 14. Pile 8 Time-history at the Government Hill Long-term Monitor (LT-01)

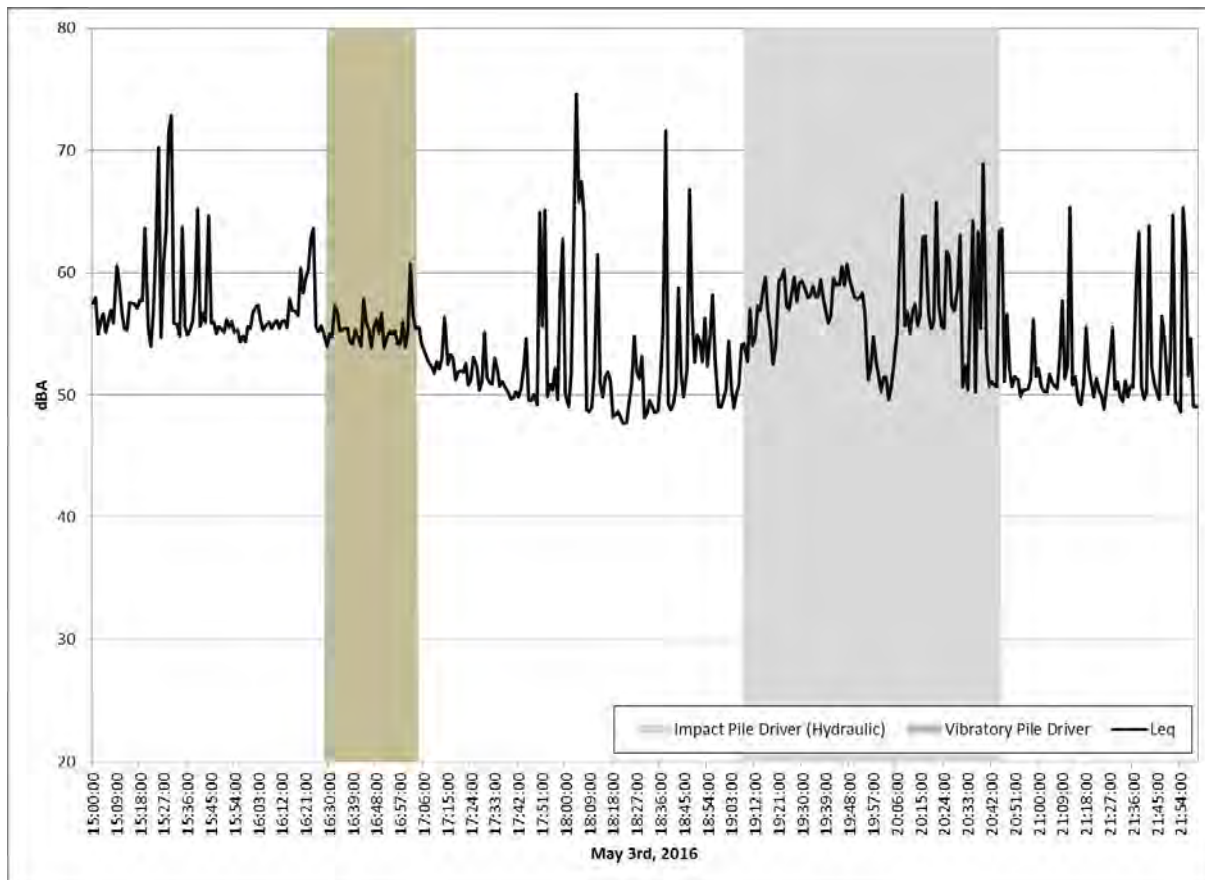
Figure 15. Pile 8 Time-history at the Cherry Hill Long-term Monitor (LT-02)

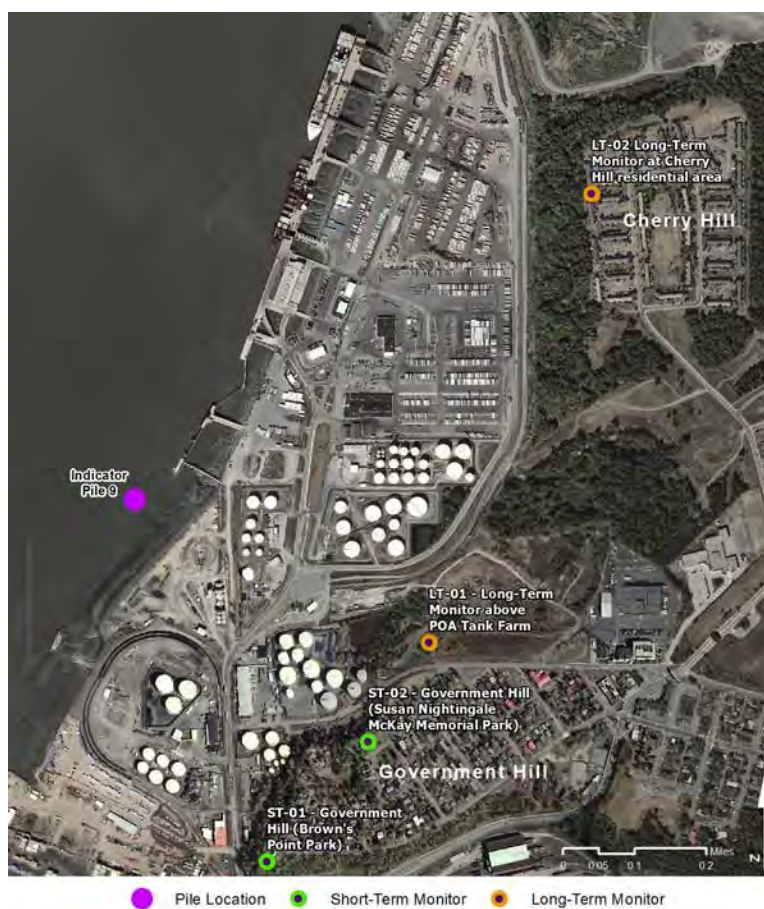
Figure 16. Pile 9 Measurement Locations

Test pile location 9 was set in the pile template and driven to depth via vibratory and diesel impact pile drivers on May 6 and 7, 2016. Figure 16 depicts the measurement locations for Pile 9. Meteorological conditions during the survey were obtained via the meteorological equipment deployed at the long-term station. The meteorological conditions during the survey were a temperature of 46°F, wind speeds of approximately 3 mph, humidity of 69 percent, and no precipitation.

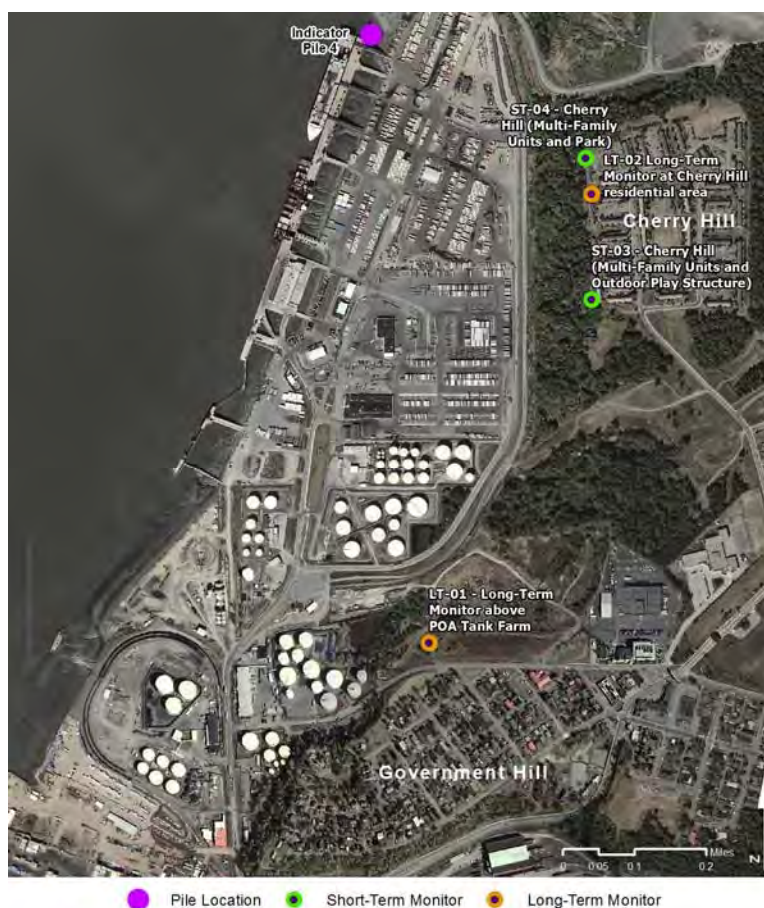
Figure 19. Pile 4 Measurement Locations

Test pile location 4 was set in the pile template on May 12, 2016, and driven to depth via vibratory, hydraulic, and diesel impact pile drivers on May 12 and 13, 2016. Figure 19 depicts the measurement locations for this pile. The meteorological conditions on May 12 were a temperature of 57° F, wind speeds of approximately 2–3 mph, humidity of 57 percent, and no precipitation. The meteorological conditions on May 13 were a temperature of 49°F, wind speeds of approximately 1 mph, humidity of 72 percent, and no precipitation.

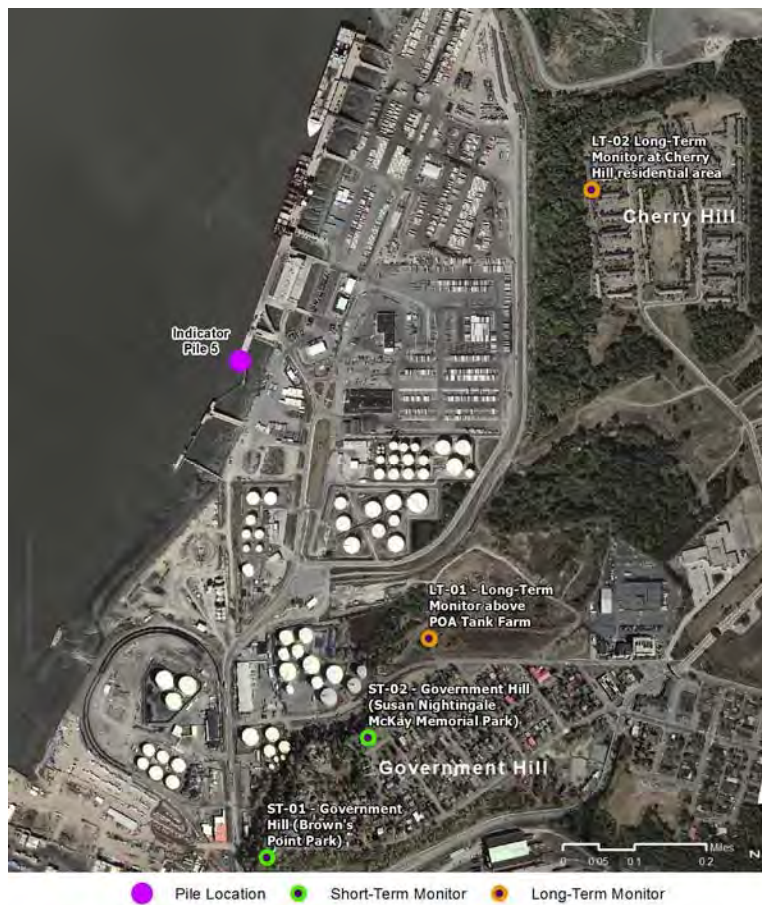
Figure 22. Pile 5 Measurement Locations

Test pile location 5 was set in the pile template and driven to depth via vibratory and diesel impact pile drivers on May 18, 2016. Figure 22 depicts the measurement locations for this pile. The meteorological conditions during the survey were a temperature of 52°F, wind speeds of 2 mph, humidity of 71 percent, and no precipitation.

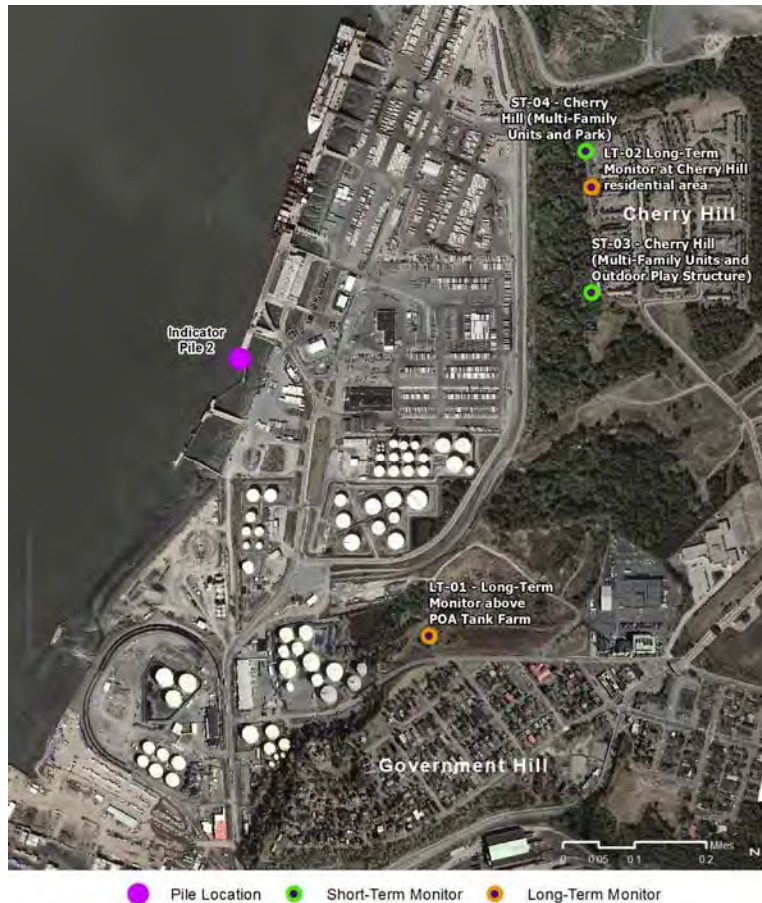
Figure 25. Pile 2 Measurement Locations

Test pile location 2 was set in the pile template and driven to depth via vibratory and diesel impact pile drivers on May 19, 2016. Figure 25 depicts the measurement locations for this pile. The meteorological conditions during the survey were a temperature of 51°F, wind speeds of 2 mph, humidity of 75 percent, and no precipitation.

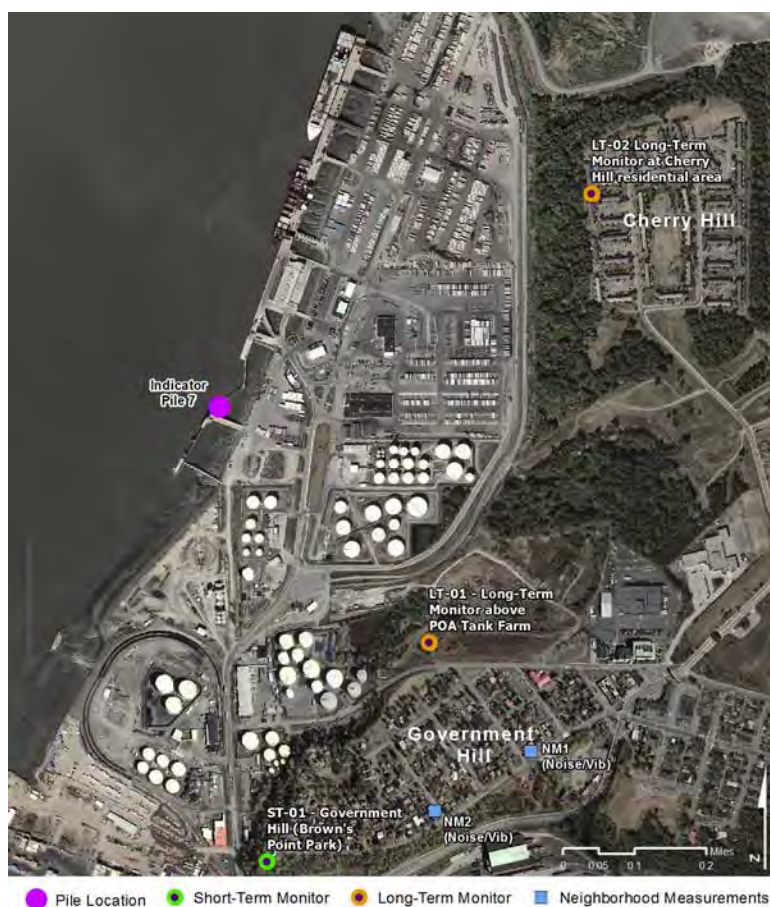
Figure 28. Pile 7 Measurement Locations

Test pile location 7 was set in the pile template and driven to depth via vibratory and diesel impact pile drivers on May 25, 2016. Figure 28 depicts the measurement locations for this pile. The meteorological conditions during the survey were a temperature of 57°F, wind speeds of 2 mph, humidity of 58 percent, and no precipitation.

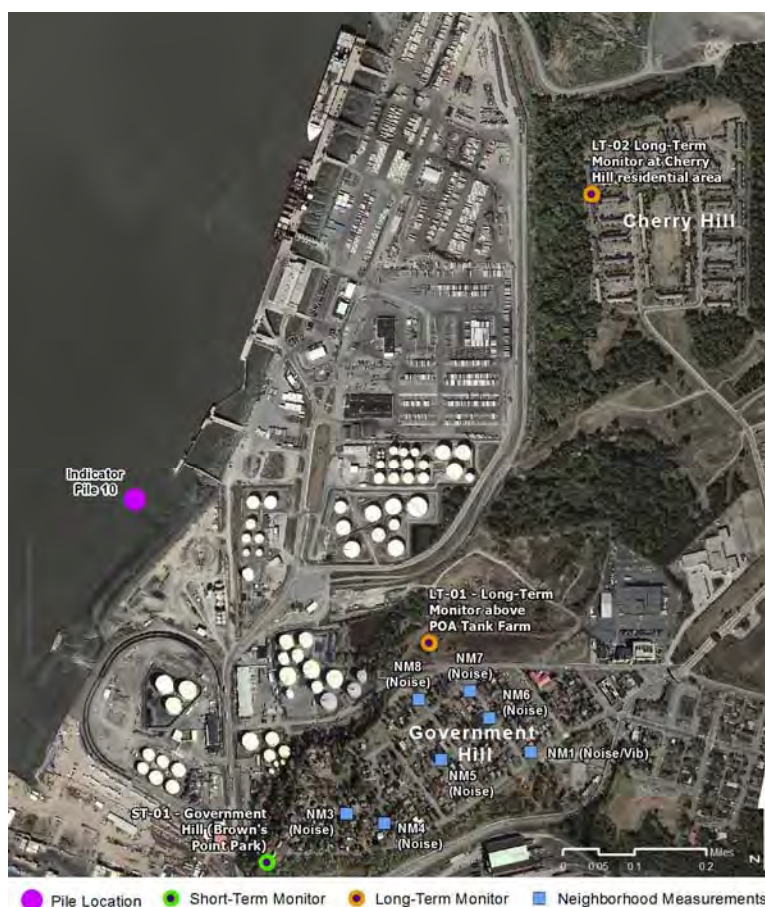
Figure 31. Pile 10 Measurement Locations

Test pile location 10 was set in the pile template and driven to depth via vibratory and hydraulic impact pile drivers on May 26, 2016. Figure 31 depicts the measurement locations for this pile. The meteorological conditions during the survey were a temperature of 61°F, wind speeds of 2 mph, humidity of 53 percent, and no precipitation.

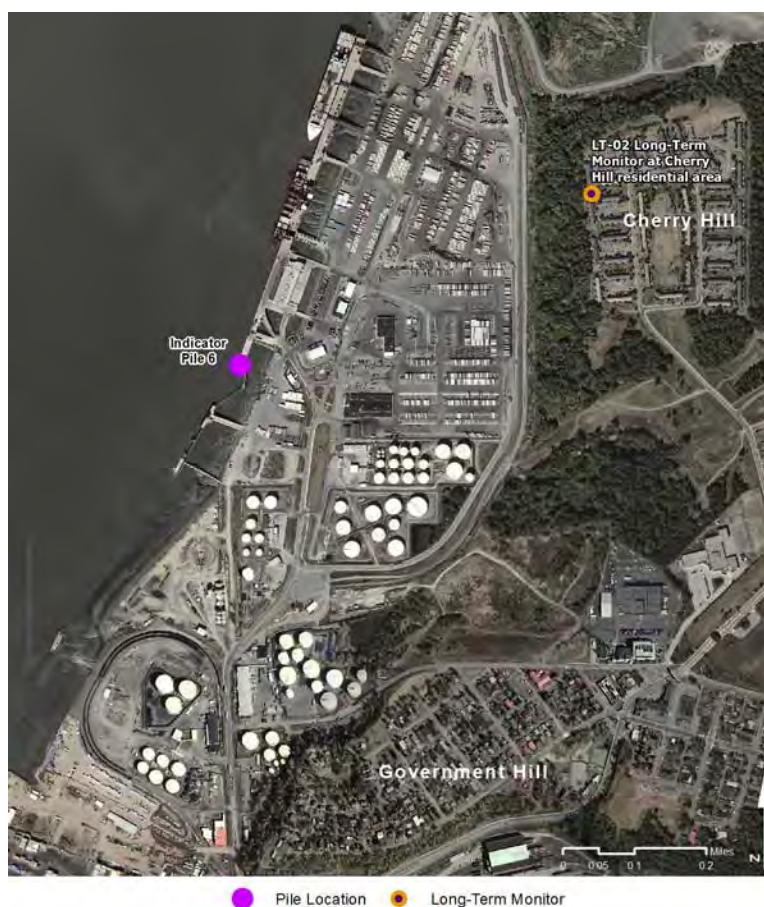
Figure 34. Pile 6 Measurement Locations

Test pile location 6 was set in the pile template and driven to depth via vibratory and diesel impact pile drivers on June 1, 2016. Figure 34 depicts the measurement location for this pile. The meteorological conditions during the survey were a temperature of 56°F, wind speeds of 2 mph, humidity of 61 percent, and no precipitation.

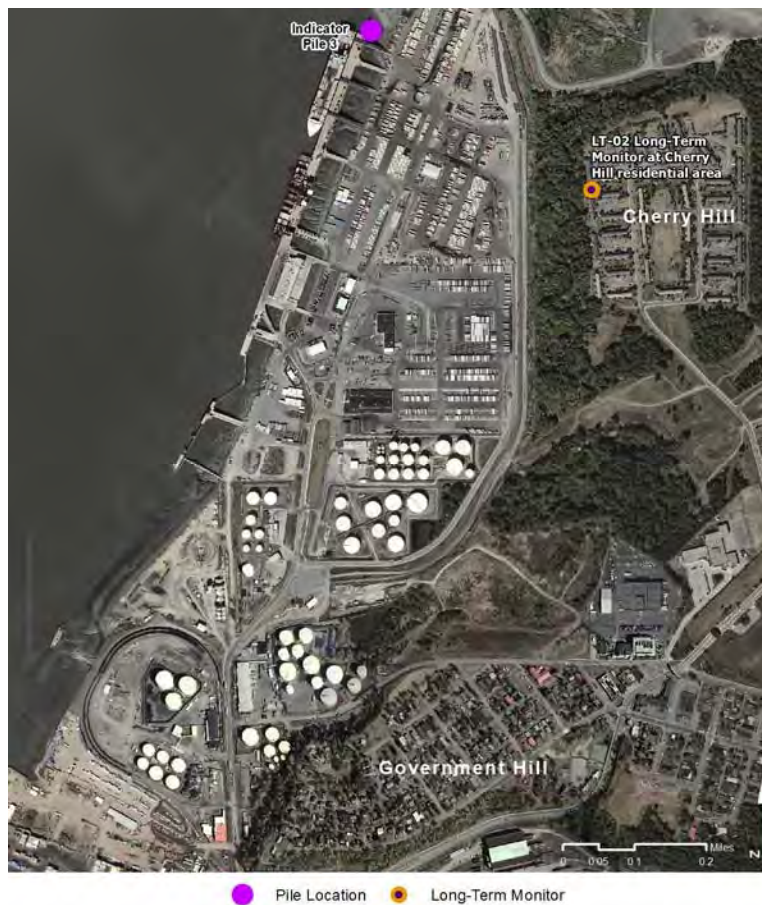
Figure 36. Pile 3 Measurement Location

Test pile location 3 was set in the pile template and driven to depth via vibratory and hydraulic impact pile drivers on June 3, 2016. Figure 36 depicts the measurement location for this pile. The meteorological conditions during the survey were a temperature of 59°F, wind speeds of 2 mph, humidity of 60 percent, and no precipitation.

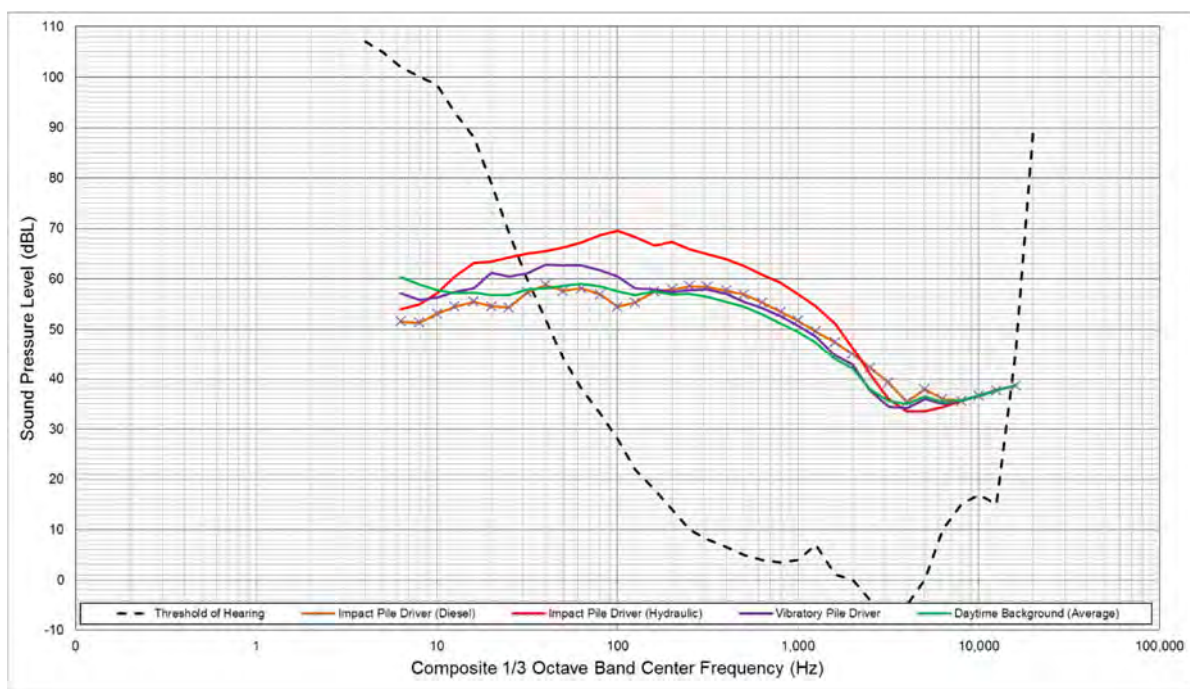
The low-frequency content of impact pile driving represents the biggest difference relative to daytime baseline sound levels. Figure 38 and Figure 39 are spectral charts of octave-band monitoring data for each of the pile drivers used, compared to the daytime baseline levels collected at LT-01 and LT-02. Included on these charts is the threshold of human hearing by octave band. The hydraulic impact pile driver was the noisiest pile driver used in the TPP and was consistently above the daytime baseline from 12.5 Hz to 2,000 Hz. Data indicated that the diesel impact pile driver noise was very similar to baseline sound levels, which matches what was experienced by field technicians. Vibratory pile drivers were almost the same as baseline sound levels at LT-02; however, at LT-01 it appears that there was more low-frequency content from the vibratory pile-driving effort. In a review of field notes and recordings of other sound sources, such as tank farm construction within the POA, these are the likely cause of the elevated low-frequency content during vibratory pile driving at LT-01.

Figure 38. Monitored Spectral Sound Levels at Government Hill Long-term Monitor (LT-01)

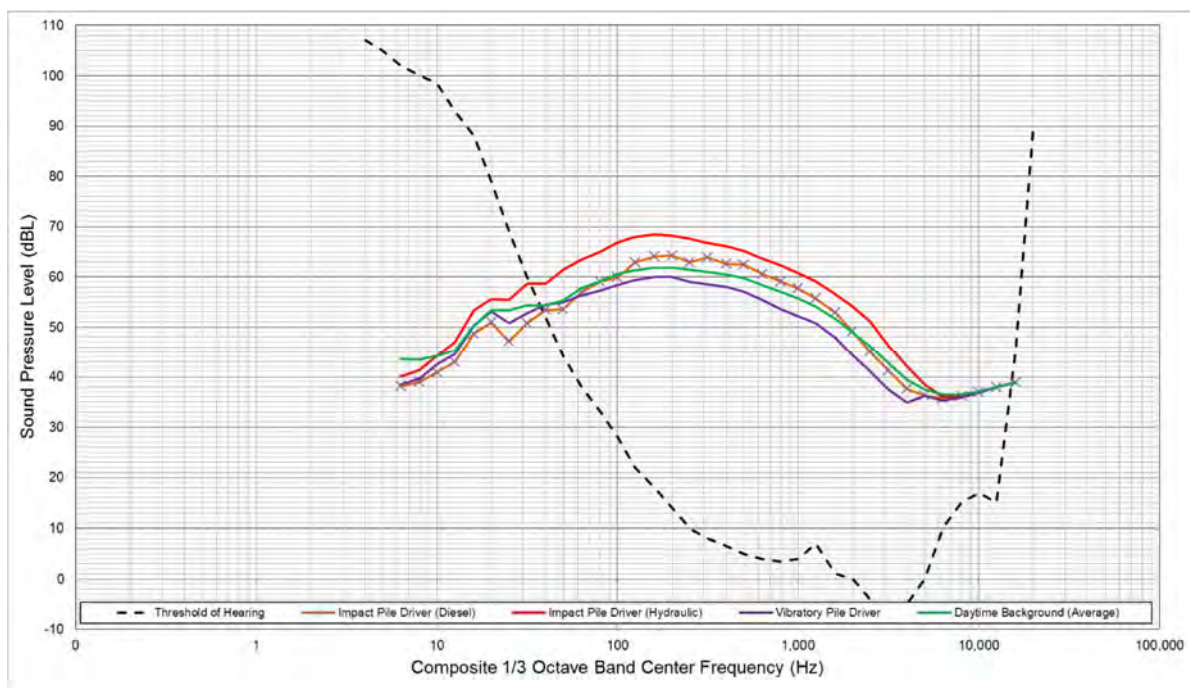
Figure 39. Monitored Spectral Sound Levels at Cherry Hill Long-term Monitor (LT-02)
