Port Board Says Tides Not At Fault

Damage Heavy As Oil Tanker Rams City Dock

Tanker Slams Into Petroleum Dock

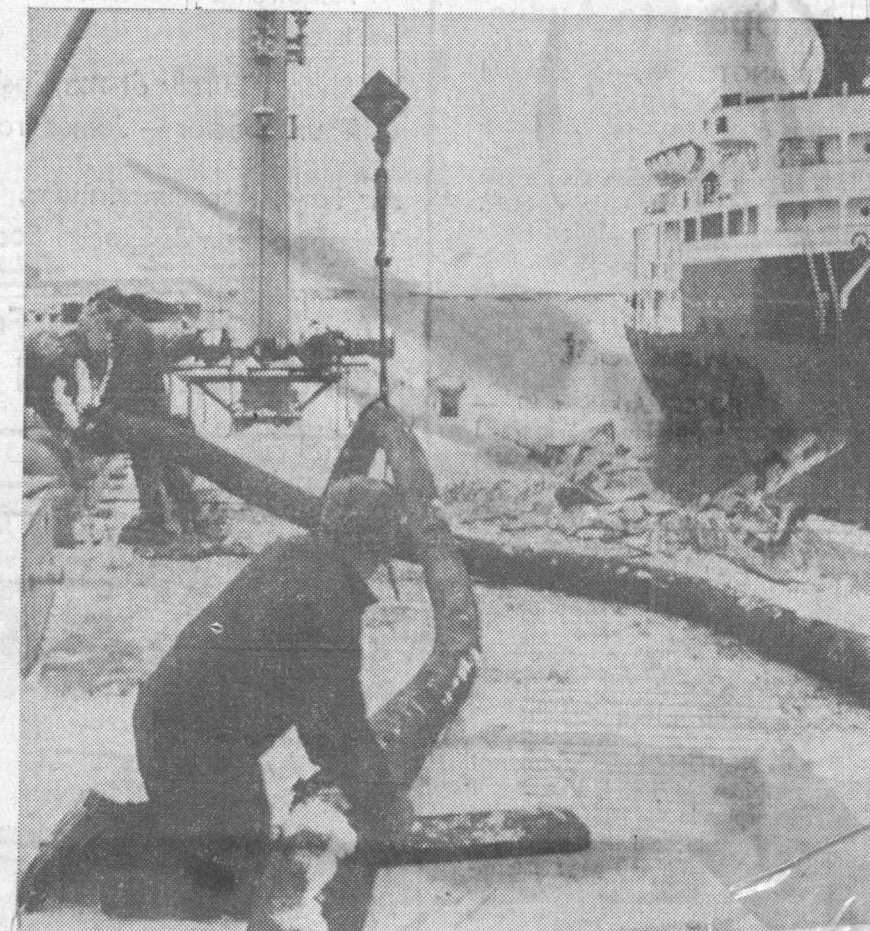
THE CHEVRON LIEGE sits quietly alongside the city dock Friday with its damaged bow shortly after it rammed the petroleum docking facility. Damage to the dock and vessel was reported as extensive. The Standard Oil tanker was carrying about 180,000 barrels of jet fuel. Below, the damaged portion of the petroleum dock is shown as workers move to unload the jet fuel. (Daily Newsphotos by Robin Smith)

A large tanker carrying jet fuel from Venezuela rammed smashed head-on into the \$1.4 million dock Friday causing heavy damage. The collision sliced a 20-foot deep gash in the bow of the tanker, but the hole was in an empty compartment and none of the 180,000 barrels of jet fuel leaked out. The accident occurred while the tanker was attempting to berth after a voyage from a Venezuelan refinery. The ship's cargo was bonded jet fuel which is sold to foreign airlines stopping in Anchorage. The vessel started unloading its cargo about 6:15 p.m. Friday and will continue through today.

Damage estimates are not yet available, but Port Director Russell Painter said the collision fractured the dock structure and will require extensive repairs. The vessel struck about midway in the 179-foot main section of the dock. The impact left the tanker's two bow anchors in the mud below the dock. One on the starboard side apparently dropped into water when the collision cut its chain. The port anchor had been dropped for use in the berthing operation, but the accident jammed the chain which would be used to lift it.

City Fireman Surveys Damage At Port
