RFI #97 – Vibracompaction Refusal

Port of Anchorage Expansion Project, Draft Report on Sheet Pile Driving Problems for MKB Constructors

# Report on Sheet Pile Driving Problems for MKB Constructors Anchorage, Alaska

Lachel Reference # 10366008.00 January 11, 2011

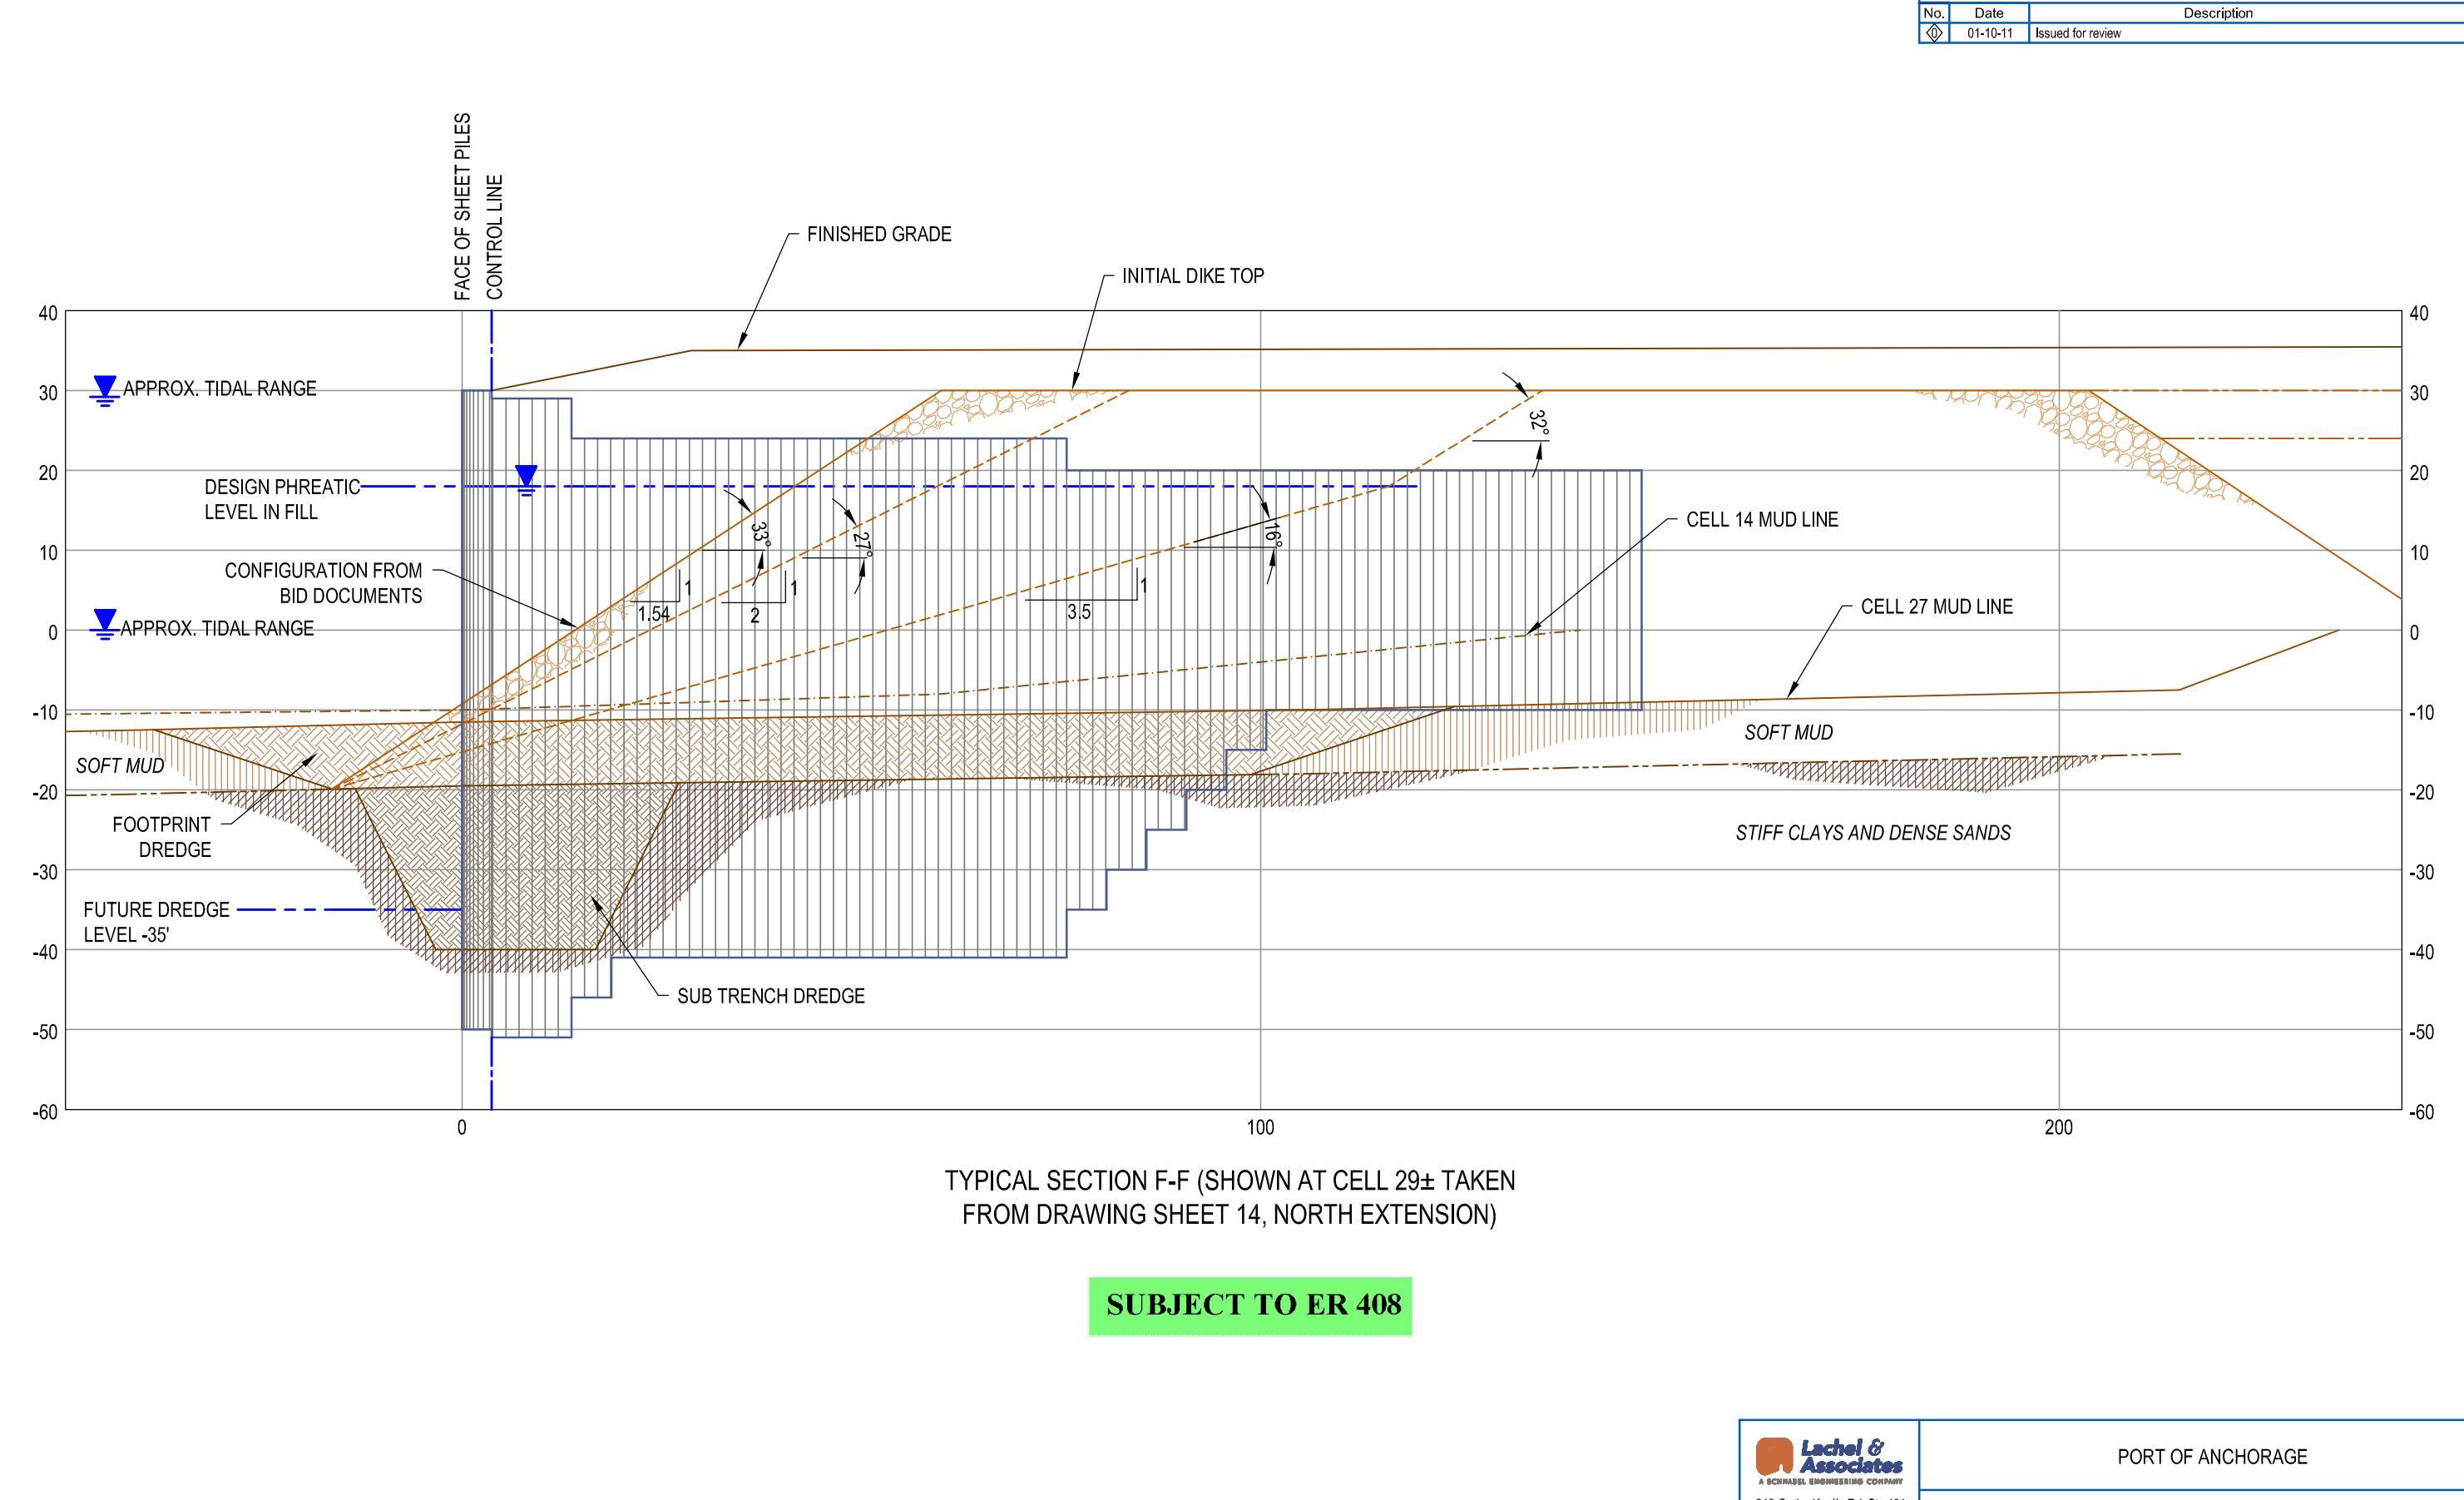
8 Ites Company		PORT OF ANC	HORAGE	
Ste 101 27-1621		CROSS-SEC	TION F-F	
KJC w:	Project No:	10366008.00	Figure 1	 0
KJC w:	Project No:	10366008.00	Figure 1	0

D. Feasible Fill Slope Angle – Typical Sections F-F and G-G, as shown on Drawing Sheets 15 and 16 depict a fill slope for the "initial dike" or work platform that intersects "very stiff clays and dense sands" of the BCF as exposed by footprint dredging, with the toe of the proposed slope shown as 20 feet +/- seaward from the bulkhead control line. The slope angle depicted measures about 33 degrees, a slope of one foot vertical per 1.54 feet horizontal (1 in 1.54). Sections F-F and G-G, as shown in the drawing set are reproduced as Figures 1 and 2 of this report.

In this case, since construction involved extensive vibration during sheet pile driving, it should have been recognized that the stable slope angle below elevation +18 is approximately 16° or less. This configuration is shown superimposed on Sections F-F and G-G in Figures 1 and 2, up to elevation +18, with a slope angle of 32° above that level. Had this been shown on the construction drawings, the dike top would have been so far back from the control line that driving from land would have clearly not been feasible and the whole concept of the work platform as expressed in the General Notes would have been meaningless. (This was apparently recognized by the time of issuance of the plans for the North Extension Bulkhead Project on April 9, 2010, as the concept of the work platform is absent from the revised plans and pulling soil back from the slope is required in the revised General Notes.)

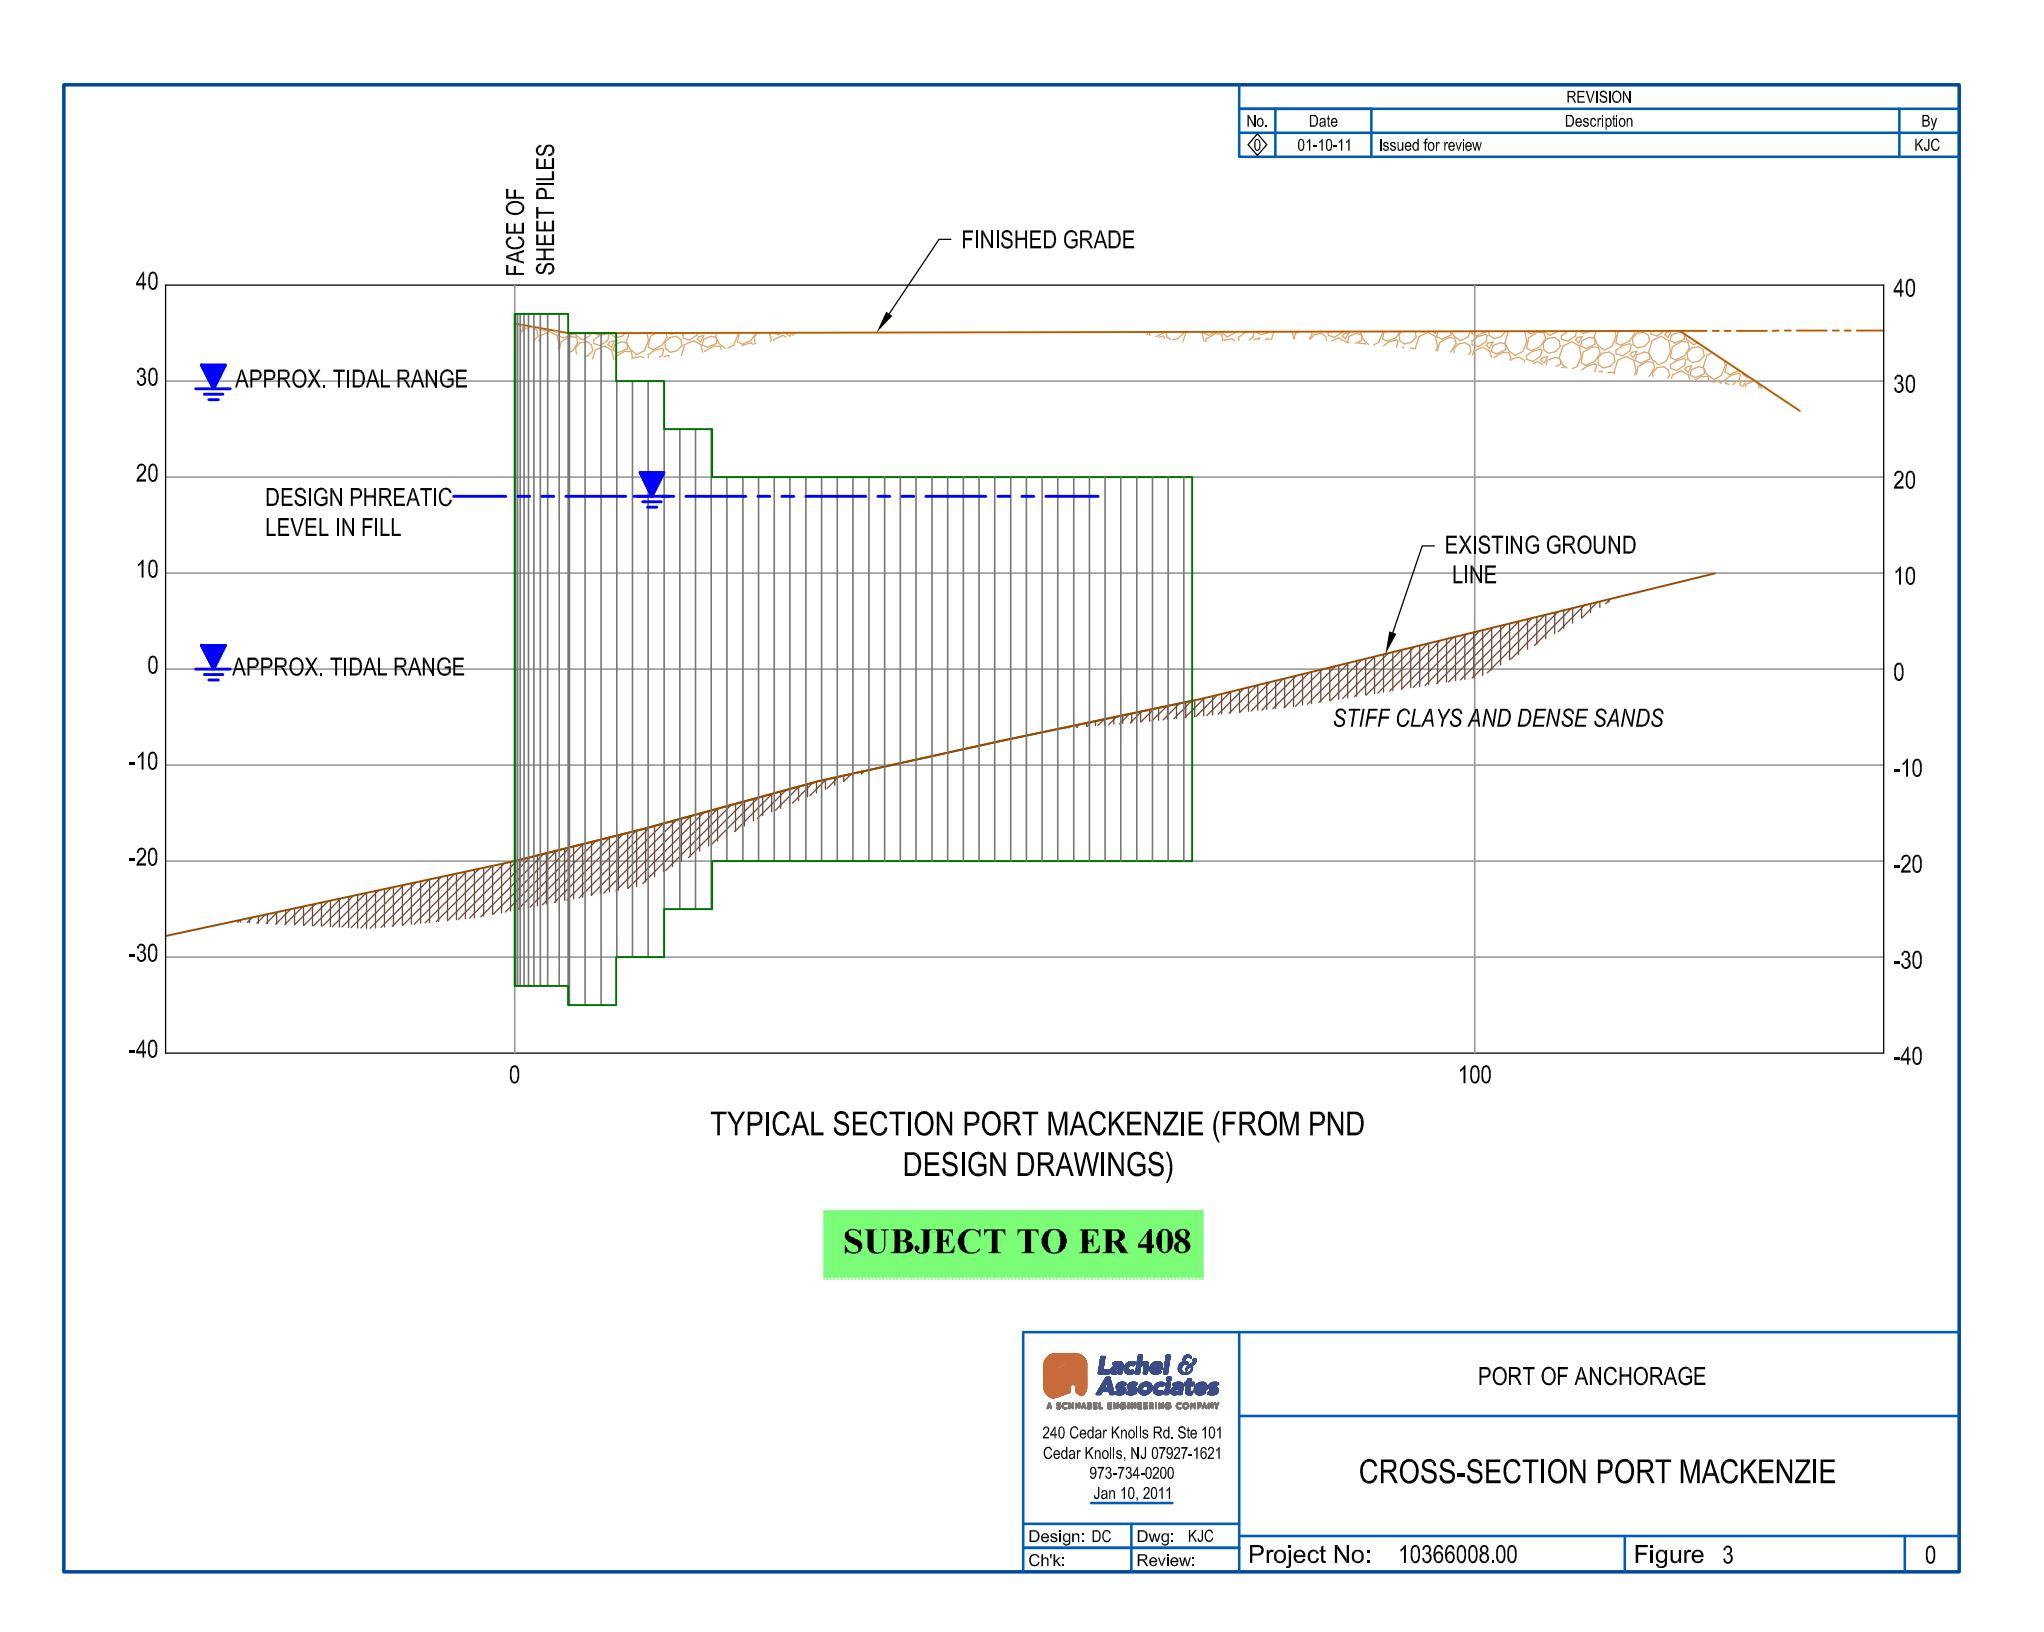
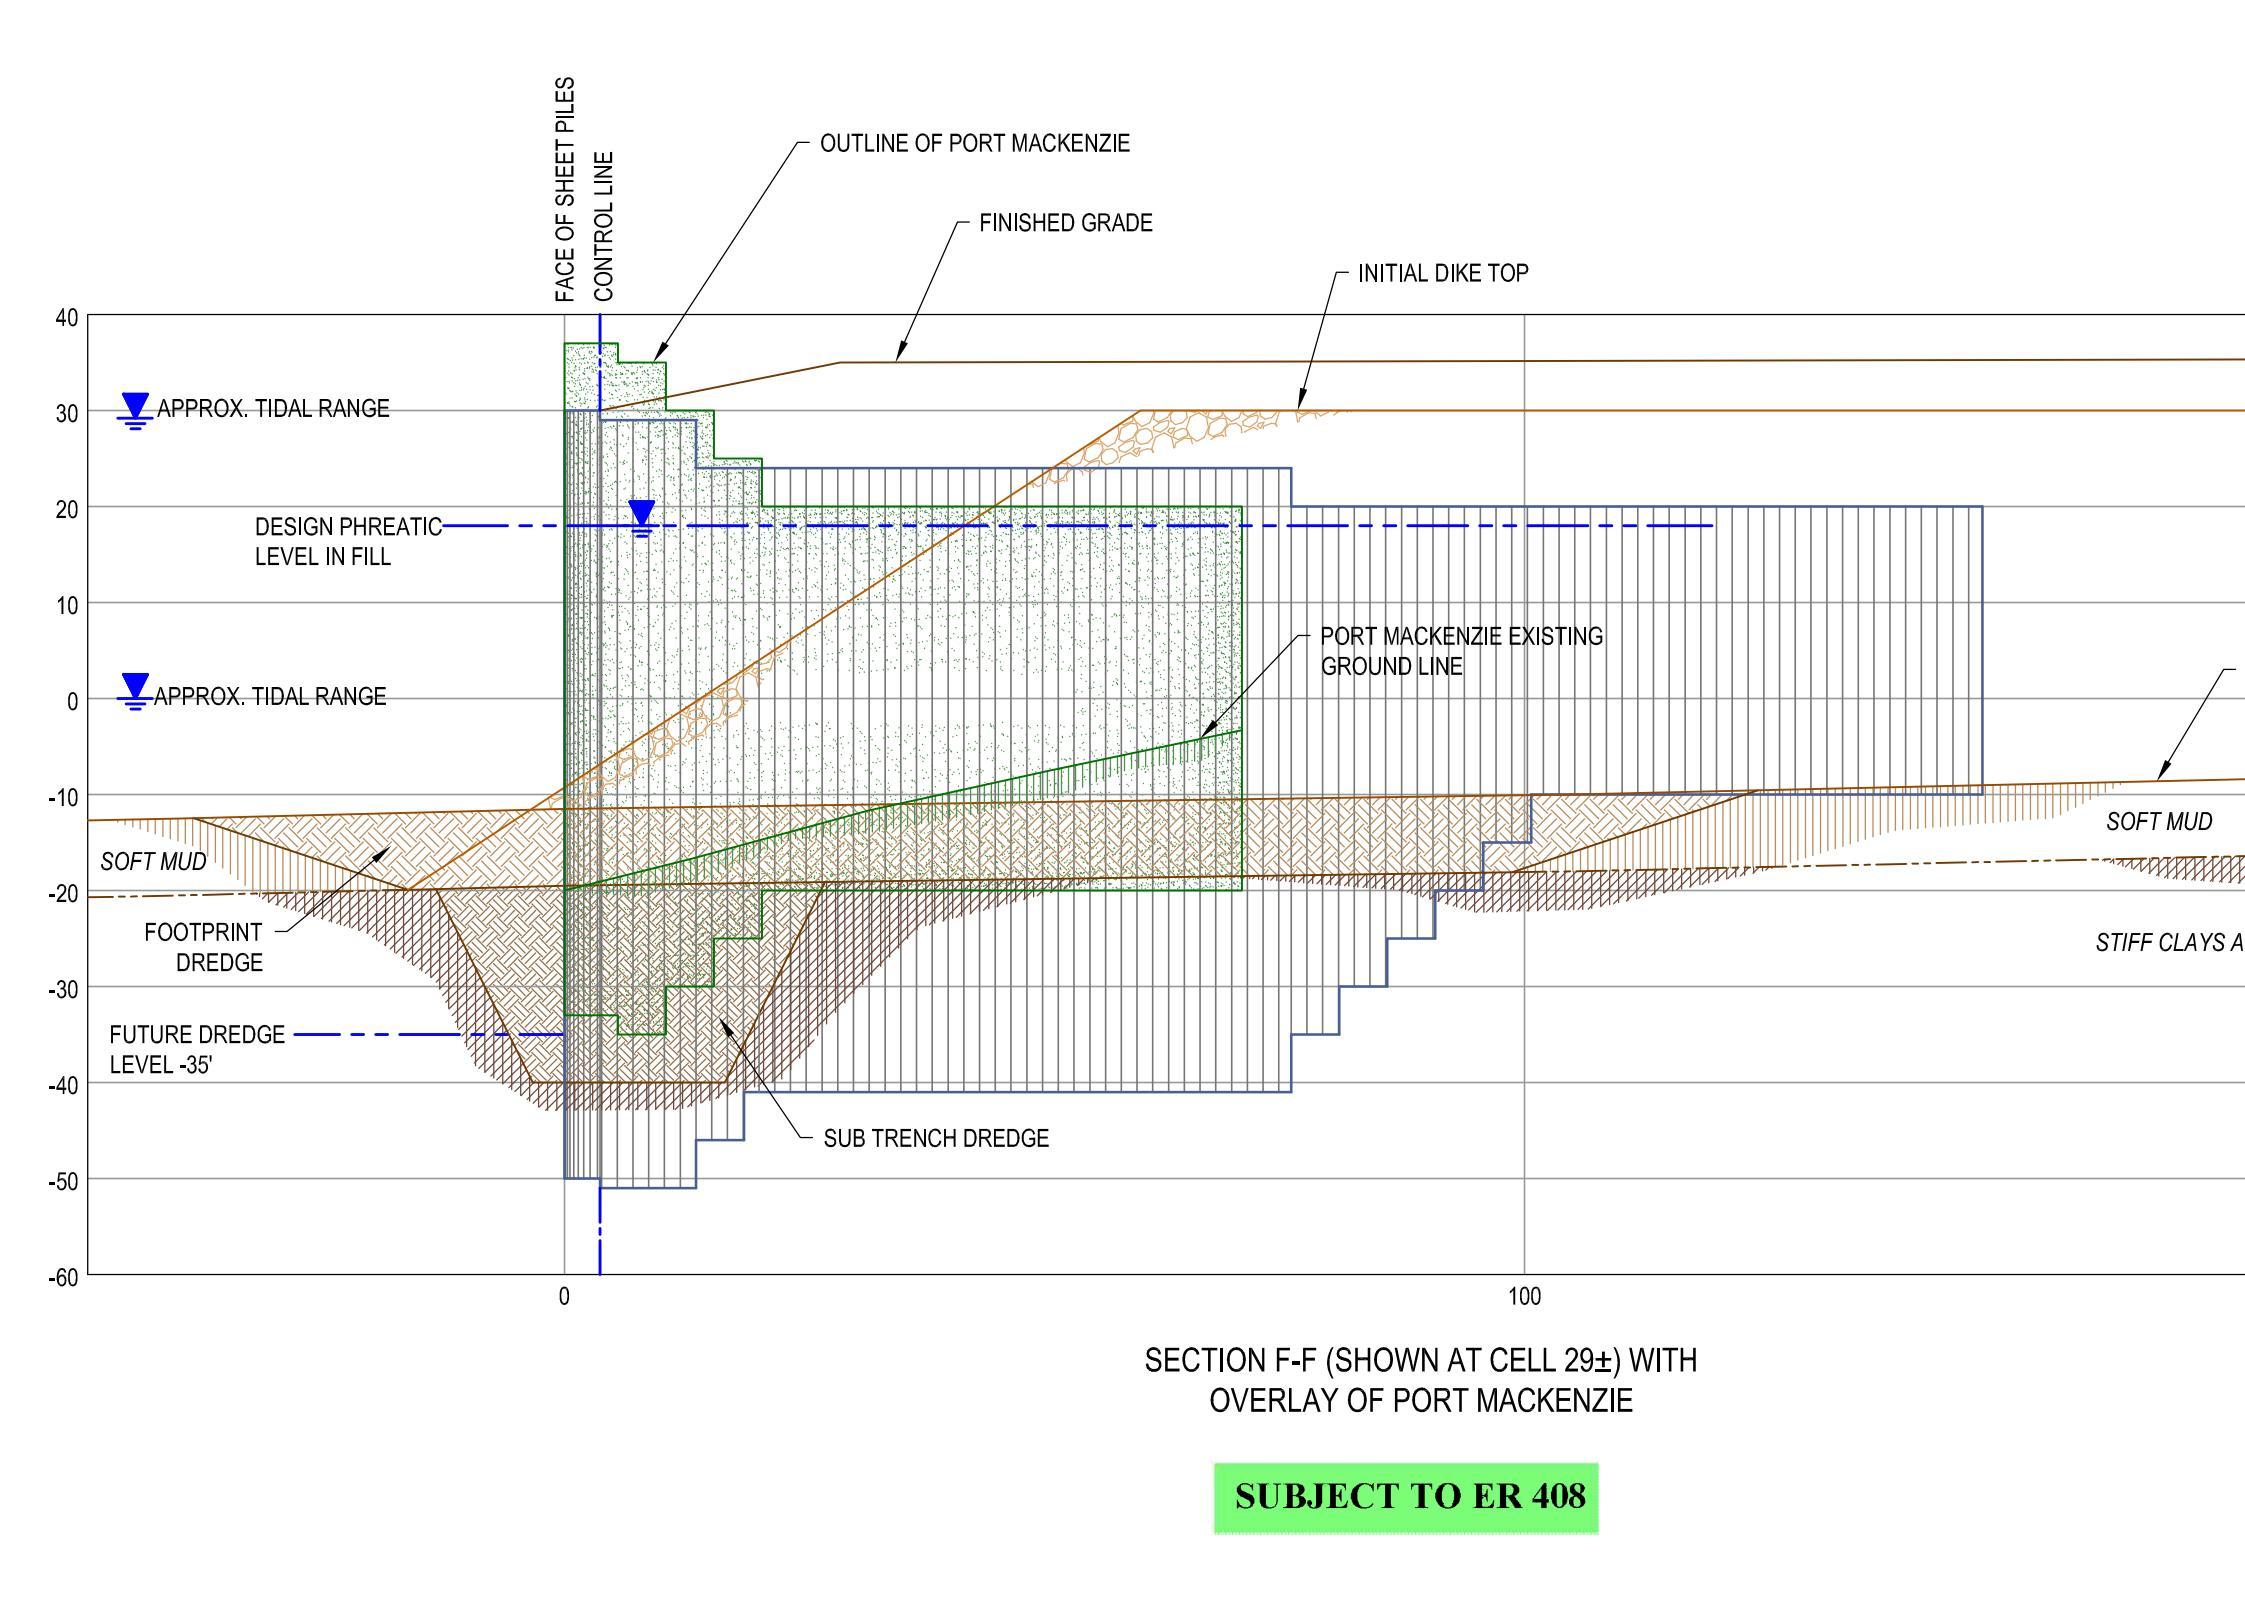
A SCHIMABEL EMOR	thei & sociates MEERING COMMANY	PORT OF ANCHORAGE				
240 Cedar Knolls Rd. Ste 101 Cedar Knolls, NJ 07927-1621 973-734-0200 Jan 10, 2011 Issue date		CROSS-SECTION F-F WITH OVERLAY	Y			
Design: DC	Dwg: KJC					
Ch'k:	Review:	Project No: 10366008.00 Figure 4	0

- It should be noted that Port Mackenzie involved sheets 70 feet in length, and that there was no fill at the dock face. Rather the face sheets were driven directly into in situ soils. The Port Mackenzie configuration is shown as Figure 3, and is also shown superimposed on the Port of Anchorage configuration in Figures 4 and 5. The clear difference in scale between the two applications is apparent, particularly for the portion of the facility represented by Section G-G.
