**Port of Anchorage Intermodal Expansion Project
North Extension/Wet Barge Berth Sheet Pile Inspections**

Wet Barge Berth and North Extension
Preliminary Inspection Summary Report
Volume 2 of 2

10 December 2010

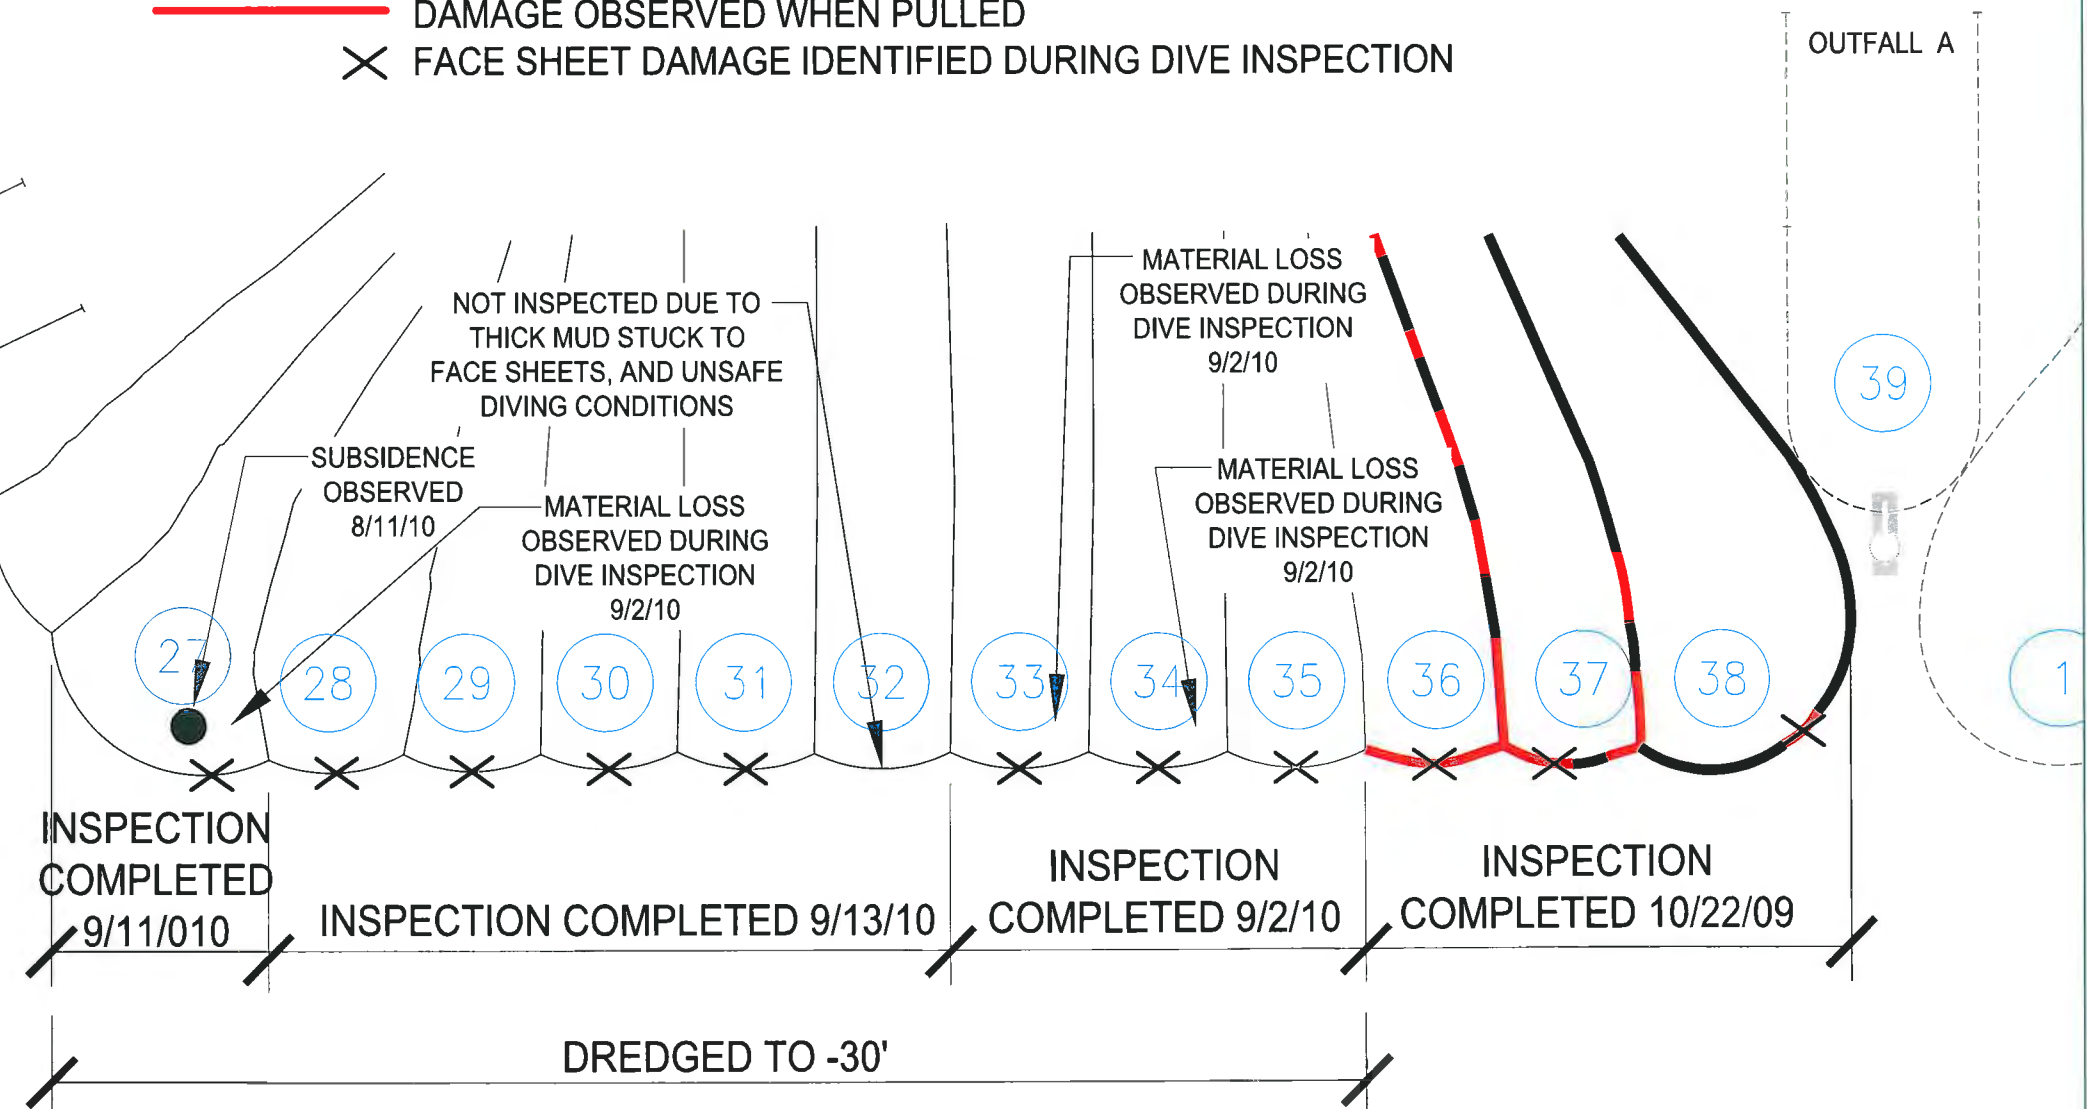
1. At the Wet Barge Berth, damage is present in every cell at face sheets or wyes at WBB cells 27-38. WBB cells 36-38 were removed during August-September 2010 and also found to have tailwall sheet damage.
2. At the North Extension cells 13-30, no damaged face sheets were found. NE cells 9-12, 31 and 32 were removed during August-September 2010 and were found to have face and tailwall sheet damage.
3. At the North Extension cells 41-66, damage is present at multiple cells spread throughout the entire area. NE cells 38-40 were removed during August 2010 and also found to have face and tailwall damage.

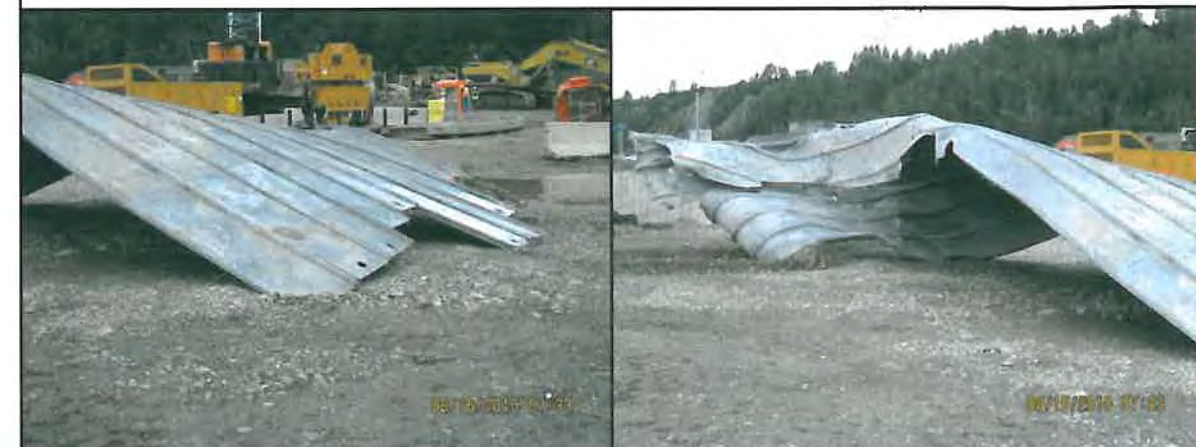
- Sheets pulled from cell 9 return wall were removed from Manson barge and placed on shore. One sheet showed a split interlock approximately 4’ from tip to the end of the sheets. The others sheets showed no major damage at the tip and varying degrees of damage due to pulling sheets with dredge bucket. See photos attached.

Cell 9 return cell sheets after pulling.

Cells 9 sheet after pulling with dredge bucket.

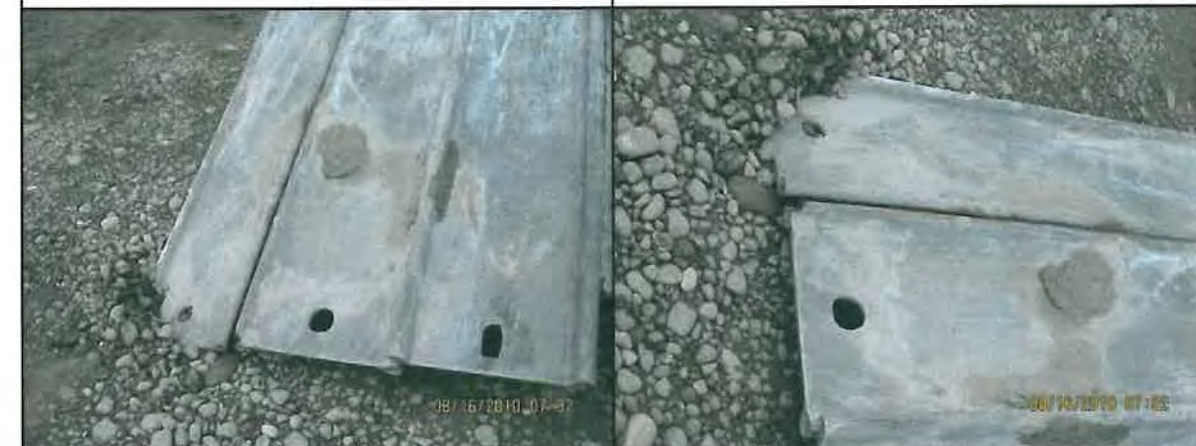
Separated interlock at tip of sheets.

Separated interlock.

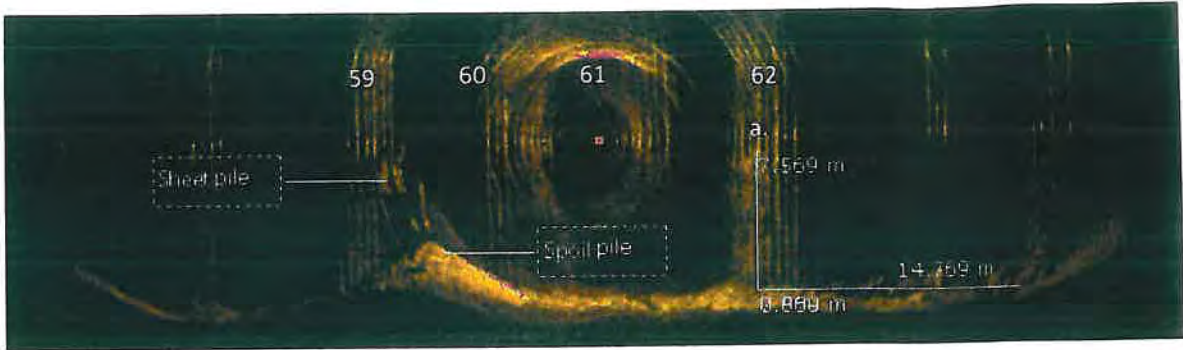
1, 2 Dim 58-64 Point of interest

- 2. 30m Range
 - a. Approximate height of mud line before dredging. Note height of point of interest, marked sheet pile, compared to height of mud line.

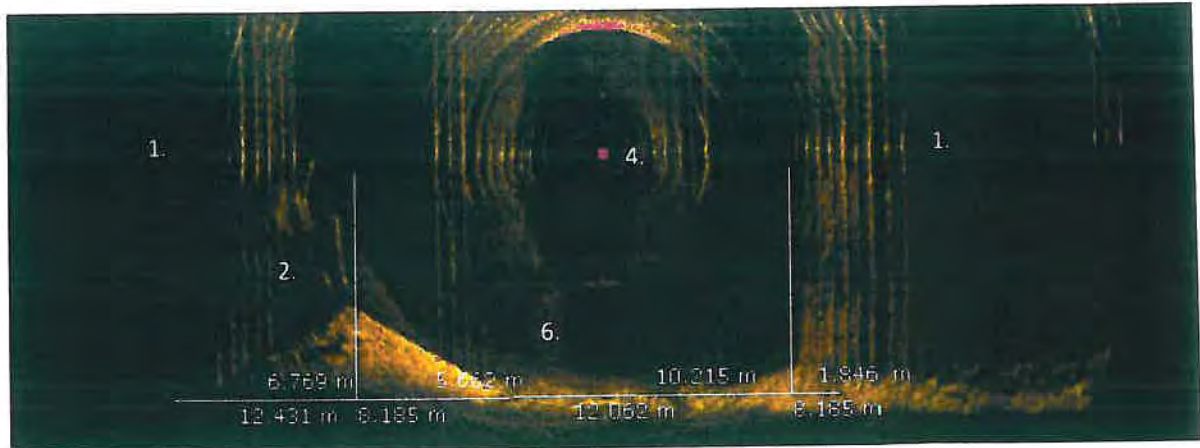
3 Dim 59-61 Point of interest I

- 3. 20m Range
 - a. Approximate height mud line before dredging and height of Point of interest above trench bottom. Add- top mud line, slab height, surface reflection and distortion.

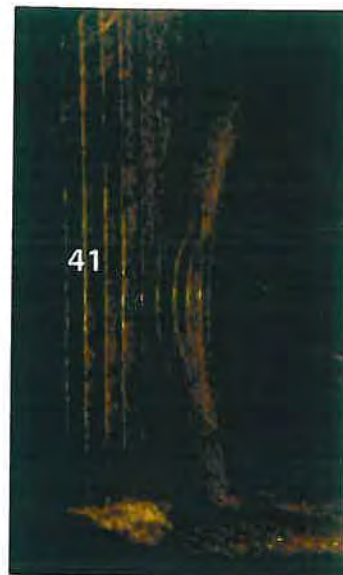
Interlocks on sheets appear to be straight and without gaps. The joints between 11 and 16 are visible on the sonar image.

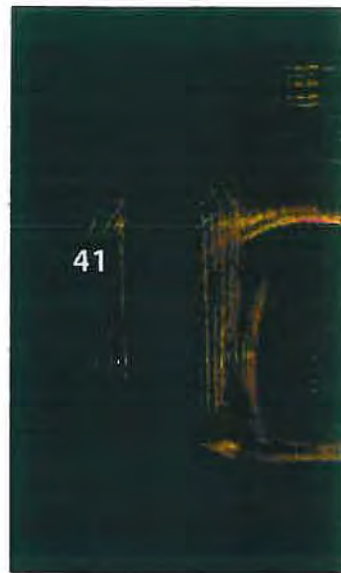
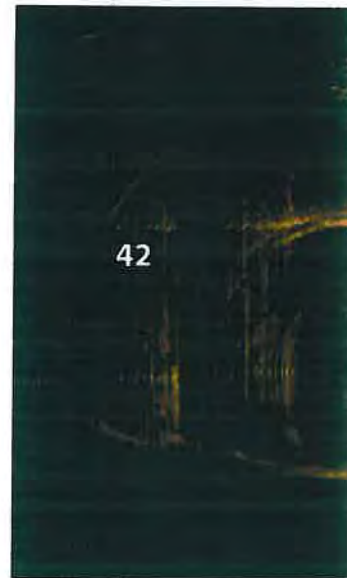
Interlocks on sheets appear to be straight and without gaps. Note: the mud line was higher to the left of cell 42, as described by the diver.

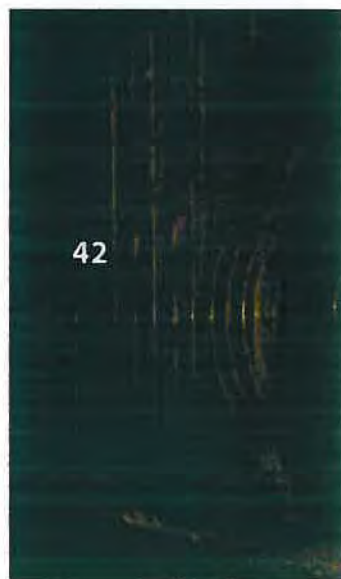
Interlocks on sheets appear to be straight and without gaps. Cell 44 is visible to the right of cell 43 in the sonar image.

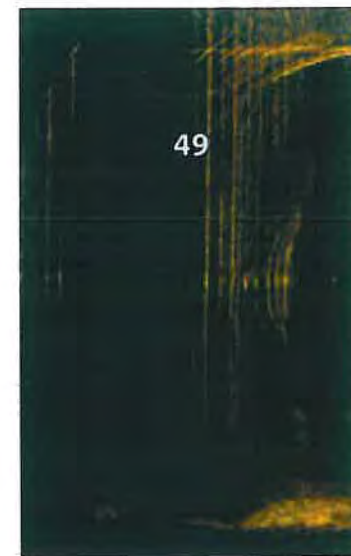
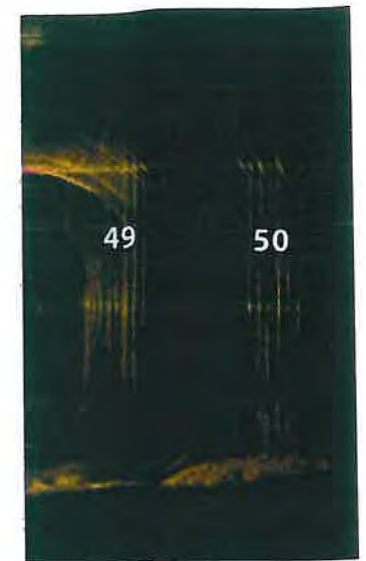
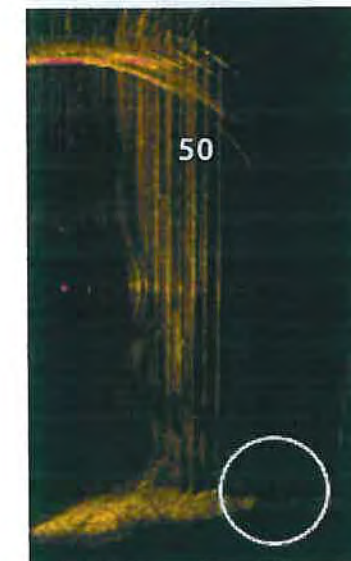
Interlocks on sheets appear to be straight and without gaps. The circled images along the mud line indicate an anomaly near the location that the divers discovered 18" from the pile walls and approximate location of sheet 11.

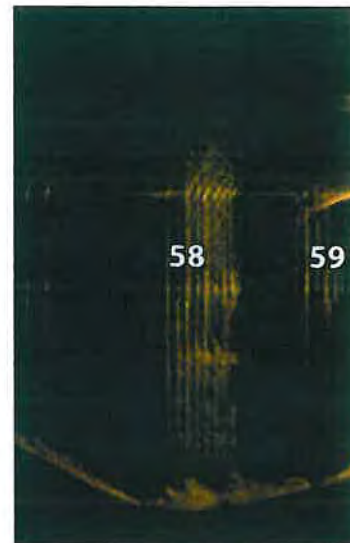
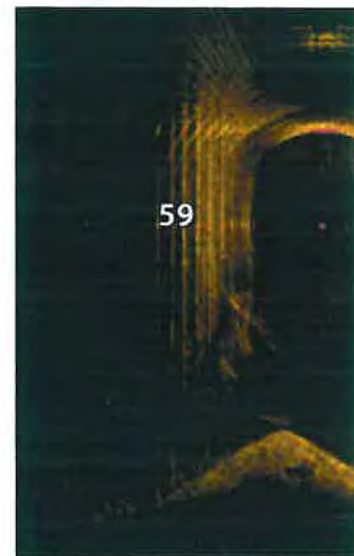
The parturitions shown on the sonar images from the south side of cell 59 are leaving long shadows angling down and to the left. This indicates that the anomalies are standing off the cell wall with approximately the same width as the sheet pile. Observe that the interlocks run continues from the top of the anomaly and come out aligned at the bottom of the anomaly's shadow. This could suggest that the interlocks on cell 59 are continues.

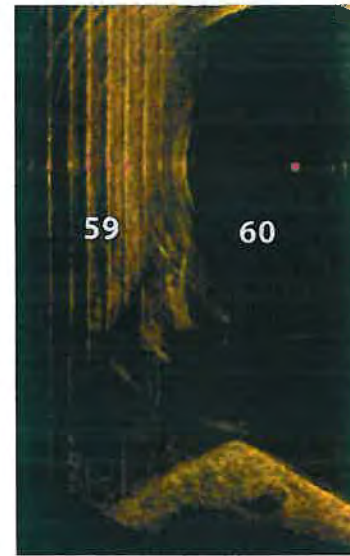
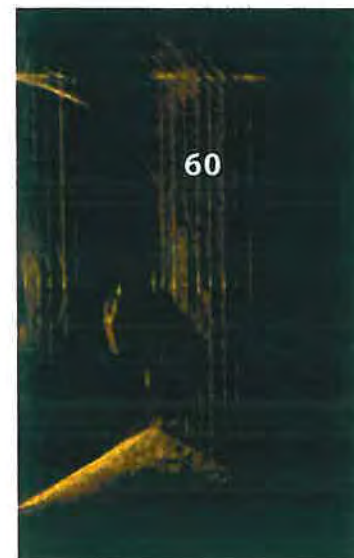
Note: The center of the spill pile is on the north side of cell 60 and is below the protruding anomaly indicating an opening in the cell wall at the intersection of cell 59 and 60. All other cell interlocks on the sheets appear to be straight and without gaps to the right of the top of the spill pile.

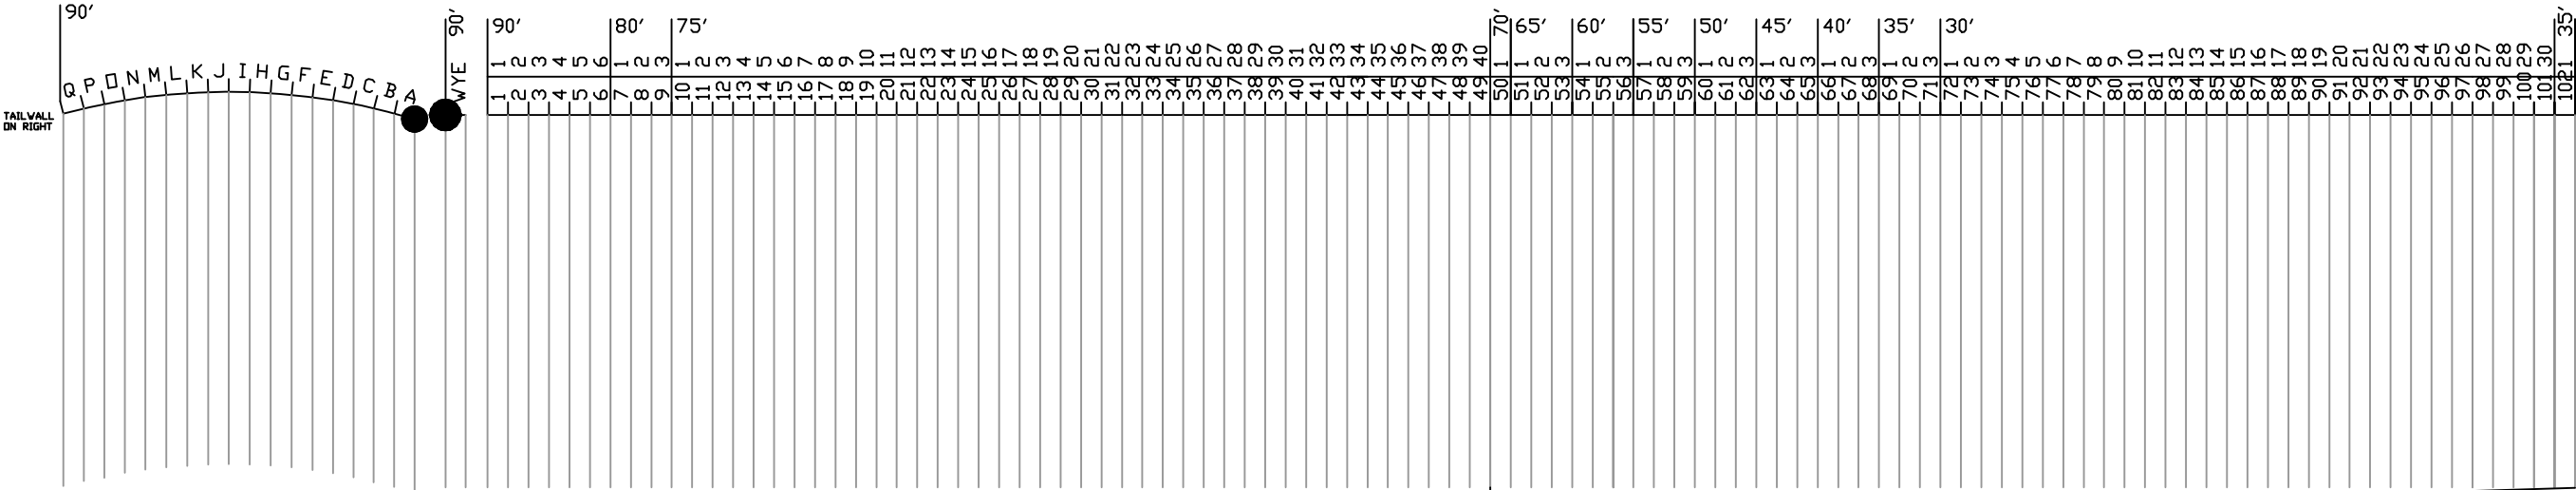
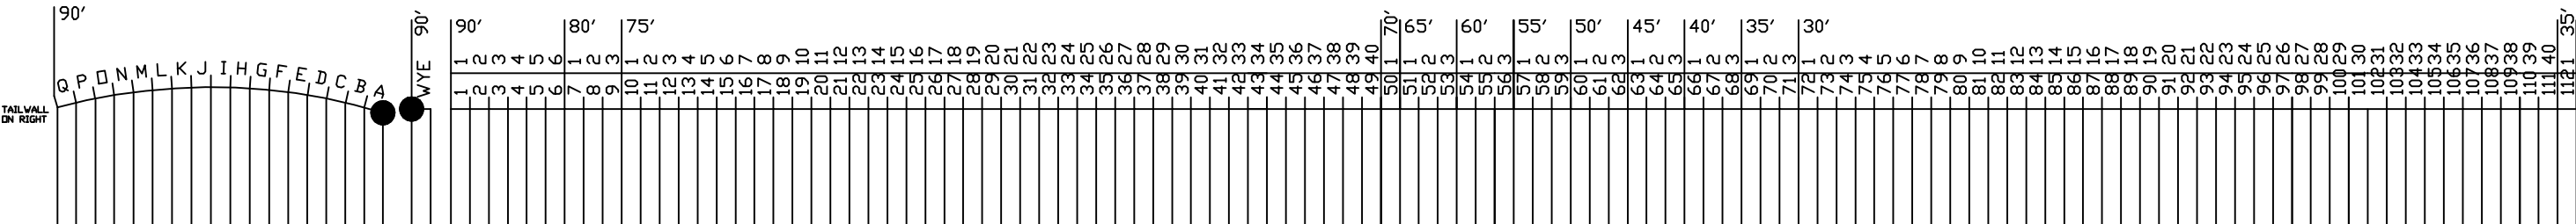
NE 63

FROM WINTER CLOSURE PLAN: "PULL AND INSPECT TAILWALLS FROM END ANCHOR TO INTERMEDIATE ANCHOR..."

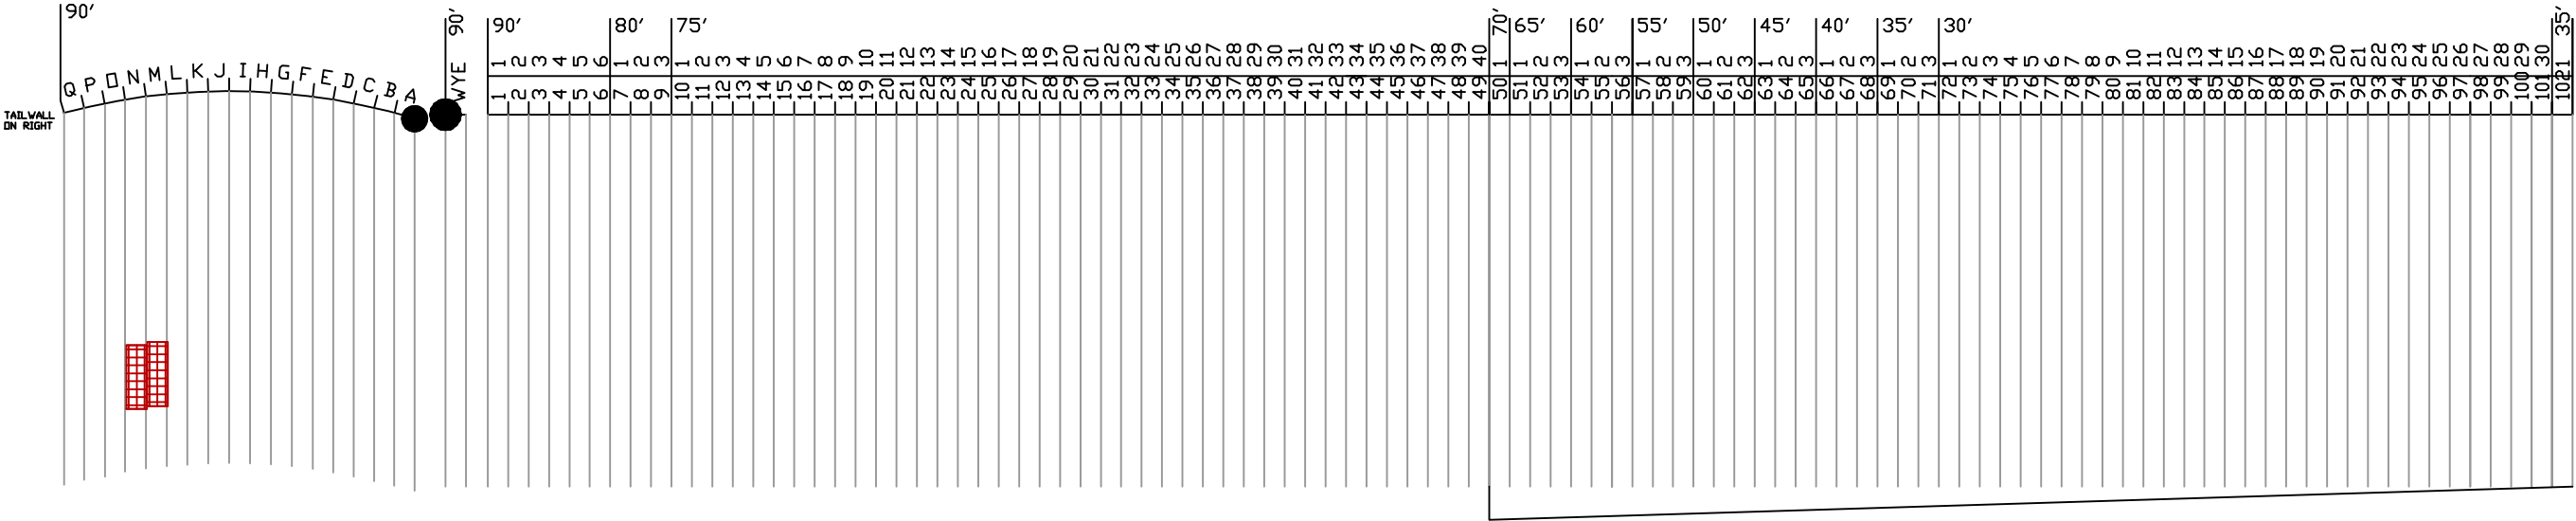
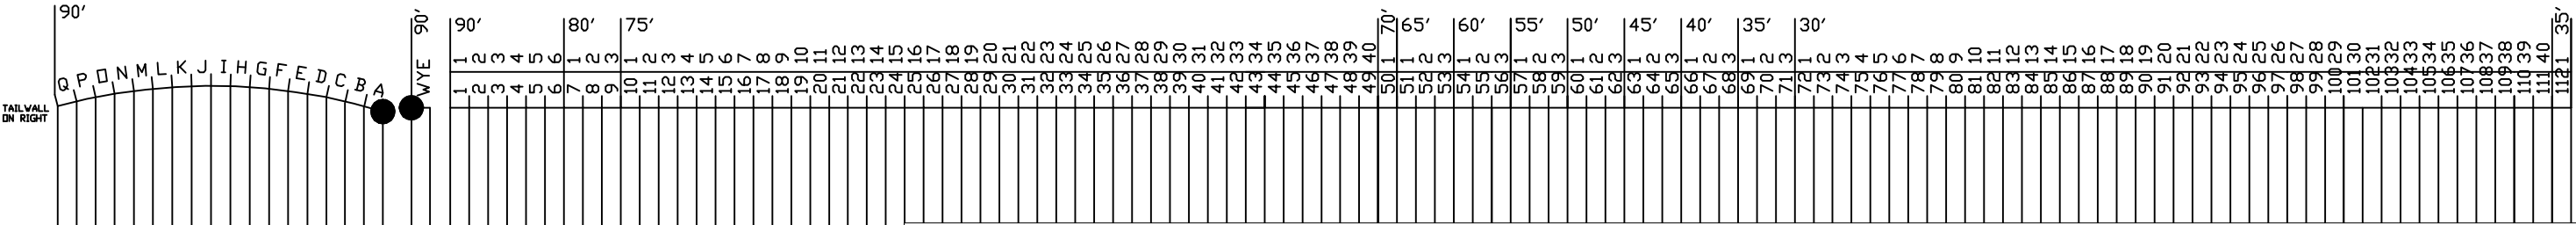
NE 64

FROM WINTER CLOSURE PLAN: "PULL AND INSPECT TAILWALLS FROM END ANCHOR TO INTERMEDIATE ANCHOR..."

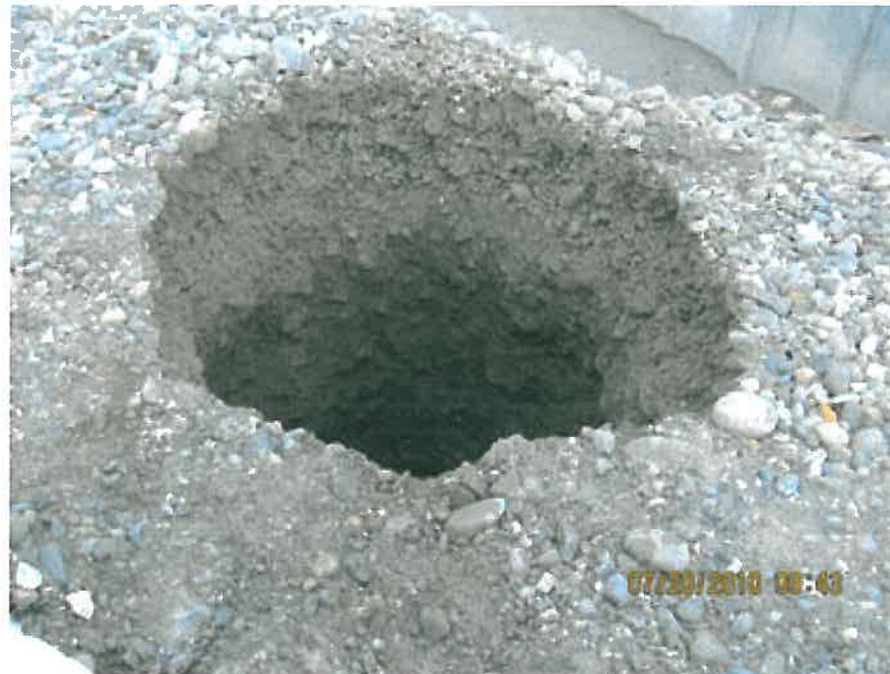
Cell 60

Subsidence Photos

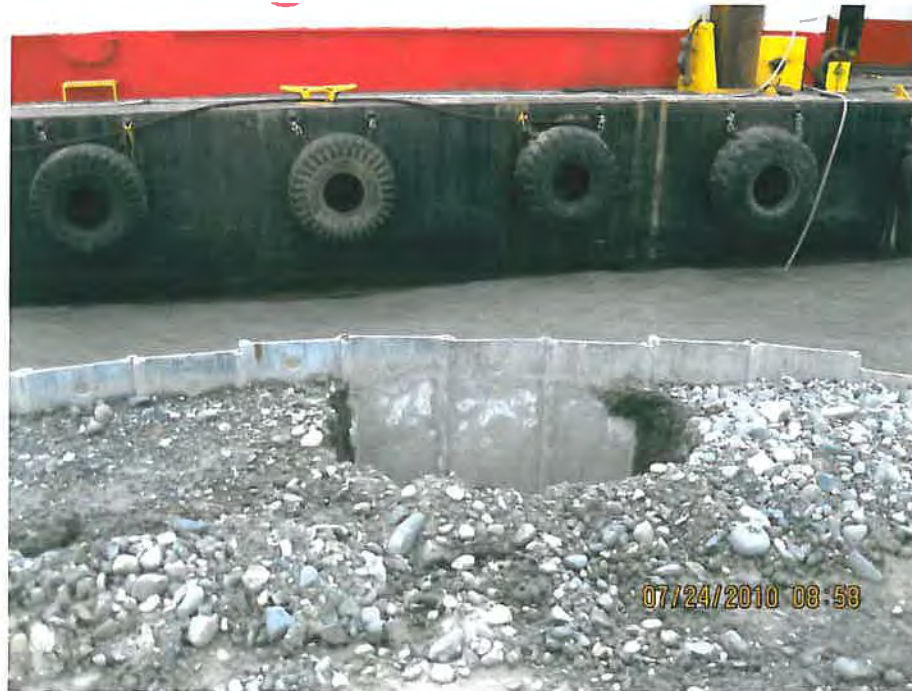
Cell 63

Subsidence Photos

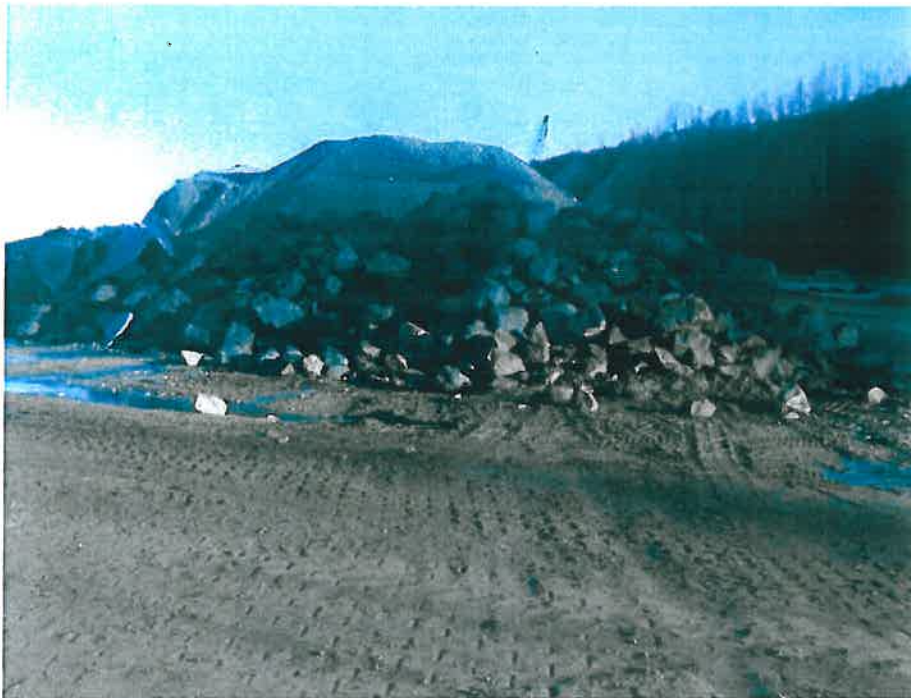
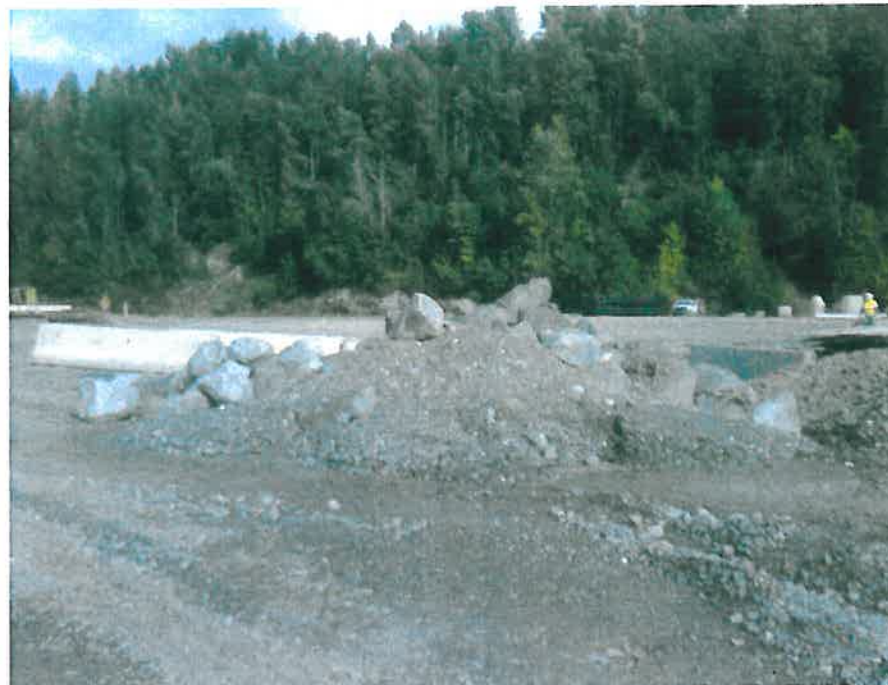
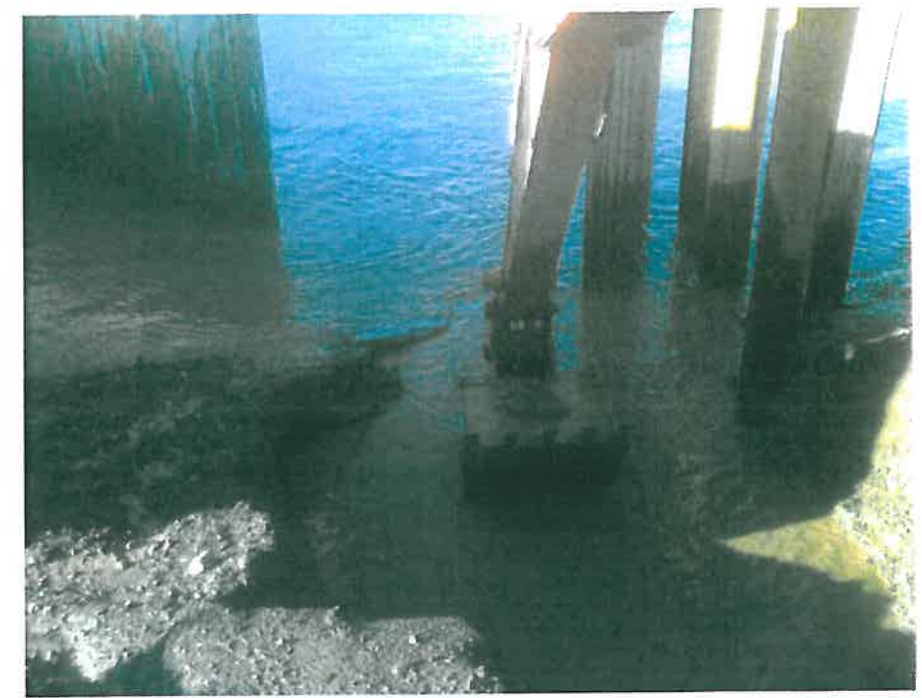
Cell 11

Boulders Photos
