Anchorage port survives nature

HARRY EKIZIAN, JR., F. ASCE
Associate
Tippetts-Abbett-McCarthy-Stratton
New York, N.Y.

THE SITING OF THE Anchorage Marine Terminal on Knik Arm, a part of Cook Inlet and the Gulf of Alaska, presented TAMS' engineers with the task of designing a pier structure in a severe earthquake zone, in an area with an extreme tidal range of 42 ft (12.8 m), and in a body of water where ice floes 4 ft (1.2 m) thick carried by strong currents would impinge against the structure. In addition the long unsupported and unbraced length of piles, the ice build-up beneath marine structures, and the poor foundation conditions combine to make the planning and design of marine terminals in Anchorage a unique engineering challenge.

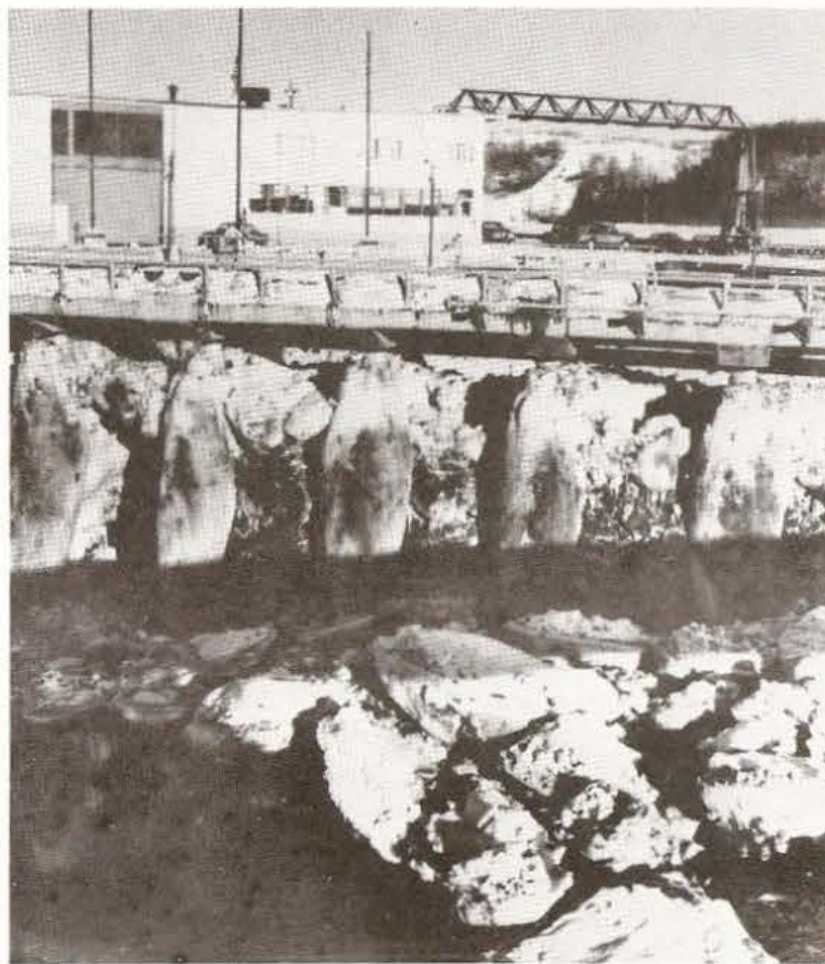
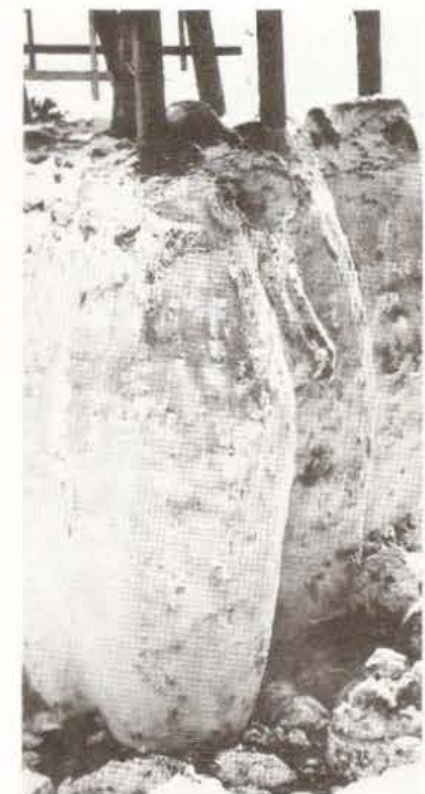
Floe ice 4 ft (1.2 m) thick carried by some of the strongest tidal currents in the world striking the pipe piles was just one of the unique conditions faced by TAMS designers. Another was the 20-ft (6.1-m) thick ice buildup under the wharf adding to the weight and uplift applied to piles with 70-ft (20-m) unsupported lengths.

The substructure design for the first wharf segment consisted of a reinforced concrete deck supported on steel pipe piles varying in diameter from 16 in. (406 mm) at the landside of the wharf to 20 and 24 in. (508 and 610 mm) near the waterside of the wharf. The outboard row of piles, however, are made of 42-in. (1,067-mm) diameter concrete filled pipe in order to absorb ice floe forces. These front caissons also serve as beams to withstand the docking forces of the vessels. The piles are spaced approximately 10 ft (3 m) apart in bents at 13.3 ft (4.06 m) on centers. All other pile piles were filled with sand. The pile heads are embedded in 4-ft (1.2-m) wide cap beams 3.5 ft (1.07 m) deep. The apron deck slab is 12 in. (305 mm) thick.
